Final Report

Accident with the helicopter Sokol W-3A,
on 14.01.2019, at approx. 11:34 UTC at Bürglkopf,
Gemeinde Fieberbrunn, A-6391, Tyrol,
GZ.: 2021-0.905.481

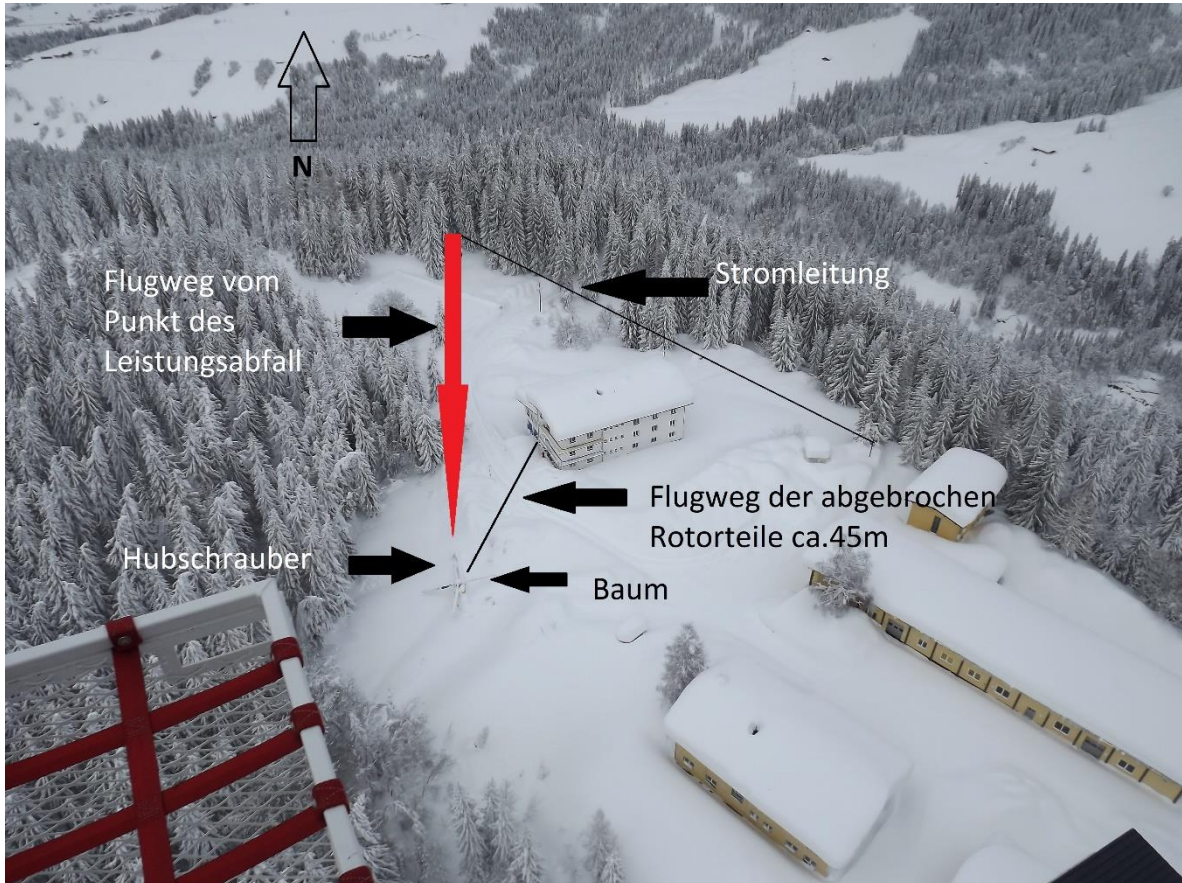
Figure 1: Overview of the emergency landing site

Shortly after reaching the Almgasthof, the pilot noticed an abrupt drop in the helicopter's performance. He was no longer able to maintain altitude, so he aligned the nose of the helicopter to the right and started forward motion with the stick to reach the later emergency landing area. The helicopter had a high sink rate. The pilot decided to land on the western side of the Almgasthof. When the helicopter touched down at around 11:34 a.m., it touched a tree on the left with its rotor blades. This damaged the main rotor blades.

Damage to a house facade due to broken main rotor blades.

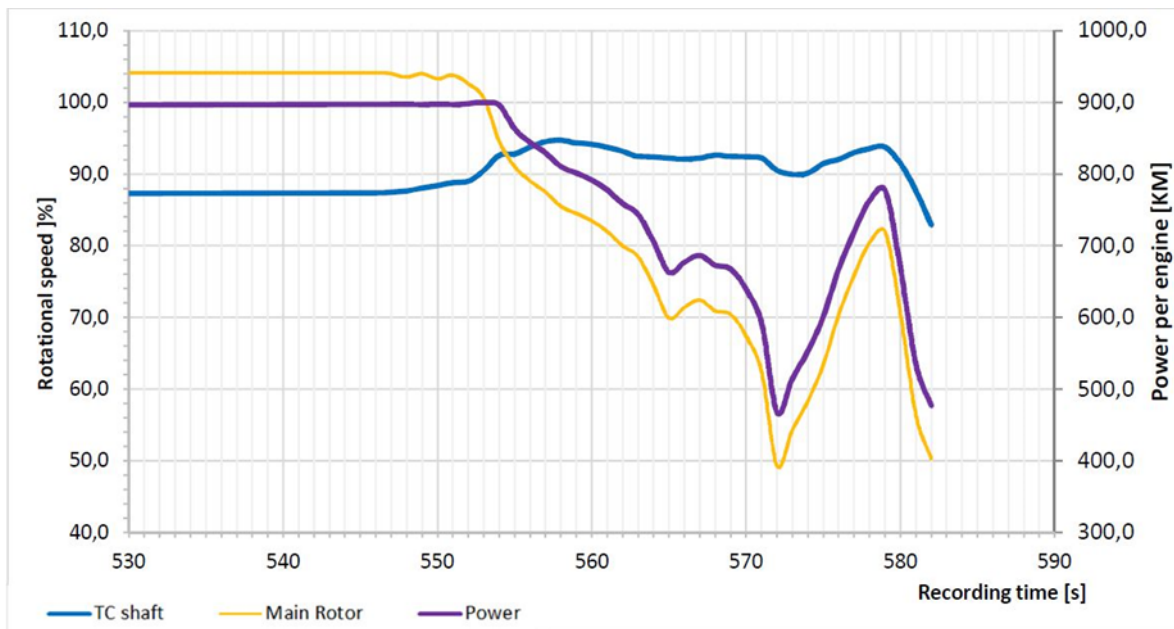
Figure 4: Extract from the report RB/P/401,64/4/2019

„...If only OEI 30min. power from one engine is available (no disposable power provided by the other engine), it is not possible to perform the hover in windless conditions for the undisturbed rotor characteristics (without icing). For the disposable power value presented in Figure 4 and the WN RPM, the hover IGE in windless conditions would have been possible

with undisturbed main rotor characteristics (no icing) until the moment of the detected ground contact. This suggests that at the time of the incident, the power demand of the engines for flight and hover was greater than that corresponding to the undisturbed rotor characteristics. In addition, the amount of disposable power of the engines prior to the onset of the event, shown in Figure 4, suggests a significantly higher demand for power needed for flight (the use of take-off power to perform a level flight shown in Figure 4 suggests an excess power demand of 400-600[hp] over the baseline level of the power needed). The accurate determination of the power required for flight is very difficult due to the lack of helicopter airspeed data at the time of the incident..."

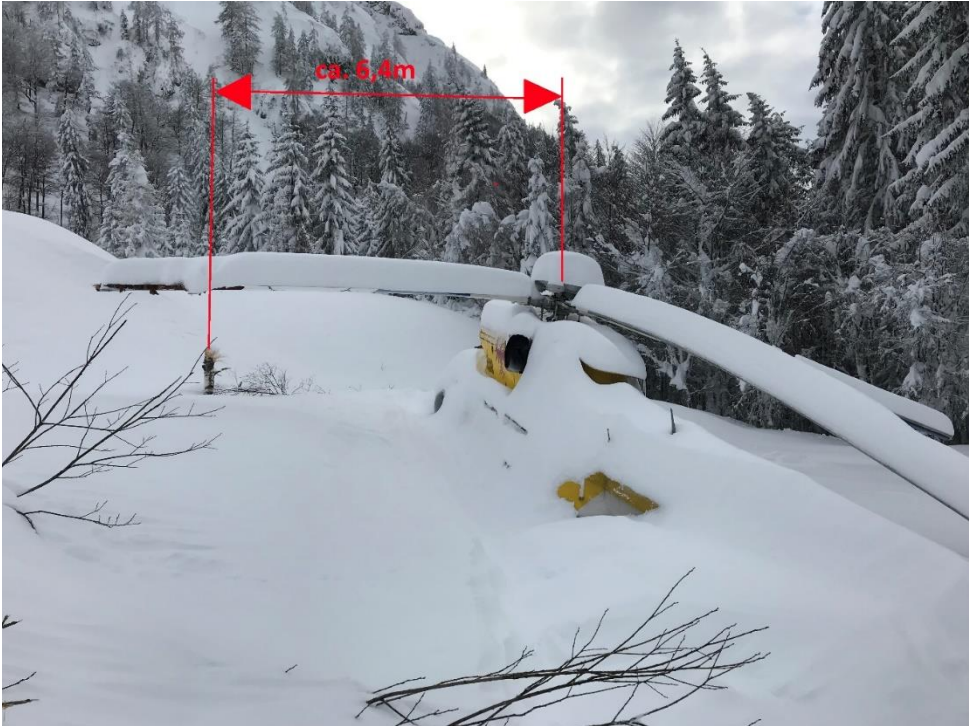
Figure 12: Distance to obstacle the picture was taken the day after

The average distance between the rotor mast and the touched tree was about 6.4 m (see Figure 12). This distance corresponds approximately to the average length of the severed main rotor blades. Furthermore, the damage to the tail rotor and the vertical fin could be attributed to the severed main rotor blades. A part of a severed rotor blade damaged the front of a local house at a distance of about 45 m (see figure 1).

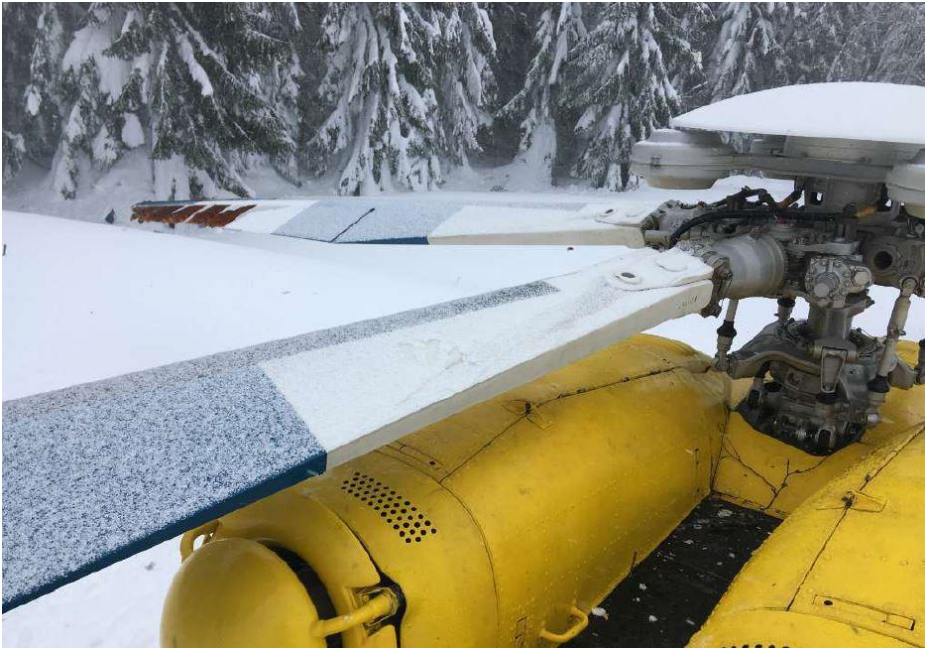
Figure 14: Picture was taken direct after emergency landing

(Figure 14) was fresh snow that was left on the aircraft after the helicopter was parked at the emergency landing site. No ice accumulations were visible on the main rotor blades. Slight ice accumulations were visible in the area of the forward landing gear fairing. Wet snow accumulations were visible above the engine cowling. (Figure 15).

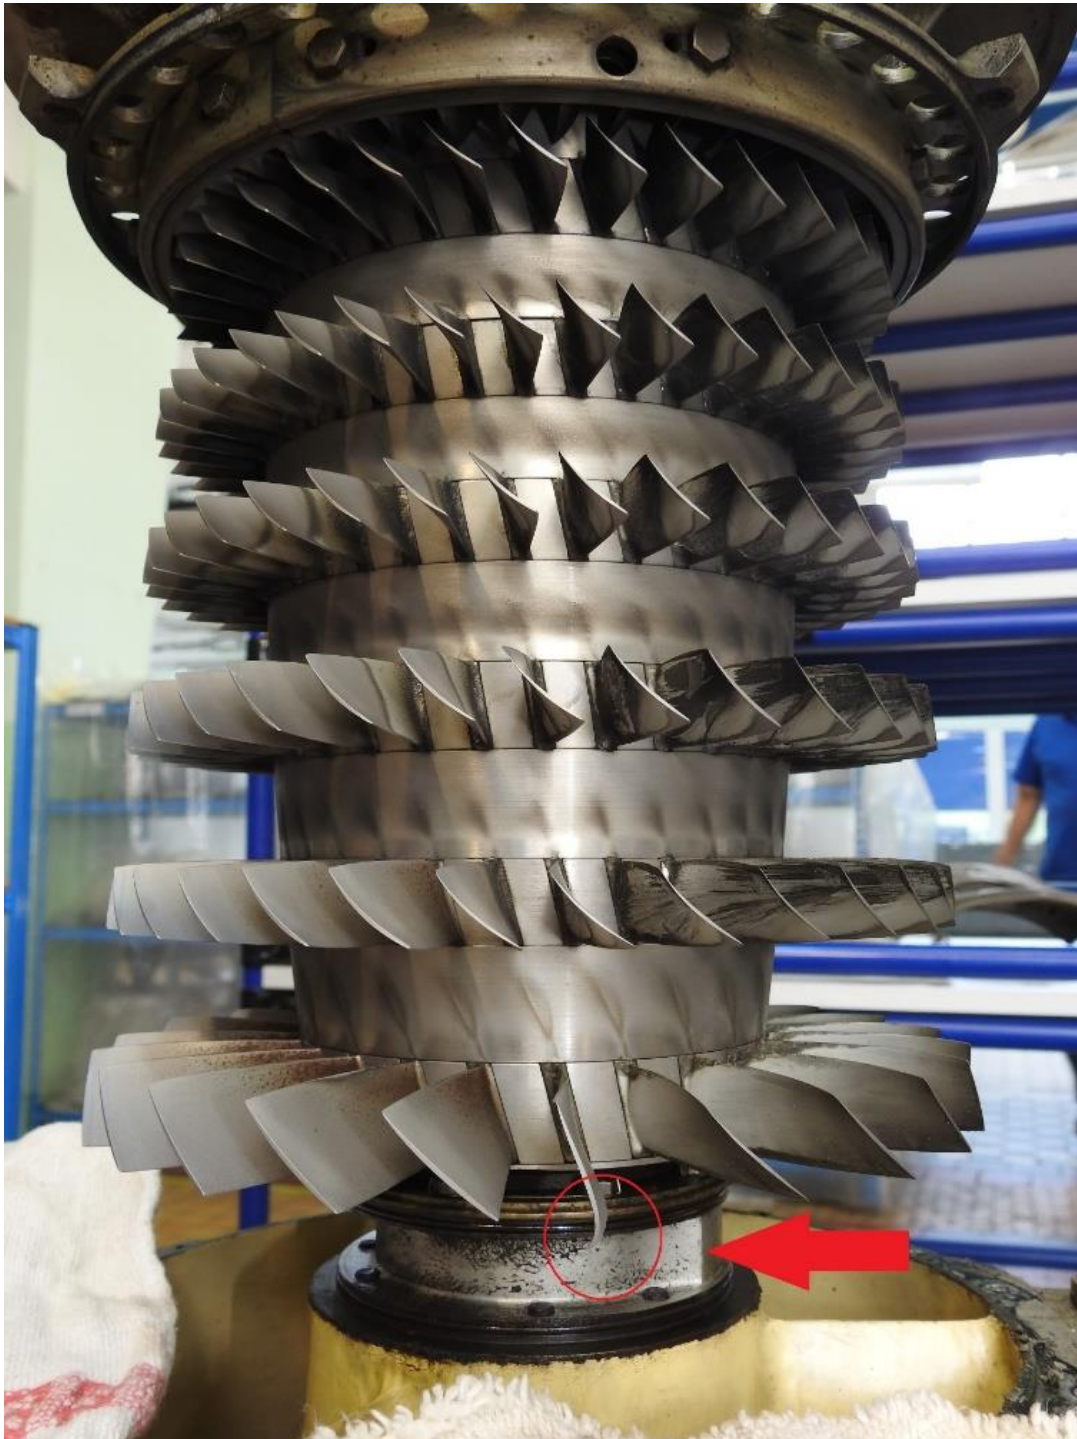
Figure 18: Compressor stage axial compressor

- *In the front axial compressor stage there was damage in the form of deformed compressor blades (2 pieces), and stator blades (11 pieces)*
- *Two Inlet Case Front Struts were painted with an atypical yellow paint; it was also found that this paint was subject to severe corrosion*

In the front axial compressor stage of the right engine (Engine 2), two compressor blades showed considerable deformation. (Position of the second compressor blade opposite).

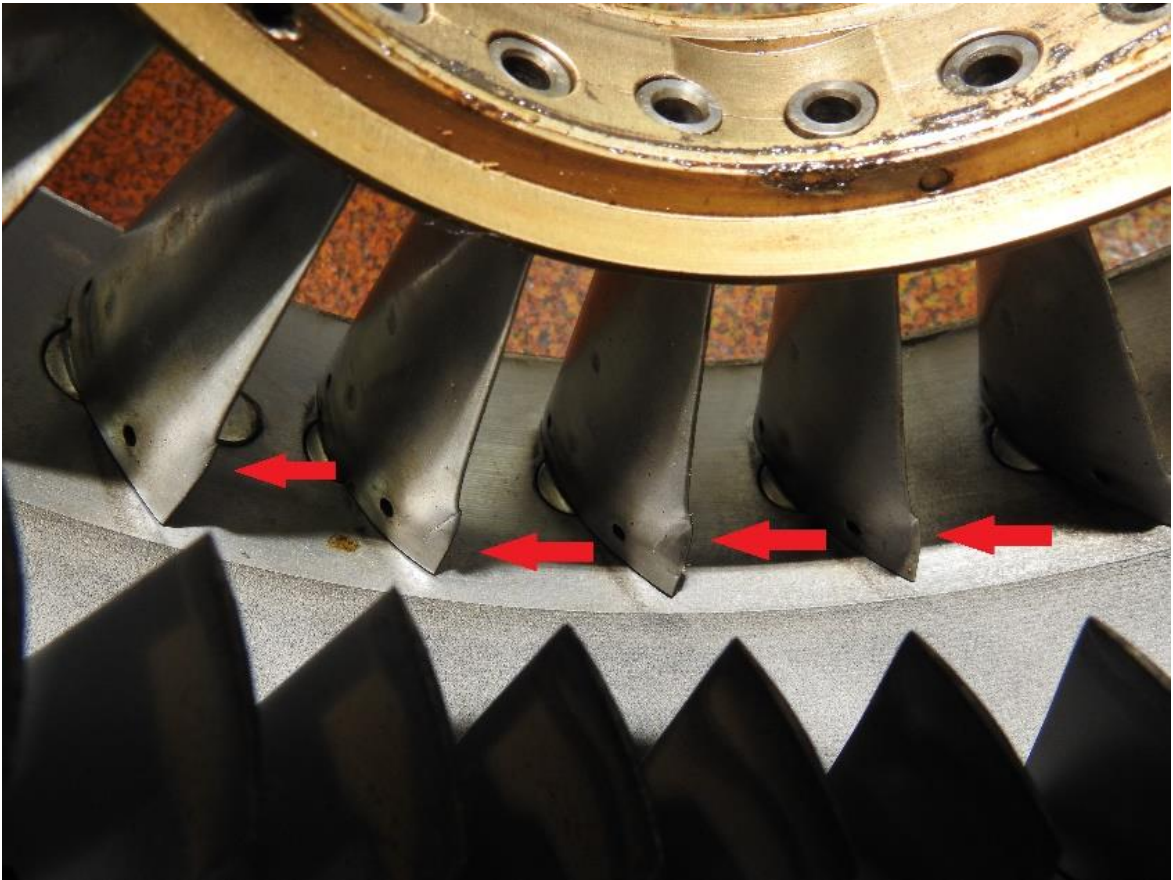
Figure 19: Stator blades of the first axial compressor stage

Eleven stator blades of the first axial compressor stage of the right engine (Engine 2) exhibited deformation.

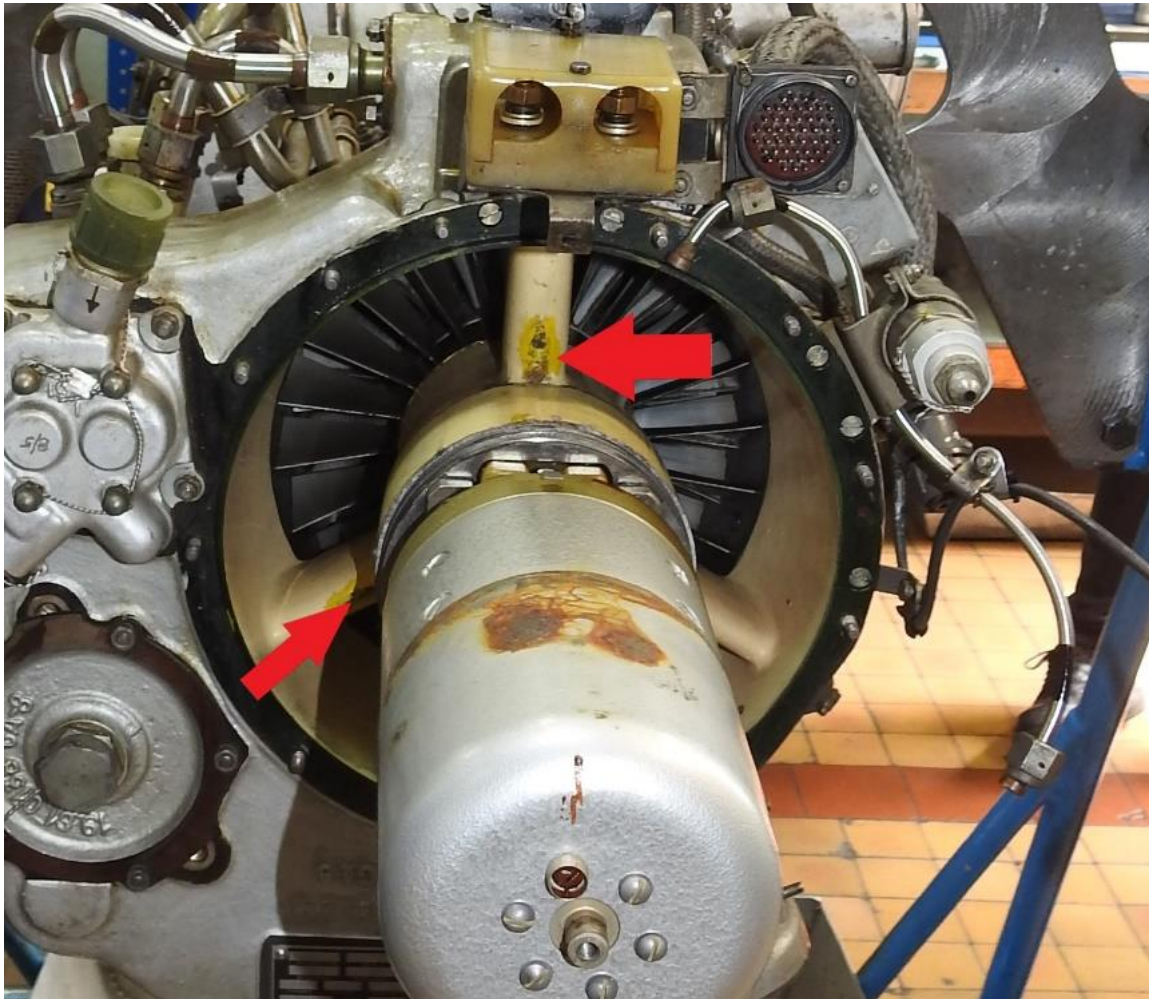
Figure 20: Anti-icing airflow ducts in intake casing

- *Openings in the two Inlet Case Front Struts referred to in the previous point, through which hot air was supposed to flow out to prevent ice build-up, were closed due to the corrosion referred to above*

At two inlet case front struts in the engine air intake cowling (Figure 15 + Figure 16), through which combustion air (hot air from the engine combustion chamber) is passed to prevent ice build-up in the engine inlet, corrosion was detected to such an extent that those openings through which the hot air was to flow out were closed. Further visible in the form of yellow paint on two inlet case front struts of the inlet case assy indications that the repair in this area was carried out improperly. According to the engine manufacturer's instructions, such repairs in this area are inadmissible and not intended, irrespective of any measures taken by the manufacturer.

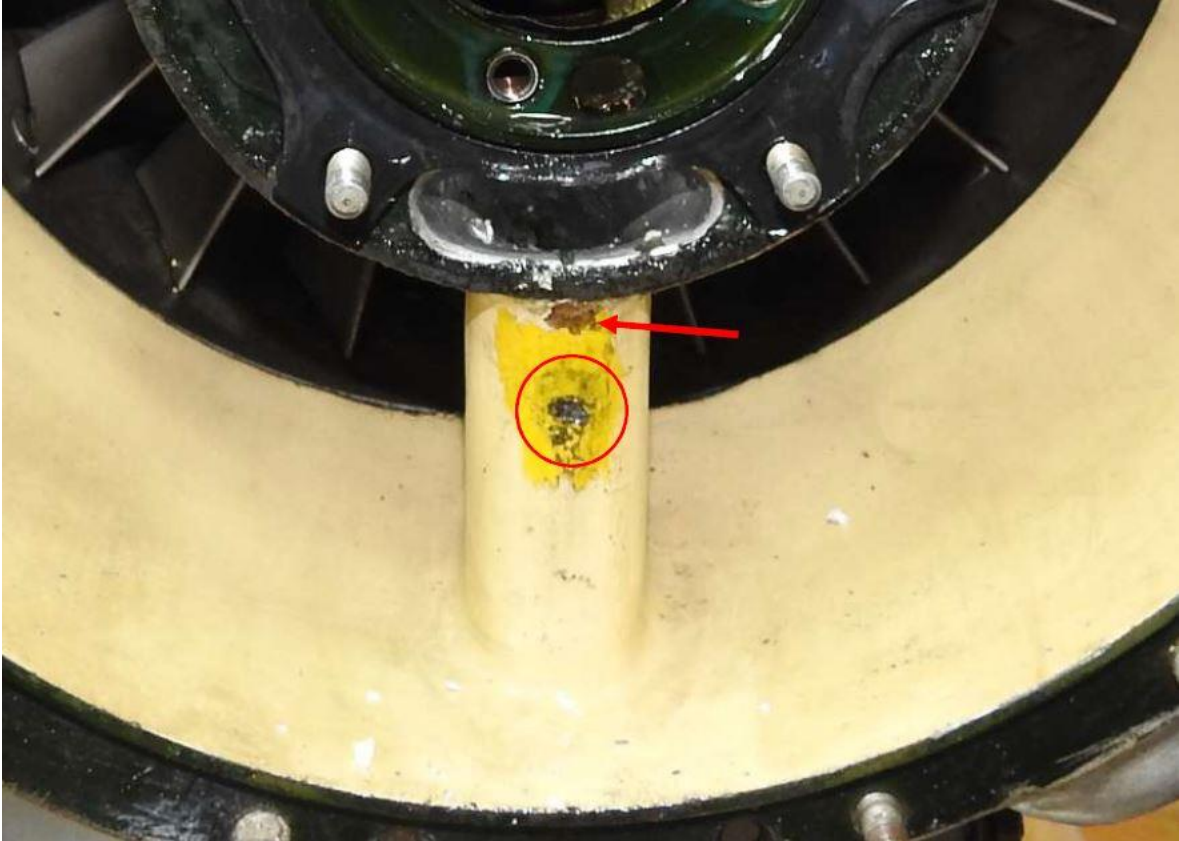
Figure 21: Corroded airflow ducts

- Corrosion formation at the outlet ducts in the inlet case front struts of the right engine was the reason for the partial failure of the ice prevention system.

- The formation of corrosion was not visible to the pilot either during the pre-flight check or during the flight.
- According to the findings of the engine manufacturer, however, there is a causal relationship between this application of paint and the formation of corrosion.

- The repair performed was not approved by the engine manufacturer.

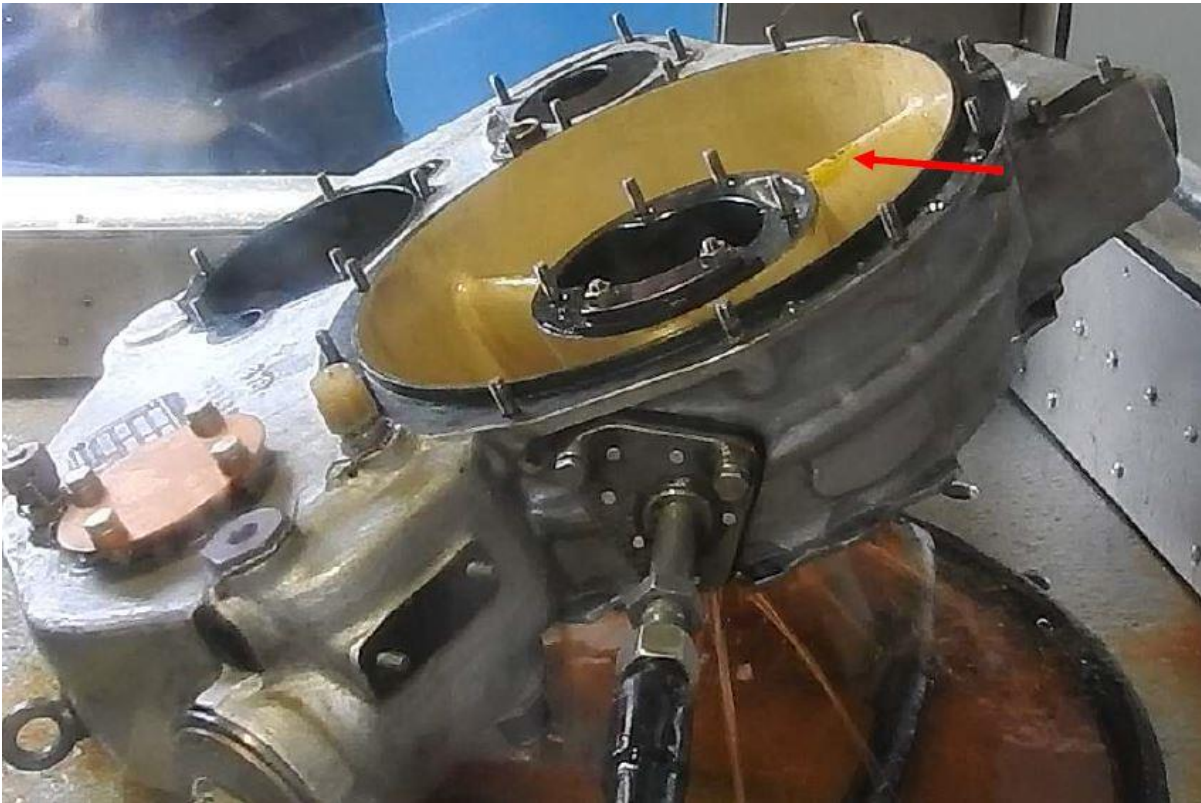
Figure 22: Test on test bench with corroded opening holes

(Test execution at the test bench with a nominal pressure of ~ 2 bar with oil as test substance).

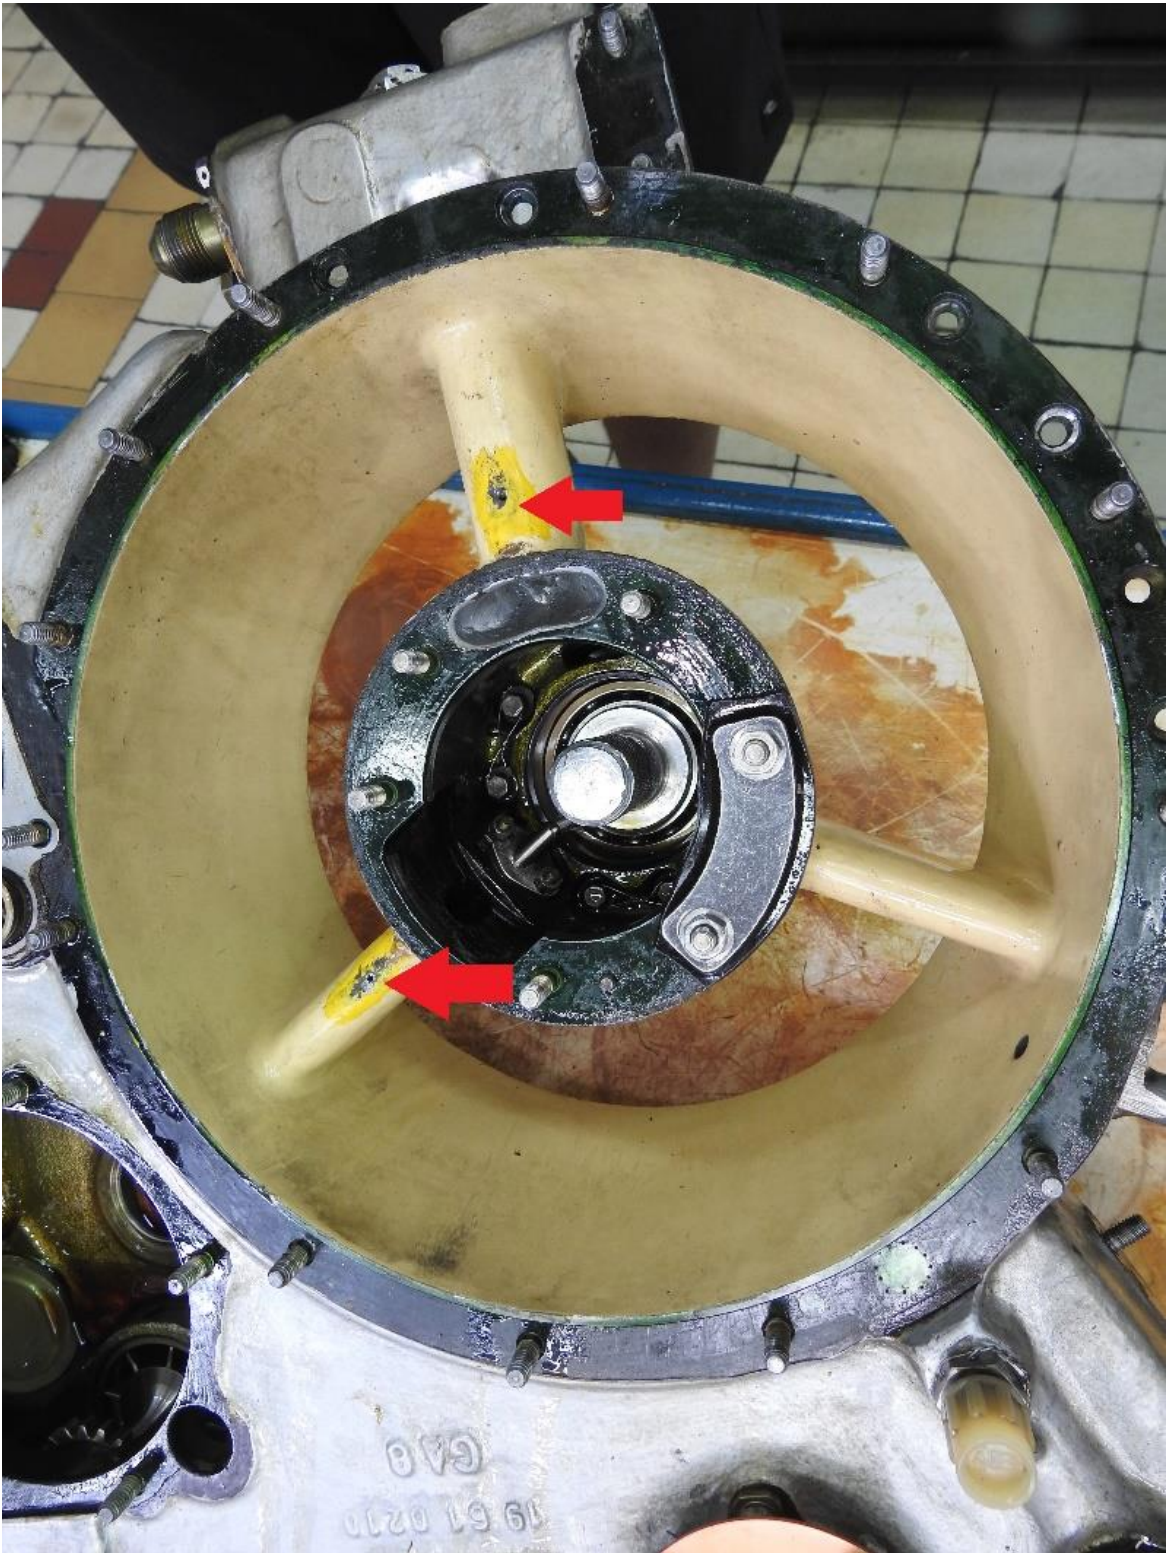
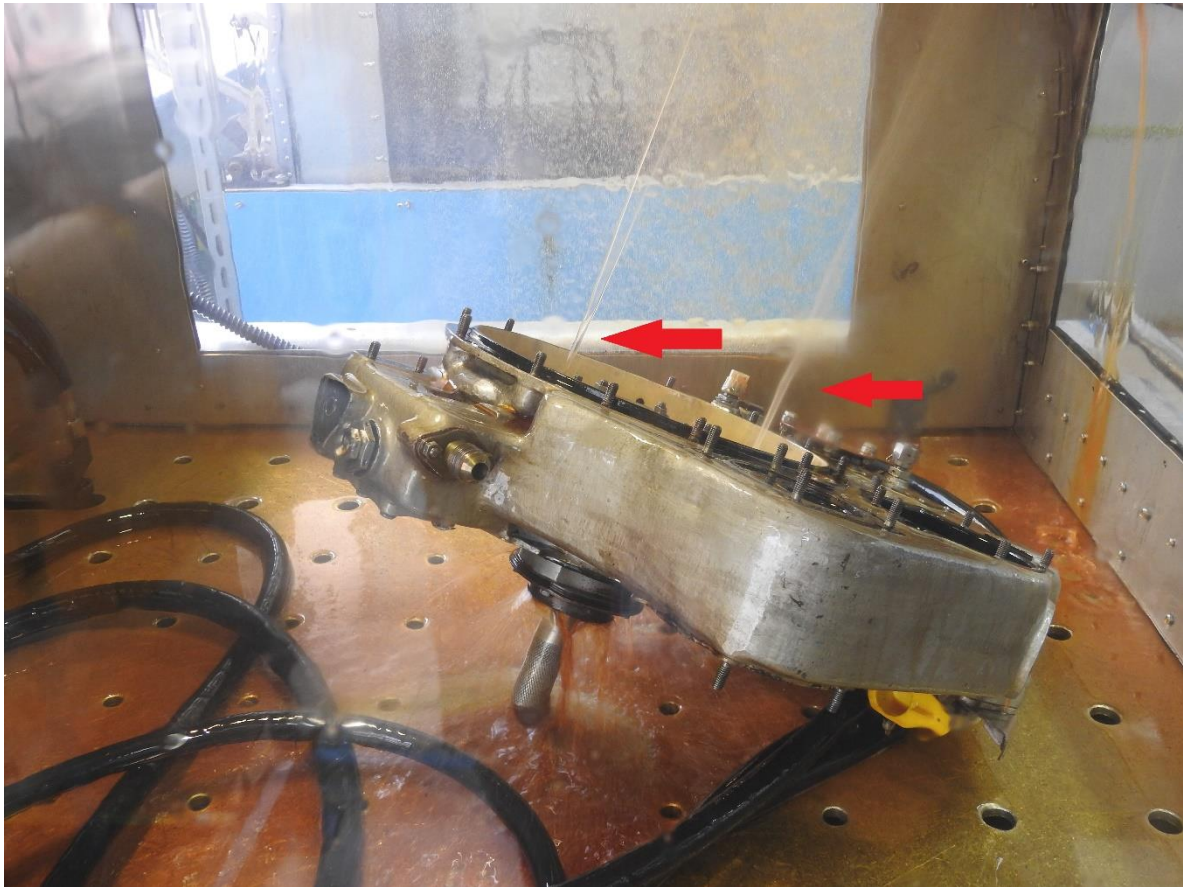
After removal of the corrosion detected at the opening boreholes, a new similar test on the test stand showed that oil could flow through as a test substance. Thus it was proved that corrosion was the reason for the partial failure of the ice prevention system.
