Final report

Accident with helicopter type MD900(902),
on 1 August 2017, at ca. 18:15 UTC on Grossglockner mountain,
municipal Heiligenblut, A-9844, Carinthia
Ref.: 2022-0.483.594

Investigation report

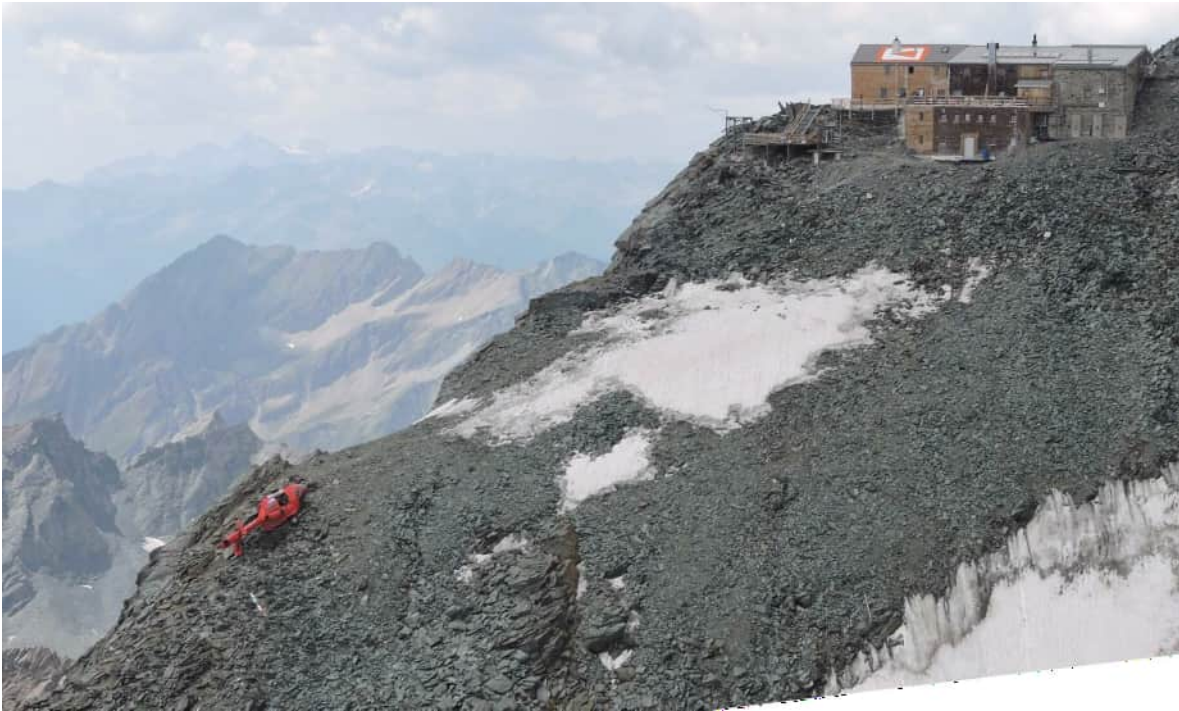
Figure 13 Site of the accident and Erzherzog-Johann lodge

In the vicinity of the Erzherzog-Johann lodge there is no paved landing site for helicopters, which is why, in the event of a medical emergency, as in the present case, patients and passengers have to be picked up and dropped off in a hover flight (with the skids barely touching the ground) or by rope. The accident site is characterized by rocky, loose and stony ground. The terrain is continuously steep and uneven. At approximately 6 m south-south-east of the accident site there is a steeply sloping rock face, approximately 200 m high.

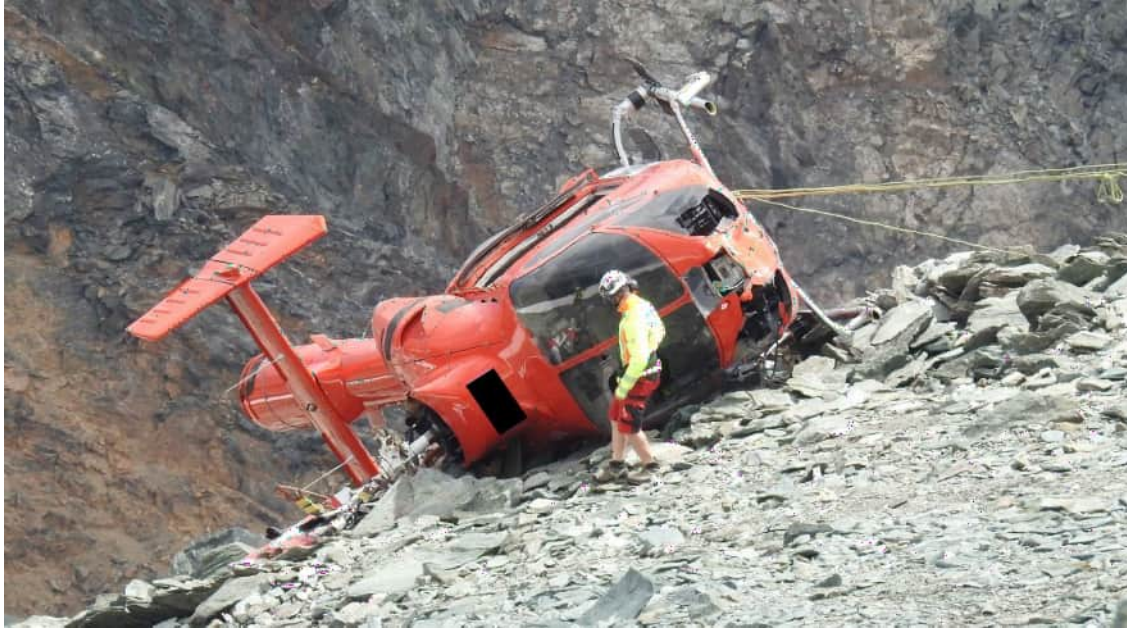
Figure 14 Final position of the wreck (operator logo redacted)

Apart from parts of the Main Rotor Blades and smaller parts of the Cockpit Window and the Fuselage Fairing, no parts came off the aircraft. The remains of the Rotor Blades had already been collected and placed next to the wreck, when the team from the Federal Safety Investigation Authority arrived. The Tail Boom showed a crack of approximately 0.5 m behind the Fuselage Attach Frame, which encompassed the entire circumference of the Tail Boom. The structure of the aircraft remained largely intact. The medical equipment and cabin equipment were partly scattered around the cabin and partly still in the designated place in the cabin.

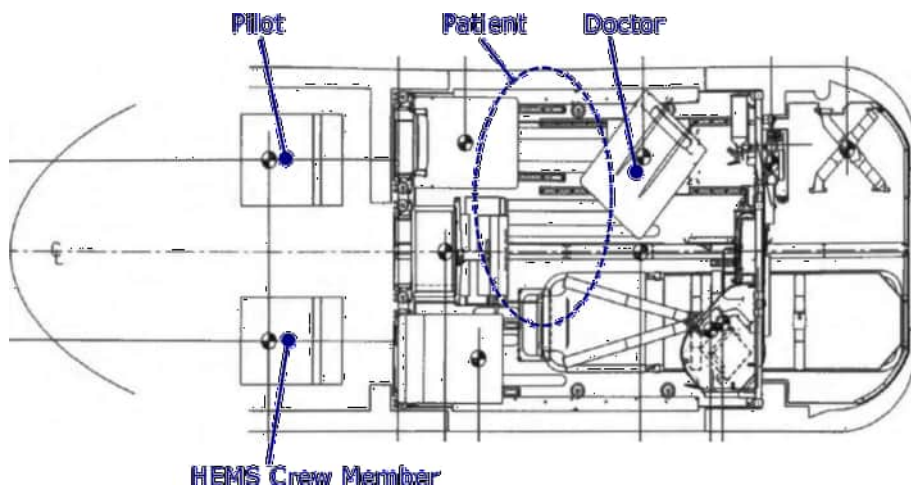
Figure 15 Occupants' positions at the time of the accident

The pilot was in the front right of the cockpit in the pilot's seat, the HEMS crew member at the front left. The doctor was sitting in his swivel chair. The patient was just about to get on the rescue stretcher and was somewhere between the sliding door and the stretcher.

Belts, inertia reels, the attachment points of the belts and seats of the pilot and the doctor as well as the belts of the HEMS crew member withstood the forces of the impact without damage, and protected the occupants. Both side tubes of the HEMS crew member's seat were found broken.

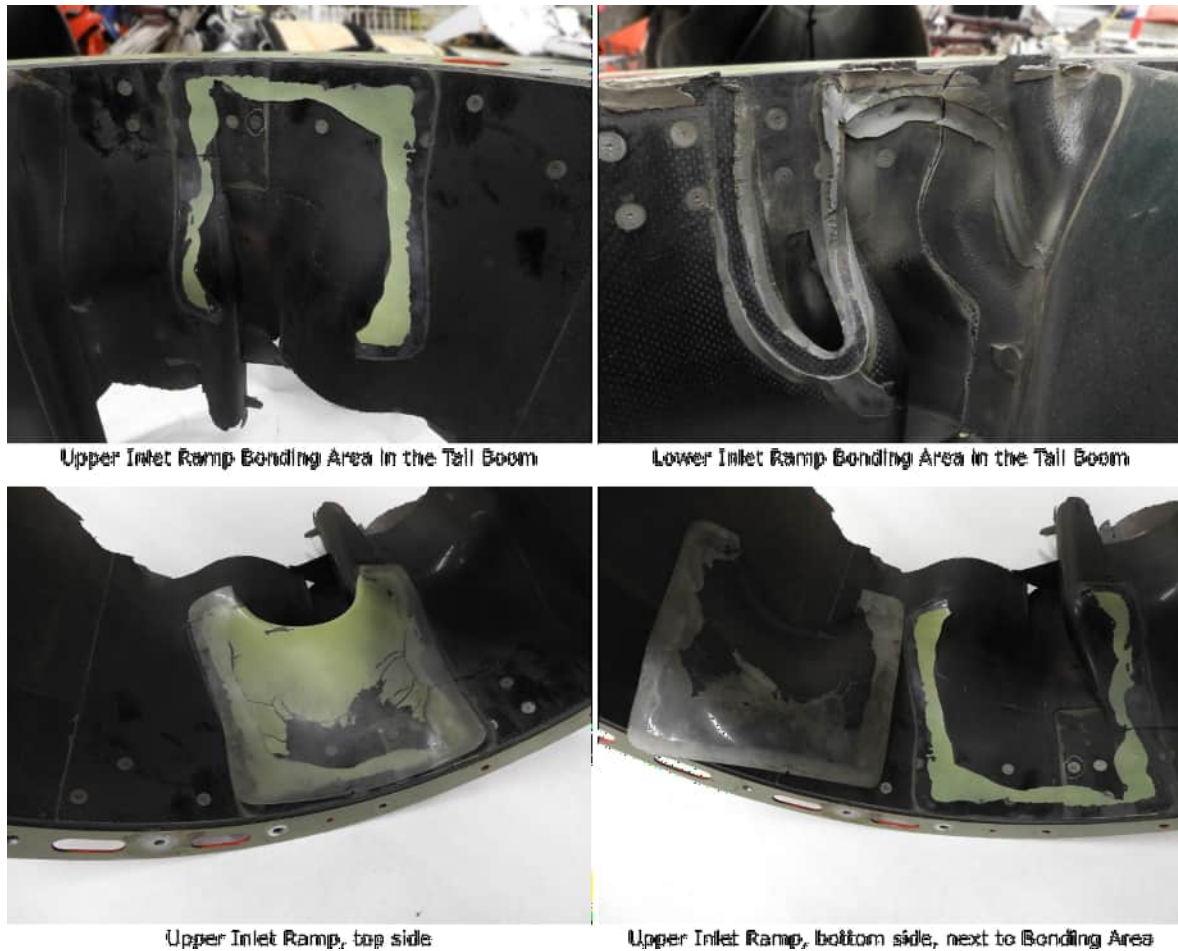
Figure 16 Upper and Lower Inlet Ramp

The material of the Inlet Ramps, according to the manufacturer's information, is polycarbonate. The bonding area were further examined by the Bundeswehr Research Institute for Materials, Fuels and Lubricants.

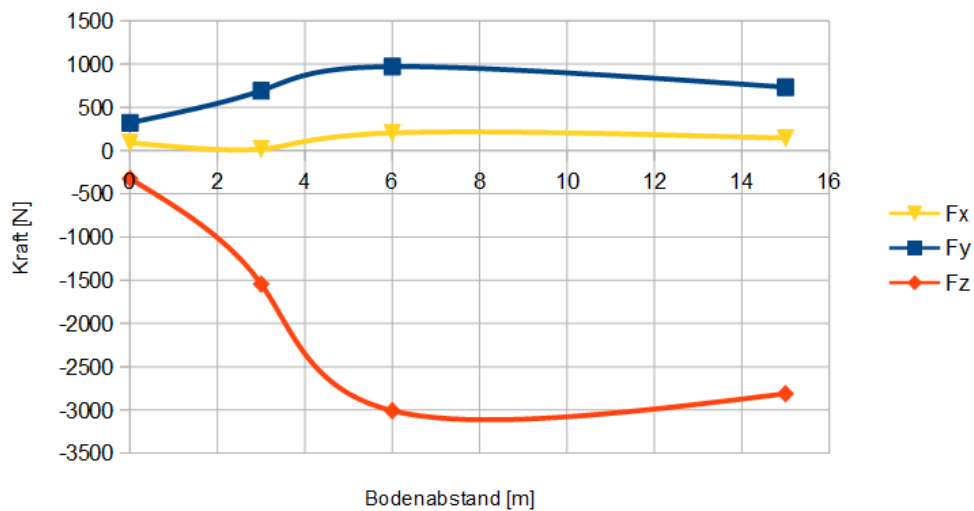
Figure 17 Resulting air forces, simulation

The figures show that both the force F_y and the yaw moment M_z increase in the course of the takeoff process. From a mathematical-analytical point of view, an aerodynamically generated lift (frictionless) can be described using the Kutta-Joukowski formula:

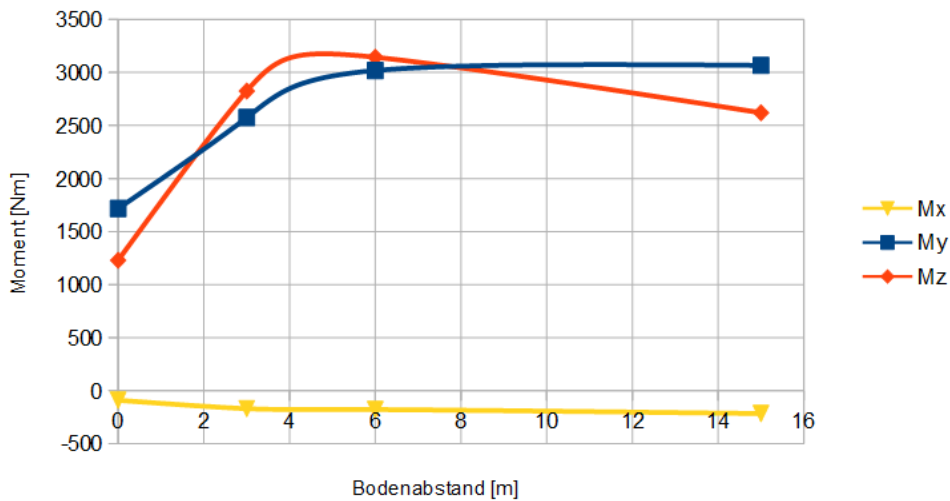
Figure 18 Resulting torques, simulation

The same applies to the resulting yaw moment M_z around the vertical axis of the helicopter (Figure 18). An increase in distance to ground from 0 m to 4 m results in a three times larger yaw moment around the vertical axis. With a distance to ground of more than 4 m, the height above ground has practically no more influence on the yaw moment.
