REPUBLIC OF CROATIA
Air, Maritime and Railway Traffic
Accident Investigation Agency

FINAL REPORT

ON THE SERIOUS INCIDENT INVOLVING AIRCRAFT CIRRUS SR-20, OE-DDD OCCURRING ON AUGUST 17, 2012 AT SPLIT AIRPORT

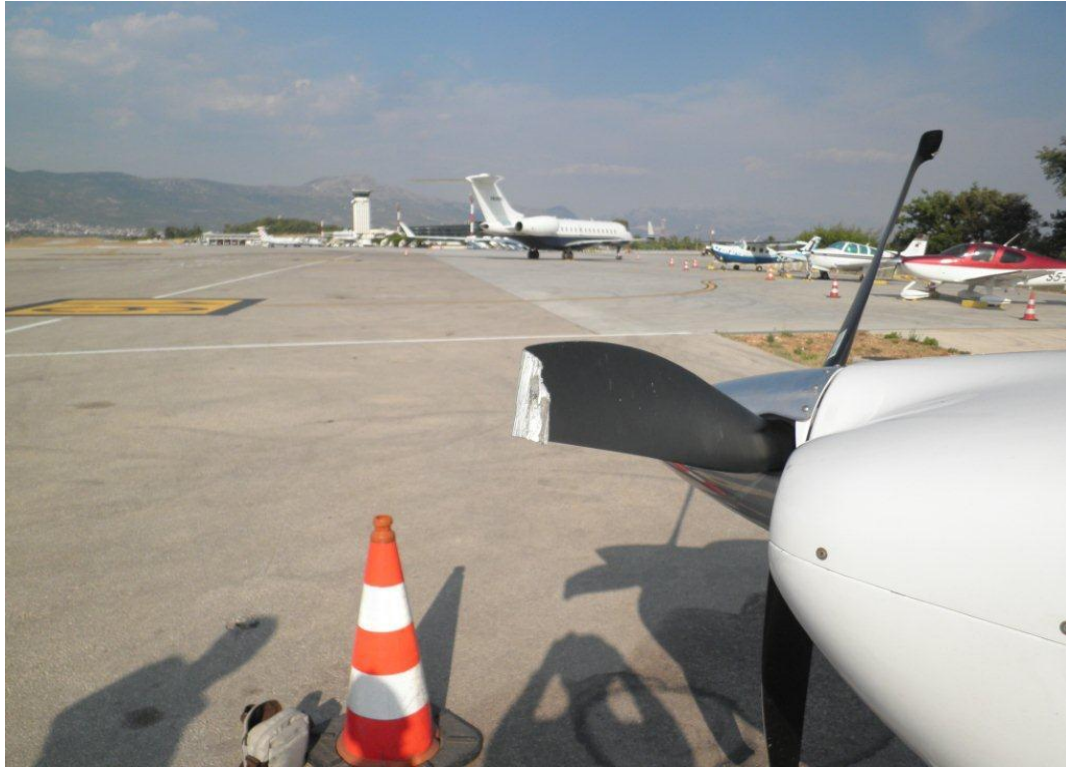
Hitting the runway caused damage to the propeller blades, engine and nose wheel.

Damage to the propeller

Pt	Works
1	Aircraft had a Propeller strike in LDSP: Hard/Overweight Landing Inspection has to be performed: Hard/Overweight Landing Inspection acc. Maintenance Manual AMM Chapter 05-50 performed: Defects on Engine, Propeller, Nose Landing Gear and Tail Bumper were found.
2	Propeller has to be removed after Propeller strike: Propeller removed and sent to Krems, (Austria) afterwards sent to MT Propeller for Inspection.
3	Governor has to be removed: Governor removed and sent to Krems, afterwards sent to MT Propeller for Inspection.
4	Engine has to be removed: Engine removed and sent to Krems, afterwards sent to Nikolaus Ghönert GmbH for Inspection.
5	Engine Mount has to be removed: Engine Mount removed and sent to Krems, afterwards sent to Gomolzig GmbH for Inspection.
6	Nose Landing Gear has to be removed: Nose Landing Gear removed and send to Krems, afterwards Landing gear disassembled and inspected. Nose Landing Gear Leg, Fork and Fairing renewed and assembled.

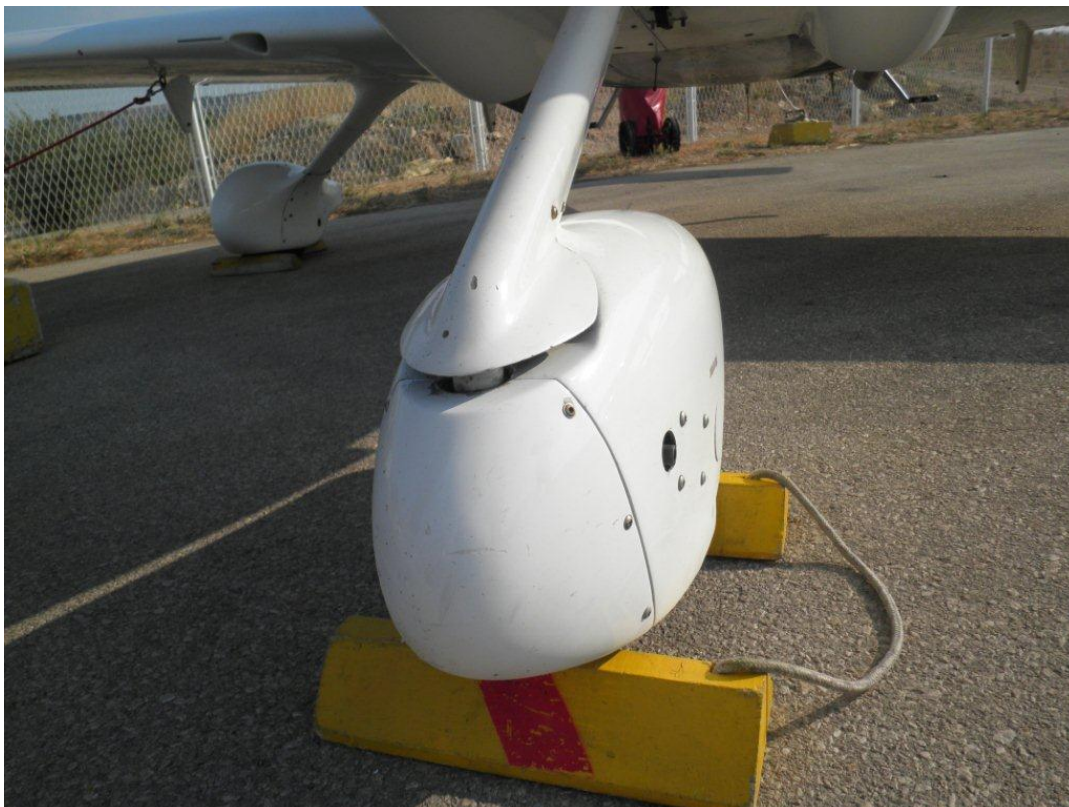
Damage to the nose wheel

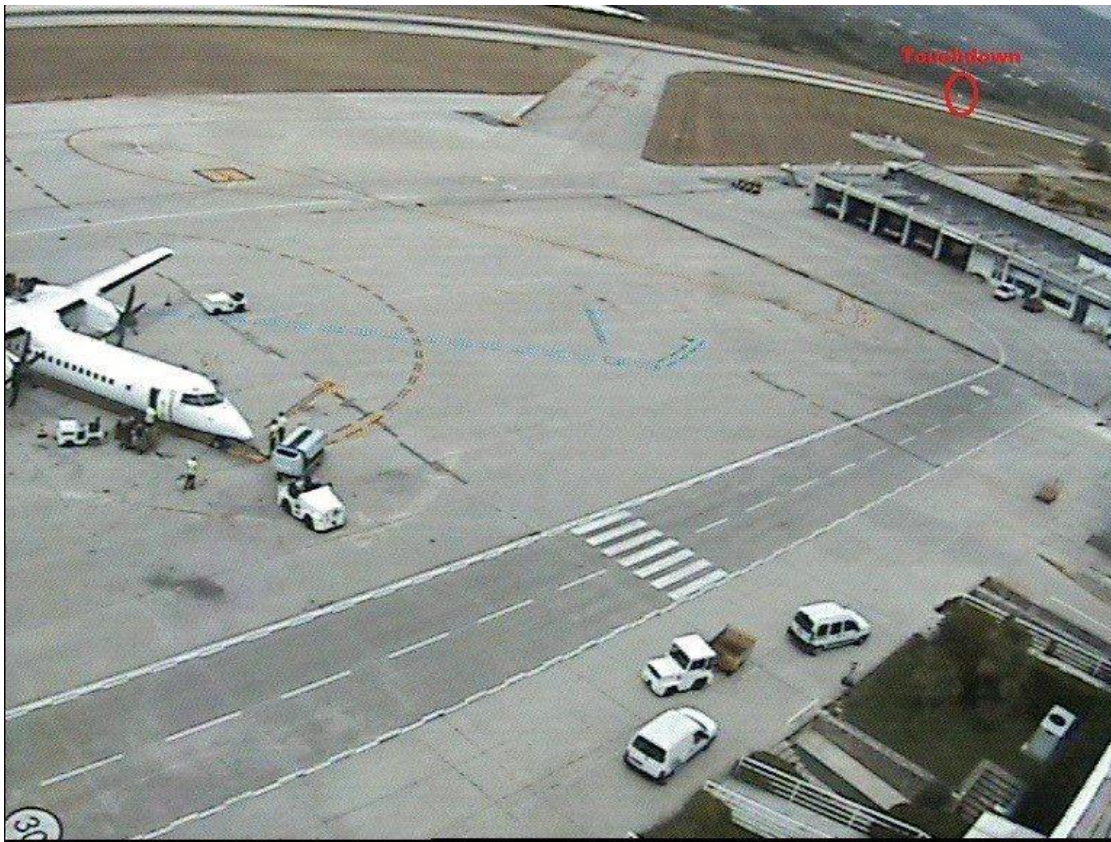
The cause of this serious incident is most likely a wrong estimate which, during landing, led to the impact and bouncing off of the aircraft and its low flight over the apron where parked aircraft were located.

First contact with runway, failed landing

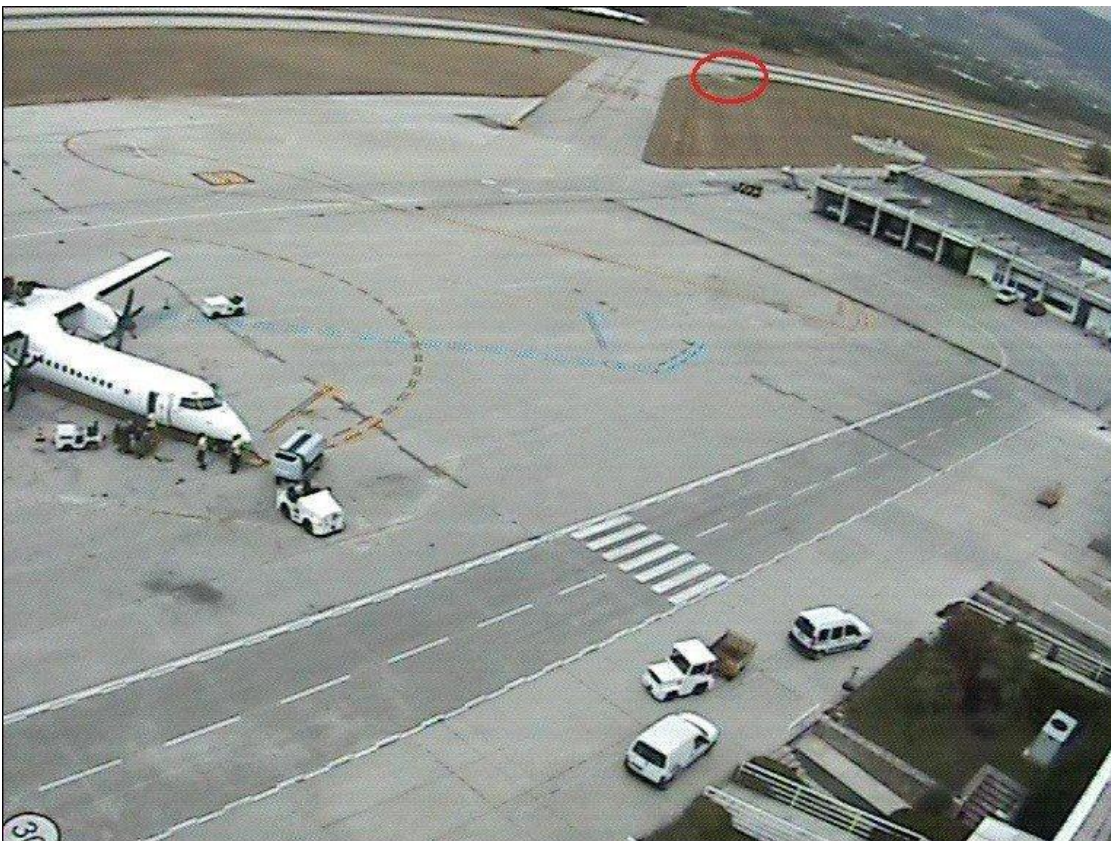
Flying over taxiway B after the failed landing

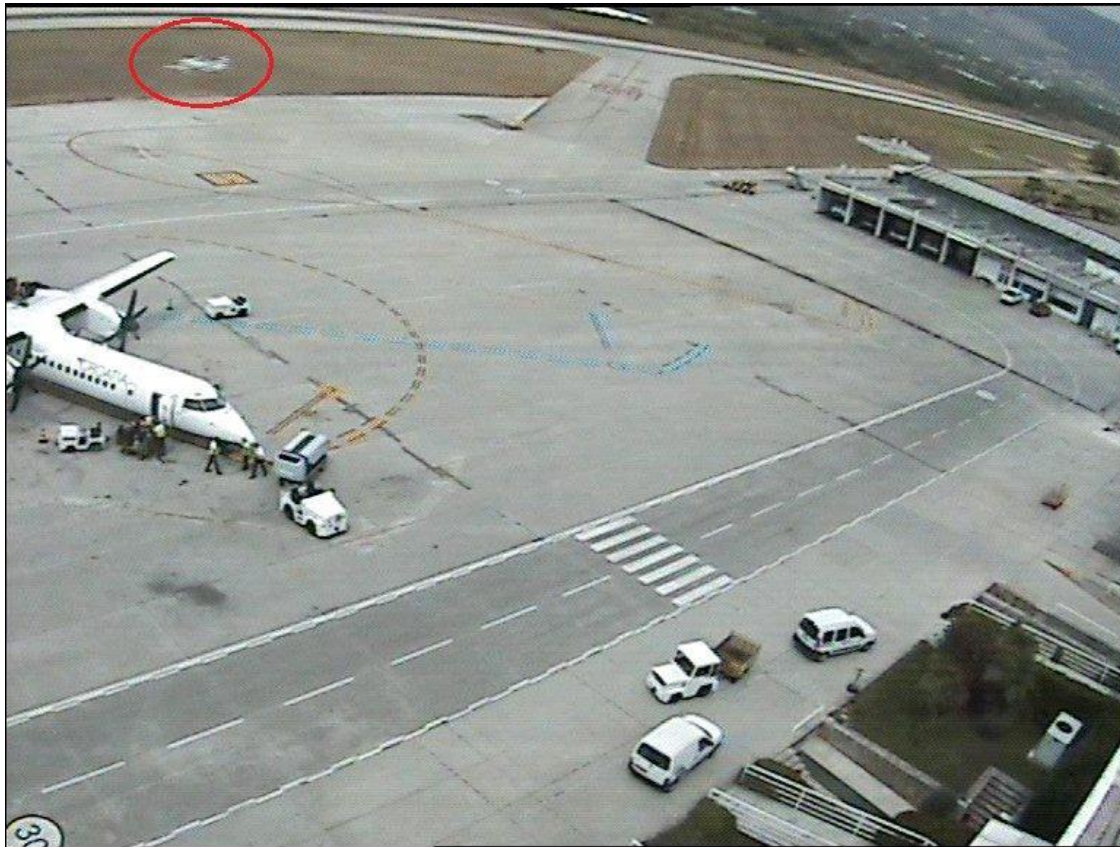
Split Airport delivered security camera footage which shows the aircraft flying over the taxiway and apron after the failed attempt at landing (Appendix).

Flying over the apron after the failed landing
