**NATIONAL BUREAU
OF AIR ACCIDENTS AND INCIDENTS INVESTIGATION
WITH CIVIL AIRCRAFT**

FINAL REPORT

**SMOKE IN THE PASSENGER CABIN
DURING TAXIING**

AC OPERATOR:	«TYROLEAN AIRWAYS» AVIATION COMPANY (AUSTRIA)
AC TYPE:	Fokker F28 Mark 0070
REGISTRATION NUMBER:	OE-LFJ
SITE OF OCCURRENCE:	DNEPROPETROVSK INTERNATIONAL AIRPORT (UKRAINE)
STATE OF OCCURRENCE:	UKRAINE
DATE OF OCCURRENCE:	29.11.2014r.

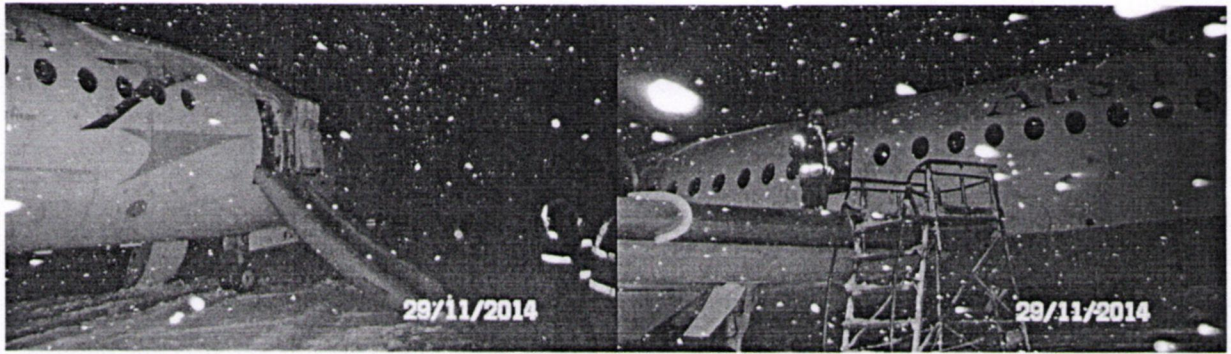
Fig.2. Use of emergency evacuation means.

For the crowd of people on the wing surfaces and snow on them (*as to the co-pilot's words* – the thickness of the snow layer was about 30 cm), and for the decrease of the smoke in the cabin, the crew slowed down the evacuation procedure and sent some passengers back to the cabin to be evacuated through the main exit. The co-pilot left the AC to check out the number of the passengers and gave a command to the ground personnel to direct the passengers to the bus to deliver them to the airport terminal. After that the co-pilot returned onboard of the AC and joined the crew which was completing the evacuation.

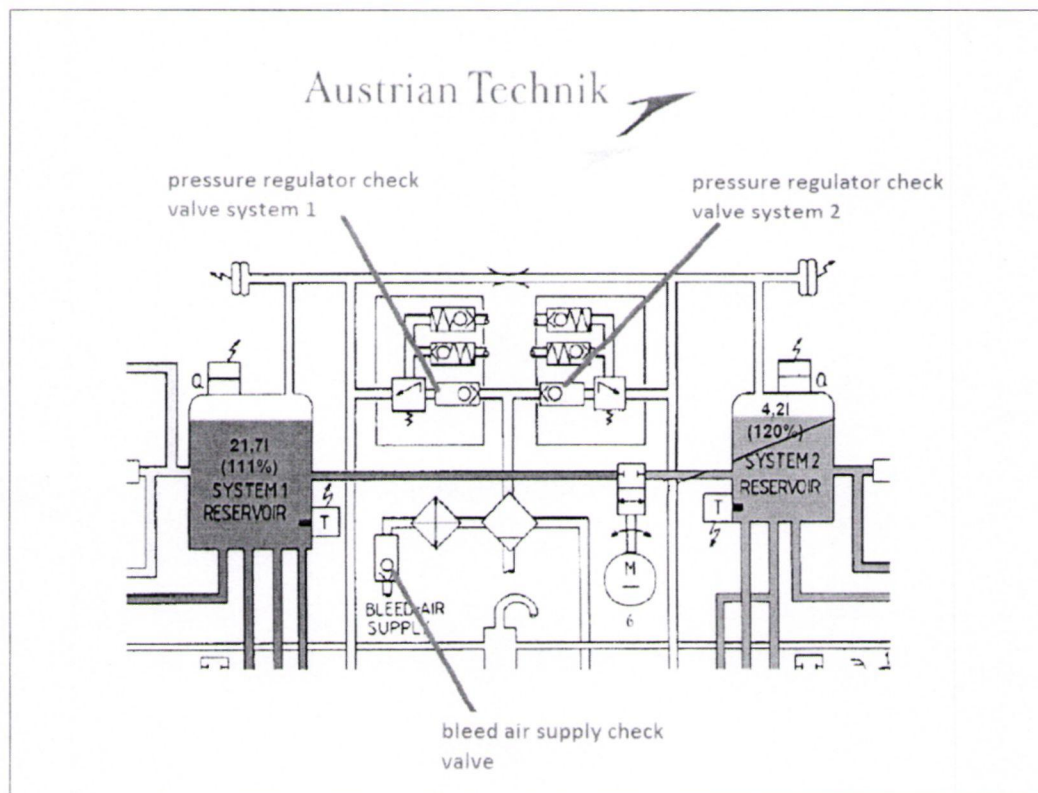
Fig.3. Layout of preliminary pressurization of №1 и №2 hydraulic system.

After the AC arrival to the base airport the Technical Department of Engineering and Aviation Service of “Austrian Airlines” Aviation Company carried out an engineering analysis and drafted additional measures for determination of causes of the smoke in the passenger cabin. As a result of the carried engineering investigation, it was determined how the air pressure regulator operated, and in particular, a failure of the air supply check valve between No 2 hydraulic system and the system of preliminary pressurization was identified, including the check valve of air supply to the system of preliminary pressurization.

The valves failure allowed the vapors/fumes of the hydraulic fluid to infiltrate from the overflown hydraulic fluid tank of No hydraulic system (the fluid level made 4,2 liters – 120%) into the air distribution system, which is finally connected to the AC cabin through the air condition system (Engineering Investigation Report of 16.12.2014, Fig. 3 and 4). As per the conclusions of the engineering analysis that became the cause of the smoke emergence.

3.7. The pressure valve of hydraulic system № 2 did not operate due to a faulty check valve between the hydraulic pressure control system № 2 and preliminary pressurization system.

3.8. The check air supply valve of the preliminary pressurization system was not operating.

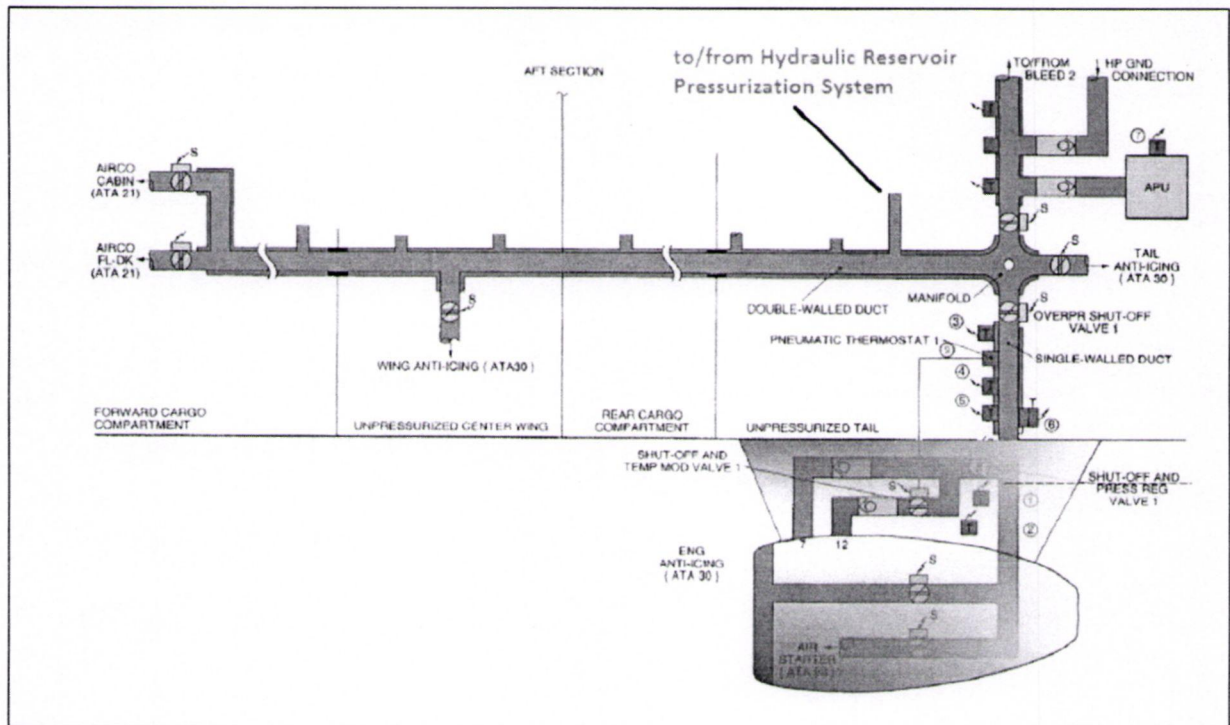
Fig.4. Layout of air distribution and induct system.

3.9. Vapors/fumes of hydraulic fluid from the reservoir of the hydraulic system № 2 got into the air distribution and bleed (the right part) system through the pressure valve and a return check valve of the hydraulic system № 2.

3.10. Formation of white, acrid smoke in the air distribution and bleed system occurred due to mixing hydraulic fluid vapor with hot air from the engine compressor and possible contamination of fumes/vapor on the heat exchanger of the air distribution system unit.

To eliminate the consequences of hydraulic fluid vapors/fumes infiltration into the air distribution and induct system (the right part) and probable contamination of the air distribution system unit (PACK No 2) and its components by hydraulic fluid, as well as in the connection with an abnormal noise in PACK No 2, there was carried out a replacement of the appropriate components as per Work Order No 7432110.
