Final Report

Accident with aircraft Bombardier DHC-8-402,
on 04 April 2019, at ca. 08:56 UTC on Innsbruck Airport (LOWI),
A-6020, Innsbruck, Tyrol
Ref.: 2021-0.432.817

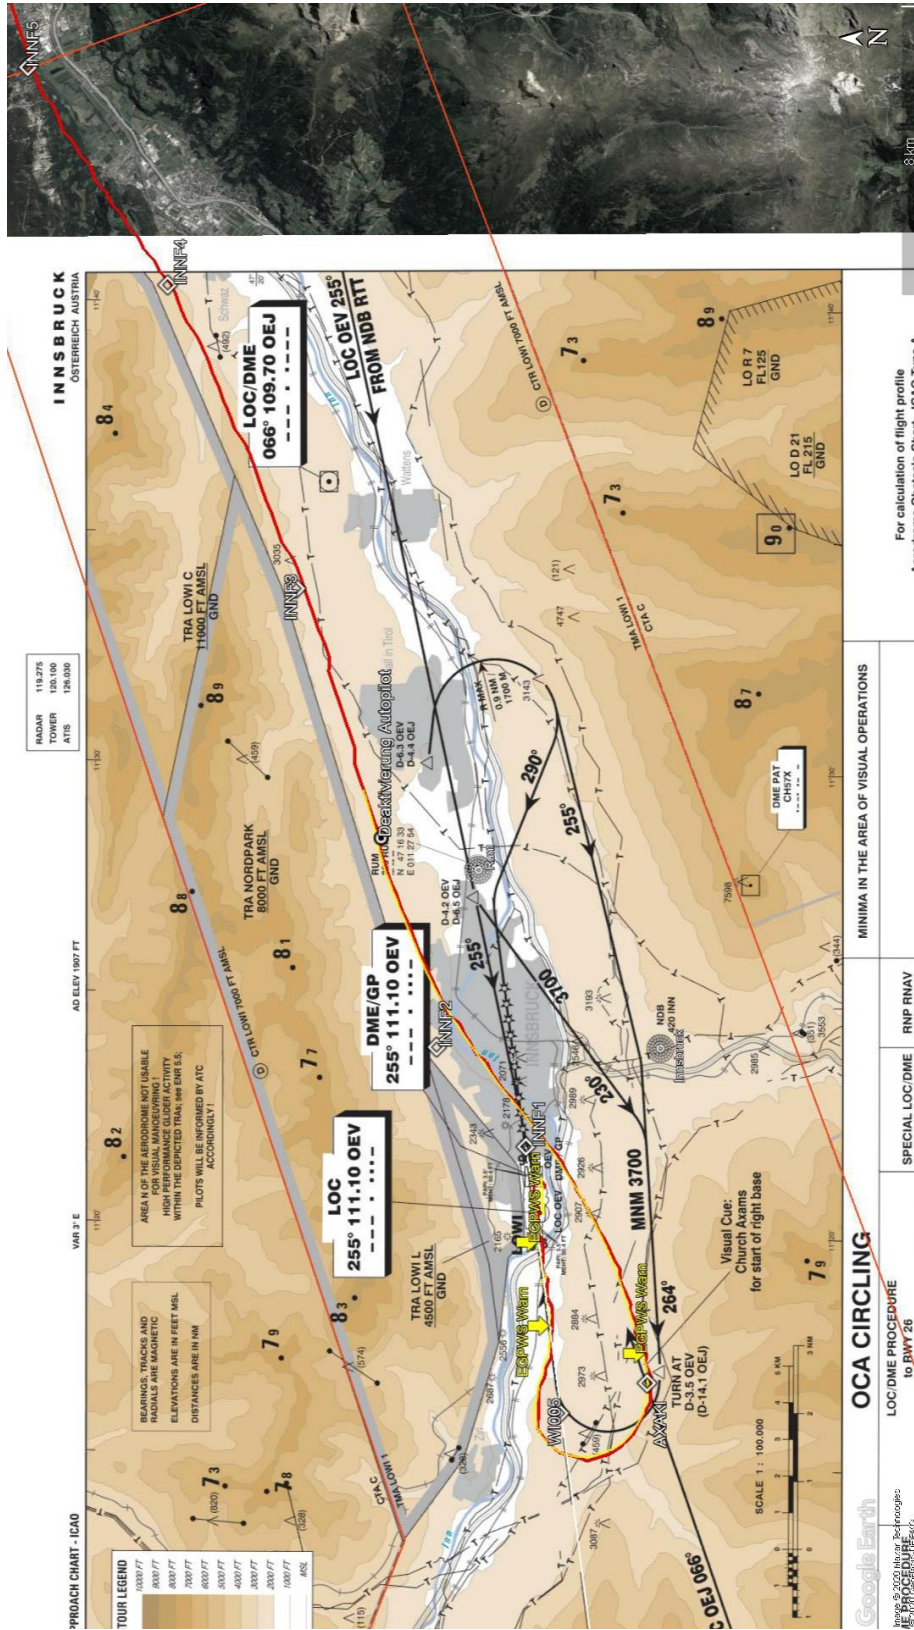
Figure 1: Visual Approach LOWI 08

Figure 1 shows the approach of the aircraft on runway 08 at Innsbruck Airport. The position data of the flight data recorder (FDR) is shown in red, the radar data from Austro Control is yellow. The control zone at Innsbruck Airport (CTR LOWI) is shown in orange. The approach procedure "Föhn Approach along Nordkette" leads along the northern range ("Nordkette") via points INNF5, INNF4, INNF3, INNF2, INNF1, AXAKI, WI005 to runway threshold 08 and is defined as shown in section 1.10.2.

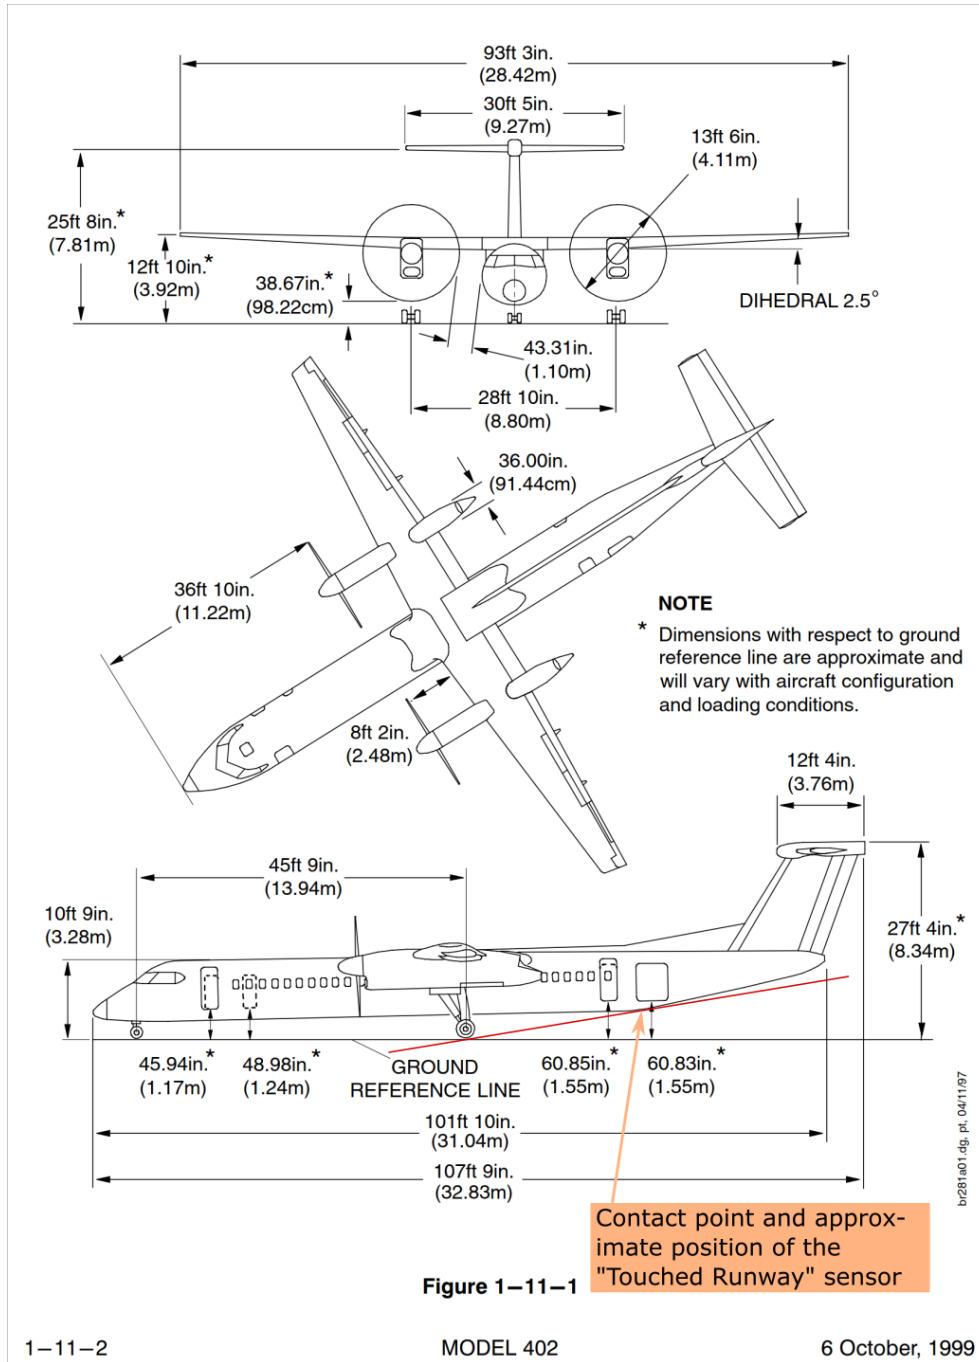
Figure 4: Dimensions DHC-8-402 incl. contact point with runway

According to the final report HCL 25/00 of the Danish Aircraft Accident Investigation Board on an accident on 27 May 2000 (or HCL 62/00, accident of 22 October 2000), according to the aircraft manufacturer, with full compression of the suspension struts of the landing gear, a pitch angle of $+7.6^\circ$ is needed on touchdown in order for a type DHC-8-400 to have contact between the tail and the runway. The manufacturer considered the difference between the 6° from the AFM and the 7.6° as a safety factor.

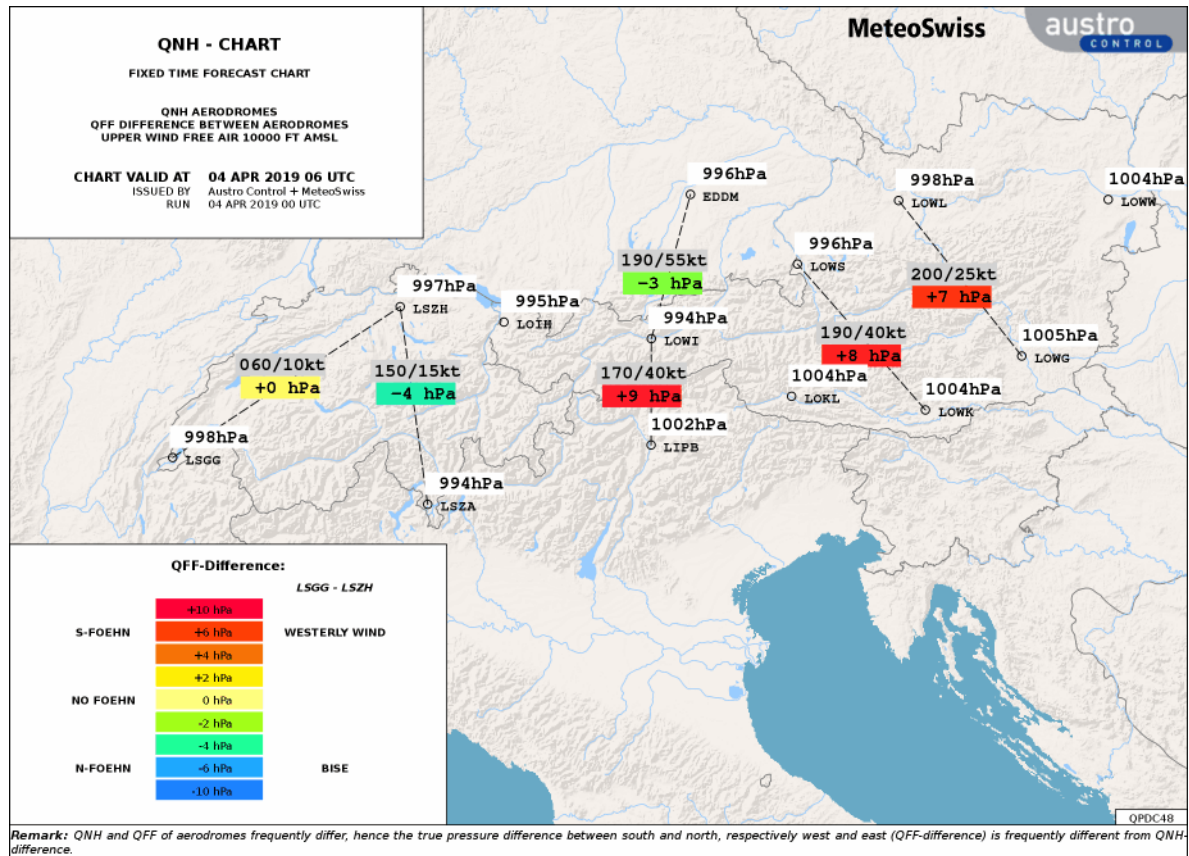
Figure 5: QNH / Foehn chart

By comparing the weather observation, especially between Bolzano and Innsbruck, the characteristics of southern foehn conditions can be seen: Air pressure difference from 1000 to 993 hPa, temperature/dew point of 10°C/9°C (dew point spread: 1°C) to 16°C/2°C (dew point spread: 14°C) and significantly better cloud conditions and visibility in Innsbruck. The southern foehn conditions are also evident in the QNH / foehn chart in Figure 5.

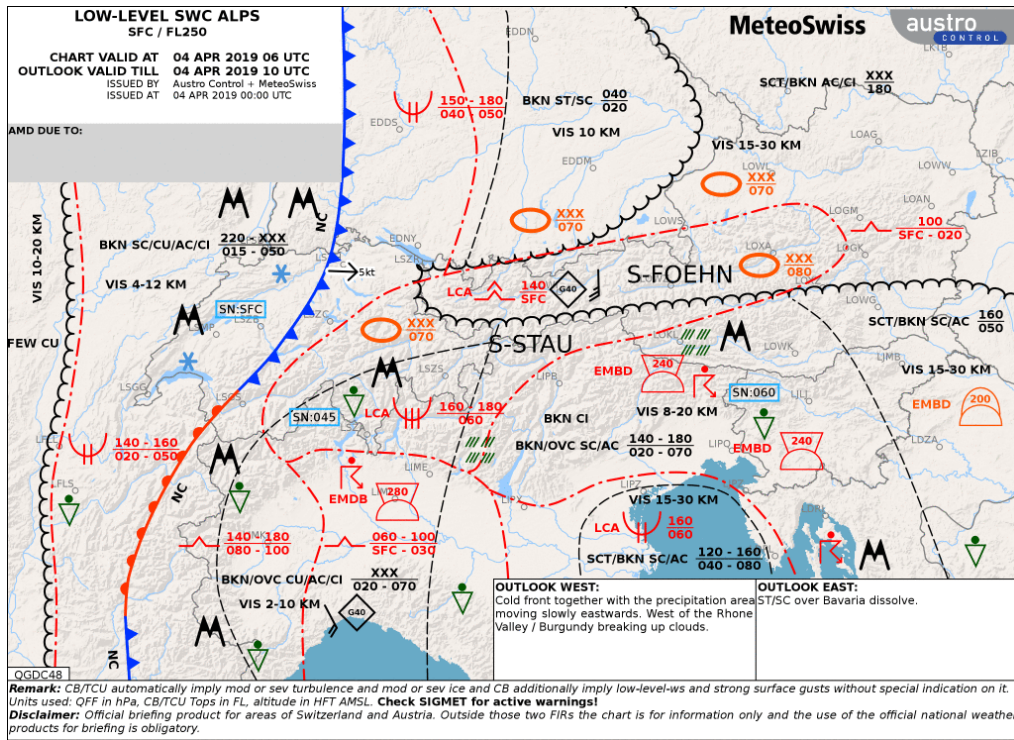
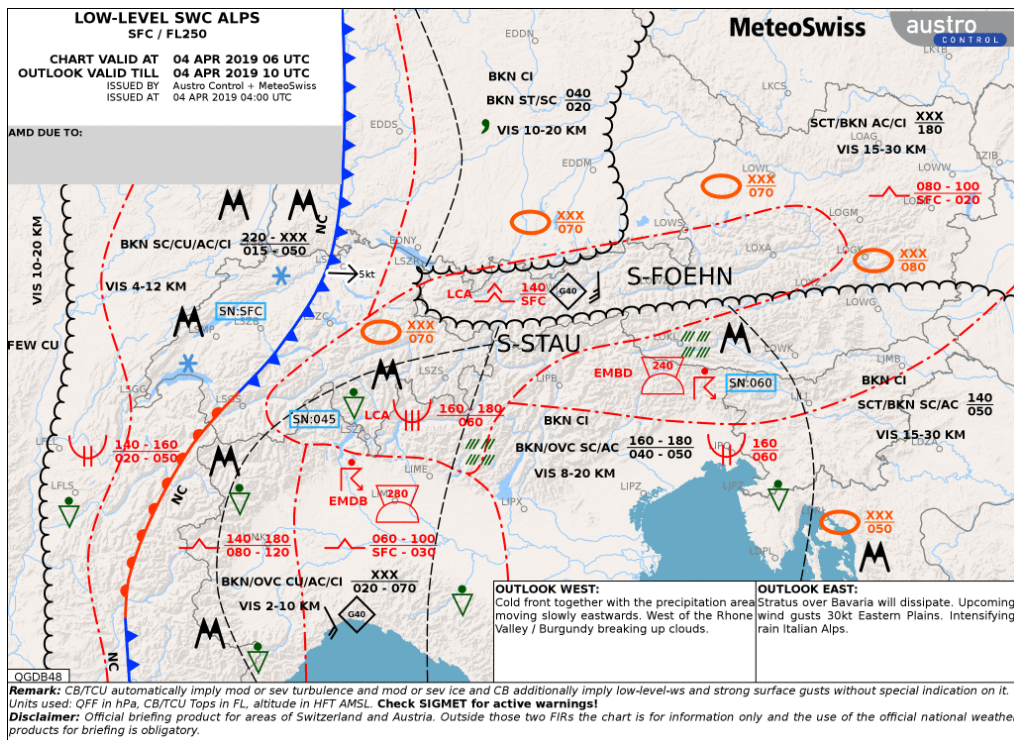
The SWC (significant weather charts) in Figure 6 and Figure 7 also show a southern accumulation (“Südstau”, S-STAU) south of the Alps, in combination with a southern foehn (“Südföhn”, S-FOEHN), for the period between 06:00 and 10:00. Wind of 25 kt was forecast from the south with gusts of up to 40 kt and heavy local turbulence.

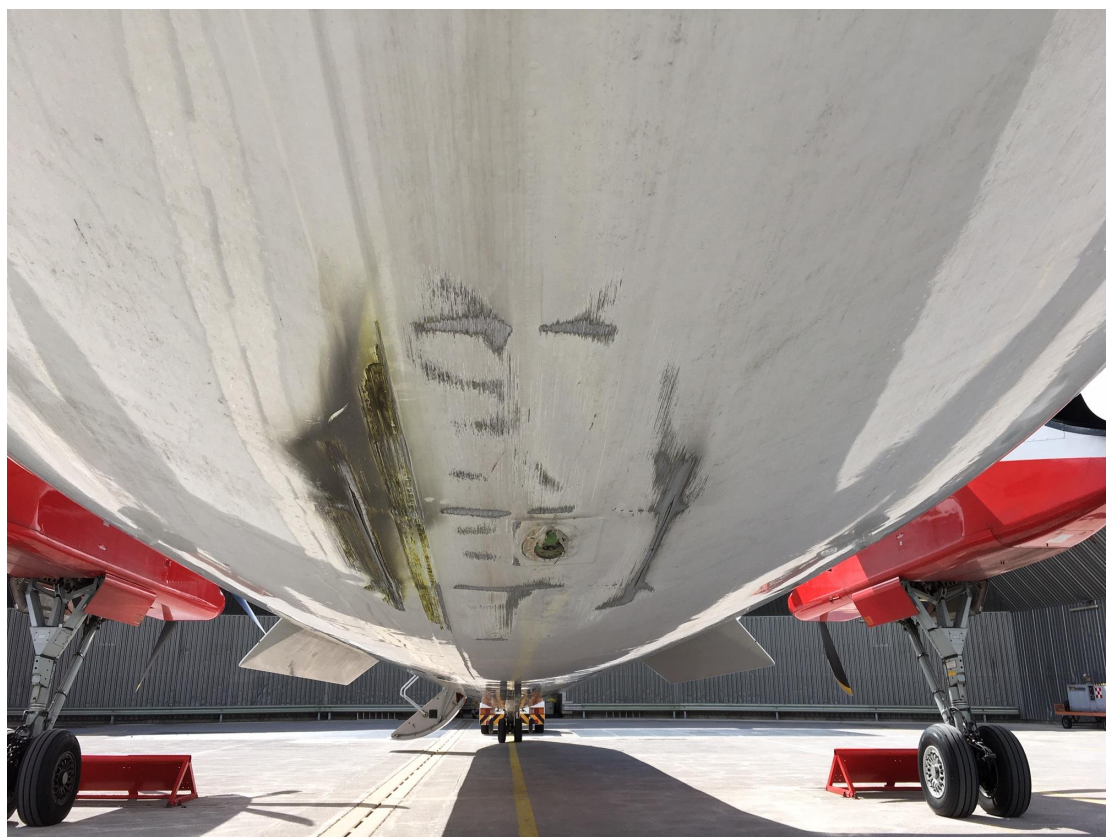
Figure 12: Damage to the tail of the aircraft

The aircraft suffered damage to the outer fairings and panels, an antenna, and to the stringers and frames on the tail. The damage was limited to part of the aircraft tail and had no further effects on the structural integrity of the aircraft or on its systems.

Damage to the aircraft was caused by abrasions and cracking of the outer skin, fairings and panels, with some rivets pulled out (Figure 12). One antenna was completely torn off. On the inside of the rear of the fuselage, stringers and frames were broken and bent, and

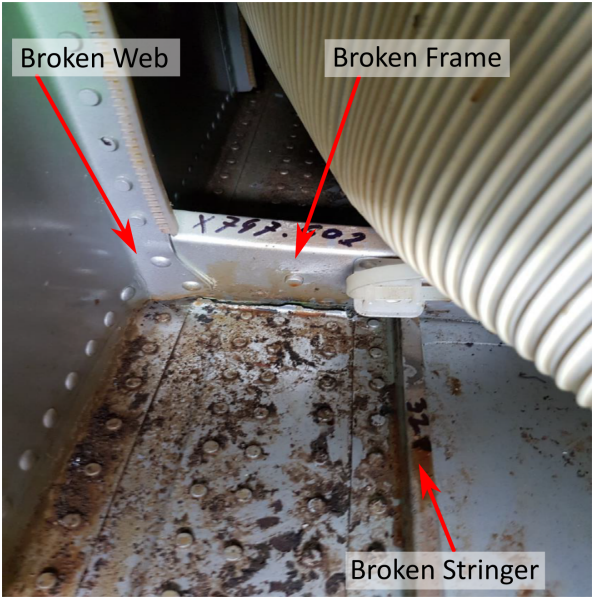
Figure 13: Damage at X747.602, STR31P to 31S

rivets were pulled out (Figure 13 and Figure 14). The damage only affected the tail as described and had no further effects on the structural integrity of the aircraft or on its systems.
