Final Report

Serious incident with the aircraft

Bombardier DHC-8-402 and Airbus A319-112,

on 16 June 2017, at approx. 10:58 UTC

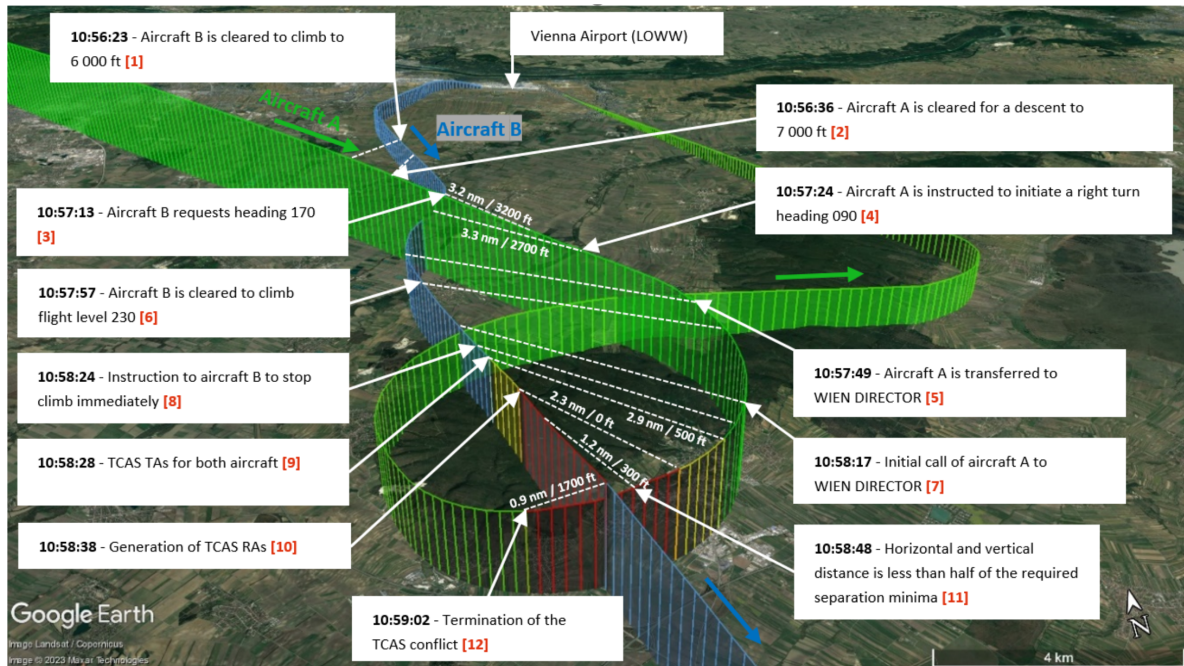
Figure 1: Flight path overview

Aircraft A continued the right turn and was subsequently guided to the final approach of runway 34 by means of a step descent and instructed headings and cleared for an ILS approach at 11:01:58. At 11:03:59, Aircraft A was transferred to aerodrome control with the call sign WIEN TOWER (123.800 MHz). Aircraft B continued the climb to flight level 230 on heading 170 and was transferred to area control BUDAPEST RADAR (133.200 MHz) at 11:01:42. The responsible controllers of WIEN RADAR and WIEN DIRECTOR were released from their working positions following the incident.

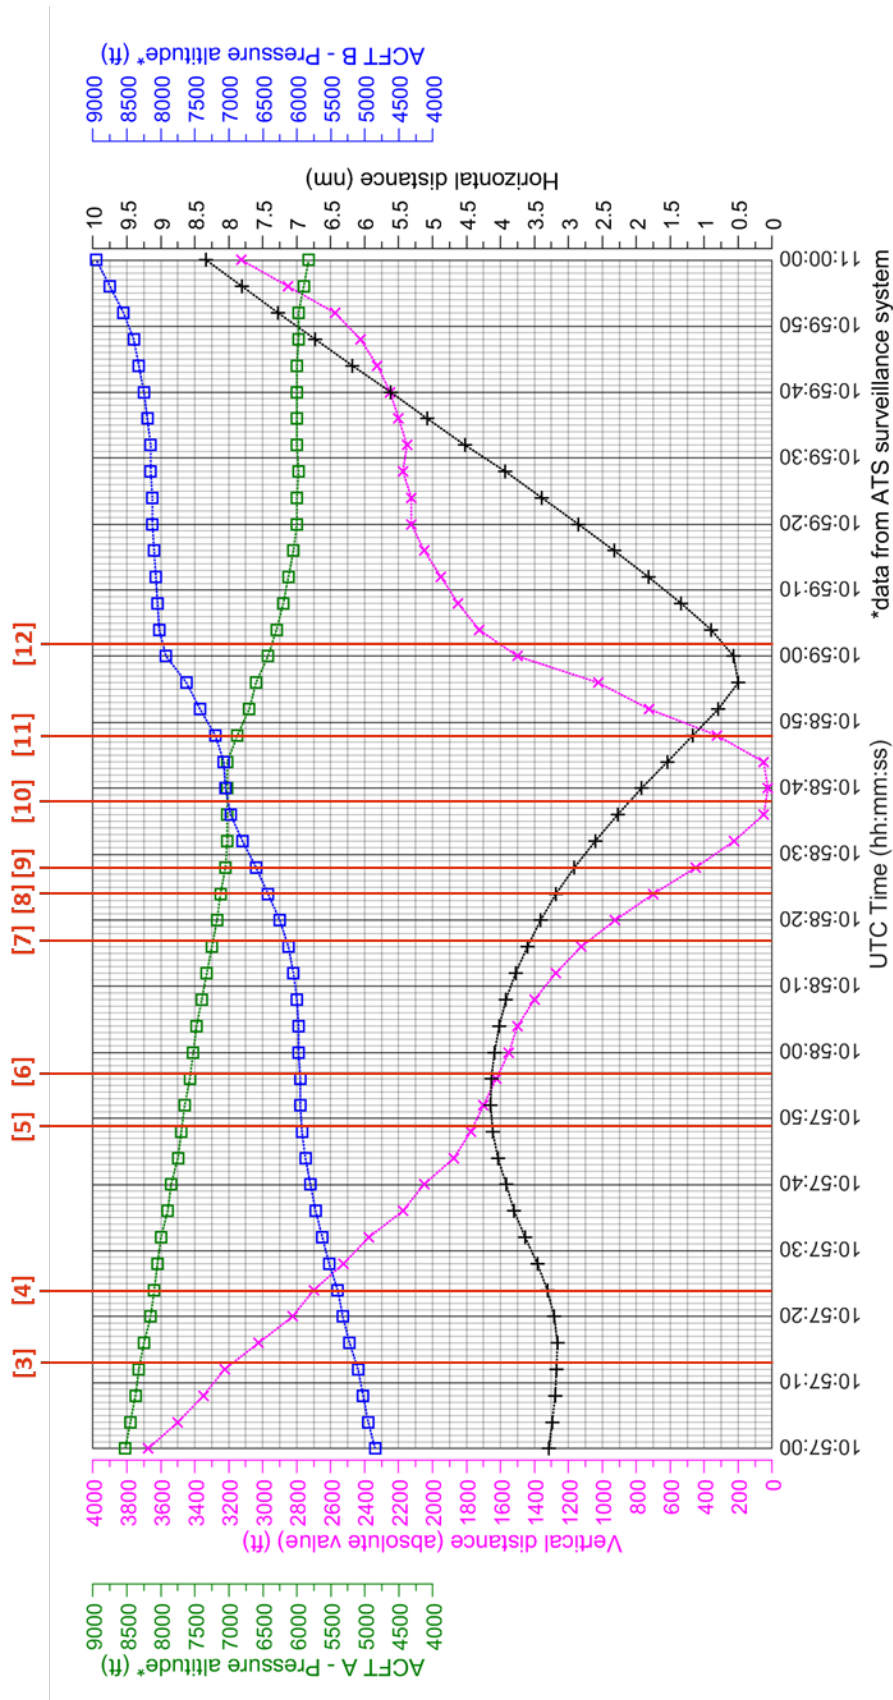
Figure 2: Horizontal and vertical distances over time

The ATS surveillance system displays the traffic situation on the controllers' air situation display, which refreshes the positions and data of the aircraft every 4 seconds. The same basic data are available to all air traffic controllers of the approach control unit. The visualization of the distance between two aircraft is usually not displayed automatically. This has been done by manually selecting the aircraft symbols. The numerical values of horizontal distances between aircraft given in Figure 1 and in the event list correspond to the display of WIEN RADAR's air traffic controller. If no numerical value is available, no distance was displayed to the WIEN RADAR controller at that moment.

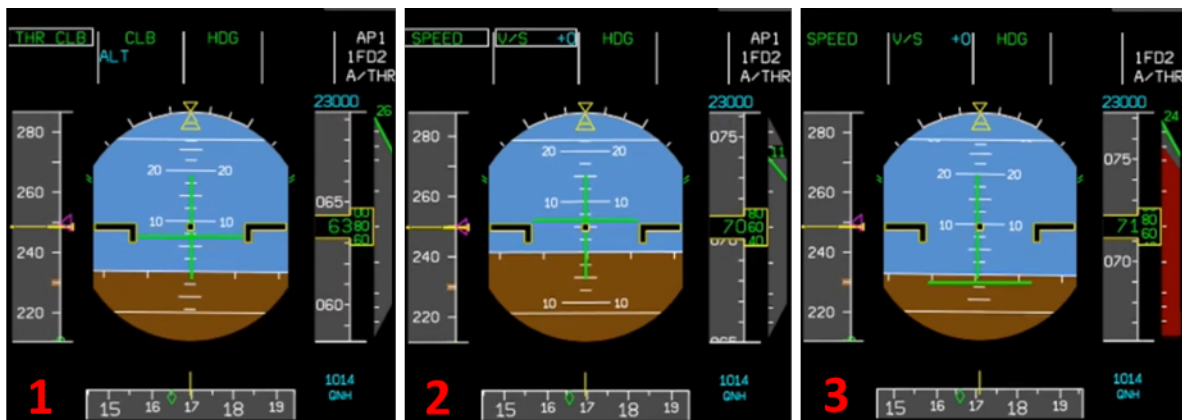
Figure 23: PFD of aircraft B in three different situations

Figure 23 shows the primary flight display (PFD) of aircraft B in three different situations. In the upper part of the PFD, the status of the autoflight system can be read from the flight mode annunciator (FMA).

The procedural deviation that occurred during the subsequent TCAS RA of not deactivating the FD is called a lapse. Similar to the slip, this is an execution error, but is assigned to memory. A lapse is characterised, as in this case, by the omission of items from a checklist or procedure. Despite CRM⁶³, the PF's failure not to order the deactivation of the FD was not noticed by the PM.

Furthermore, the FD's indication of the flight attitude during an RA deviates and gives an instruction contrary to the RA. This was also the case in this incident. Due to the instruction to stop the climb, the system was given a vertical speed of 0 ft/min. This caused the A/THR mode to change to SPEED mode. After initiating the climb according to the TCAS RA, the FD indicated a reduction of the pitch angle to bring the aircraft back to a vertical speed of 0 ft/min.

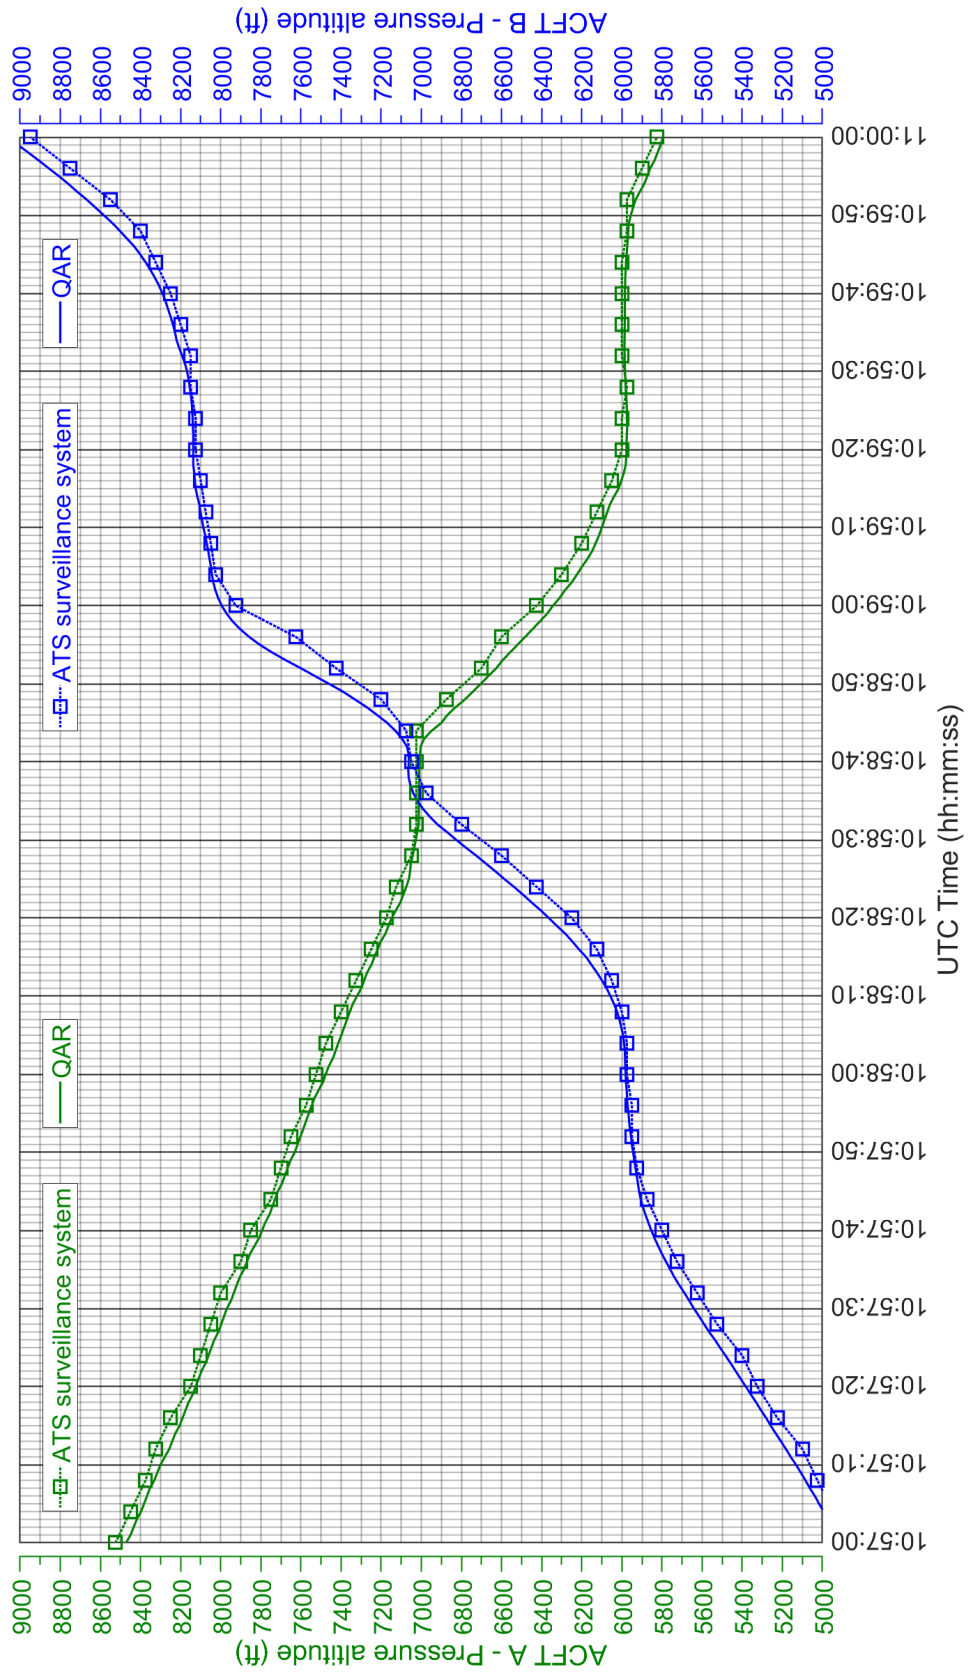
Figure 24: Comparison of QAR and ATS surveillance system altitude data

For position data, however, the time offset is eliminated by the calculation of the radar tracker. Therefore, the displayed positions correspond sufficiently accurately to the actual values.
