Final Report

Accident with helicopter of type Bell 429,
on 21 November 2021, at approx. 15:53 UTC, at airfield Wr. Neustadt/Ost,
A-2700, Wr. Neustadt, Lower Austria
Ref: 2023-0.384.199

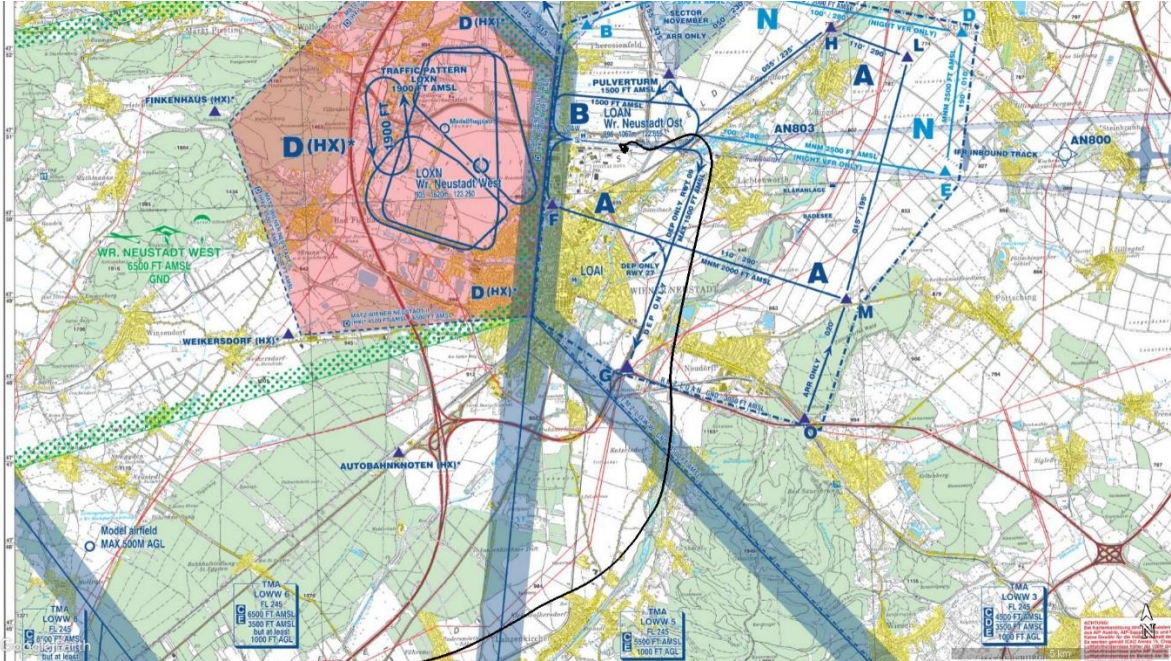
Figure 1 Flight path (black) on VFR chart for LOAN

The data in the Figures 1 and 2 were derived and averaged from ADS-B data (in Figure 2 yellow) and MLAT data (multilateration, in Figure 2 red).

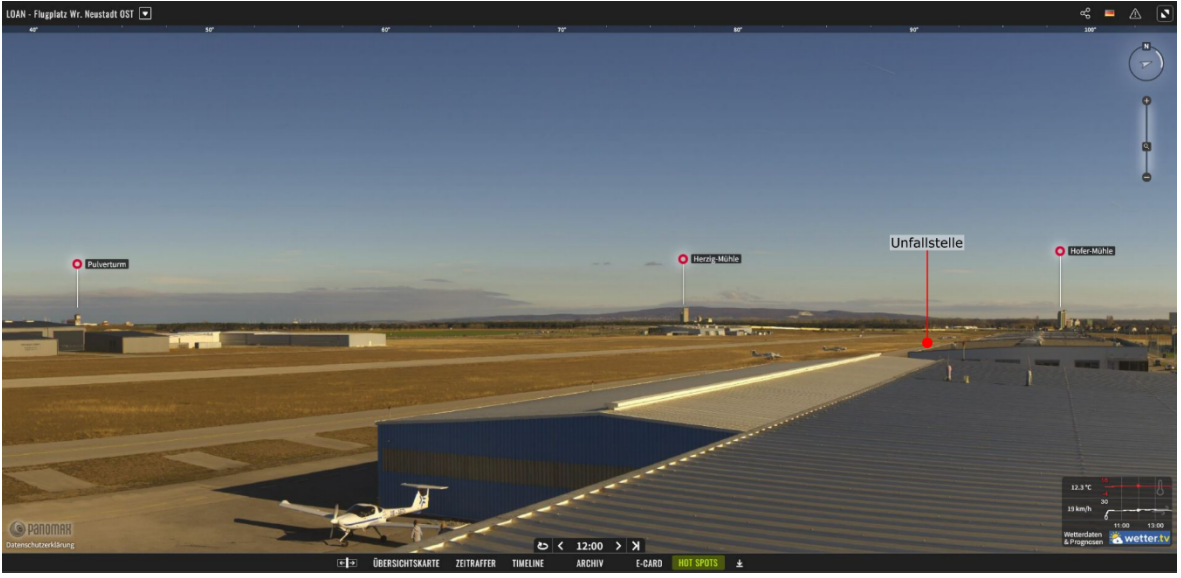
Figure 11 Webcam image looking at accident site, one day before the accident

For comparison, Figure 11 shows the same line of sight to the accident site on the day before the accident. The accident site is marked in the figure.

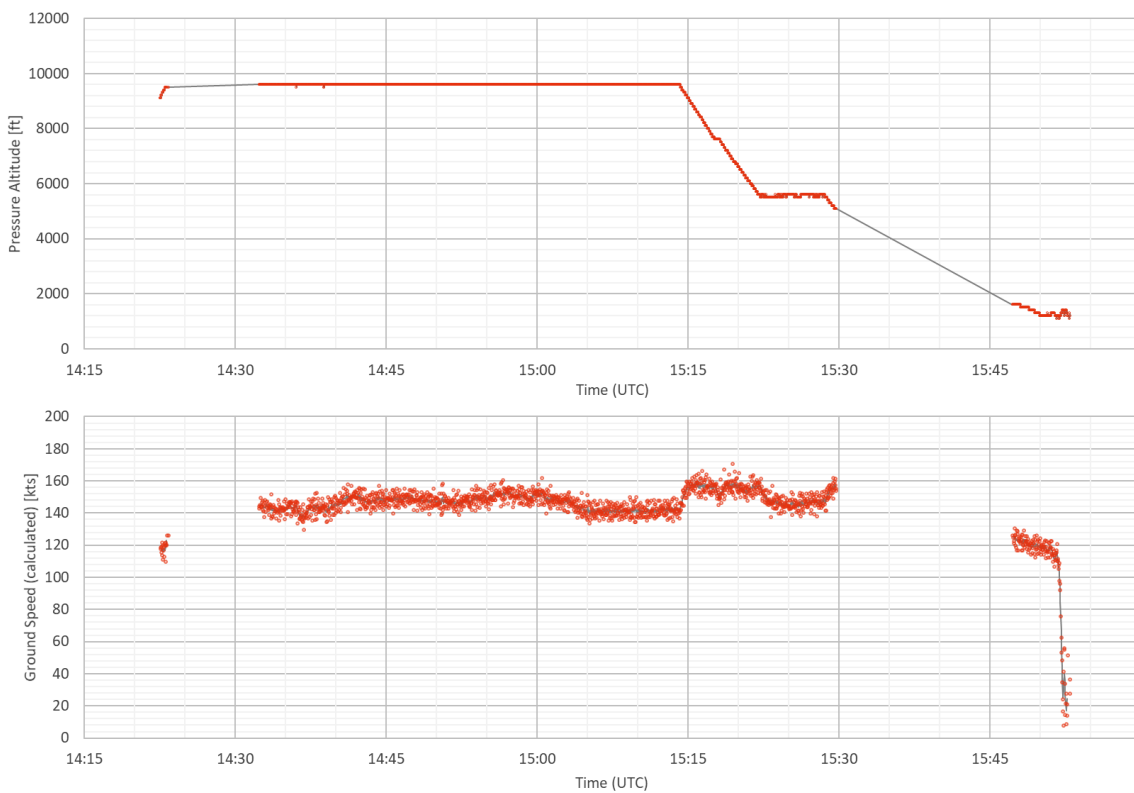
Figure 19 Radar data, altitude and speed, 14:15 to 16:00

The recorded altitude data in Figure 19 are shown in red, the gray lines represent areas where no data was available. Gray lines directly connect the recorded data in red. The actual flown altitudes in non-acquired areas may differ from the gray connecting line shown.

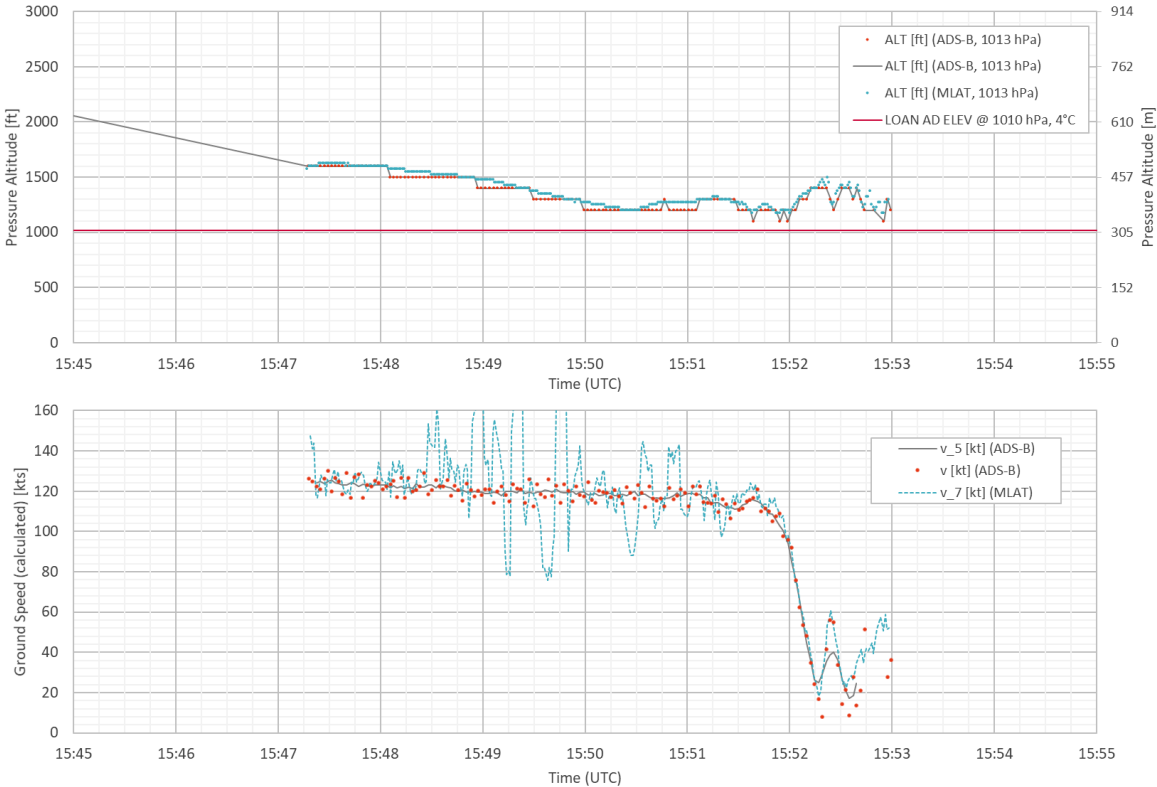
Figure 20 Radar data, altitude and speed, 15:45 to 15:55

The altitude data in Figure 20 are pressure altitudes¹ and shown as follows: Recorded ADS-B altitude data are shown in red, MLAT data are shown in blue. ADS-B data are additionally connected by a gray line. Furthermore, the airfield elevation - calculated back to a pressure altitude using QNH and temperature current at the time of the accident - is visible as a red horizontal line (pressure altitude of the airfield about 310 m or 1018 ft).

According to the data, the helicopter was flying at an altitude of 200 ft above ground level at about 15:50 when it entered RMZ LOAN (approximately near Neudörfli). At about 15:52:15, the altitude increased temporarily up to 400 ft above ground level as the helicopter passed over runway threshold 27. This altitude gain was accompanied by a reduction in ground speed from 120 kt to between 20 and 60 kt. During the final turns and

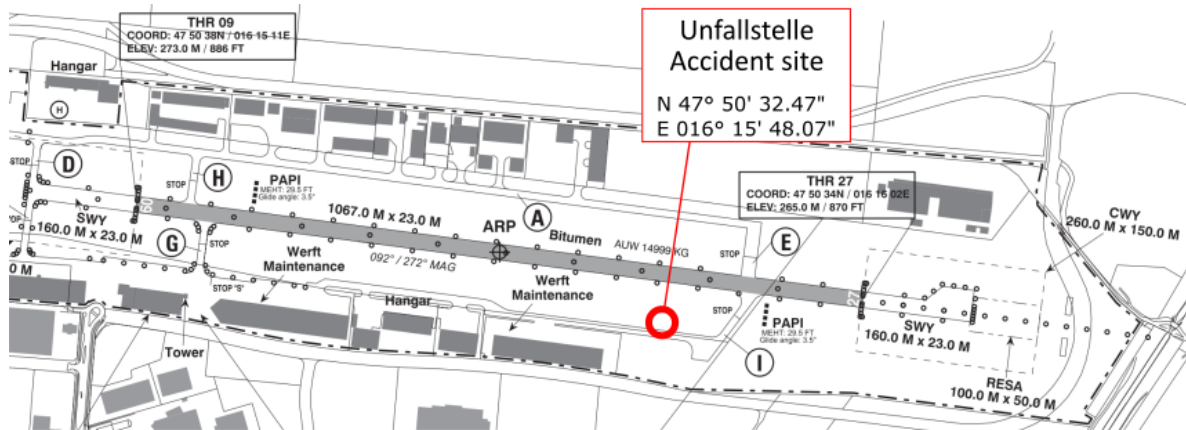
Figure 21 Accident site on the aerodrome chart (AIP Austria)

The accident site is located at taxiway INDIA of the airfield Wr. Neustadt/Ost (LOAN), refer to Figure 21. Most of the wreckage rested in the adjacent grass field north of the taxiway, with parts of the wreckage also lying on the tarmac. Operating fluids and extinguishing agents were also spread on the tarmac.
