# Final report

Serious incident involving aircraft type EMB195,  
on October 27, 2017 at approximately 15:35 UTC during the approach to  
Salzburg Airport Ref no.: 2021-0.534.000

Vienna, 2021

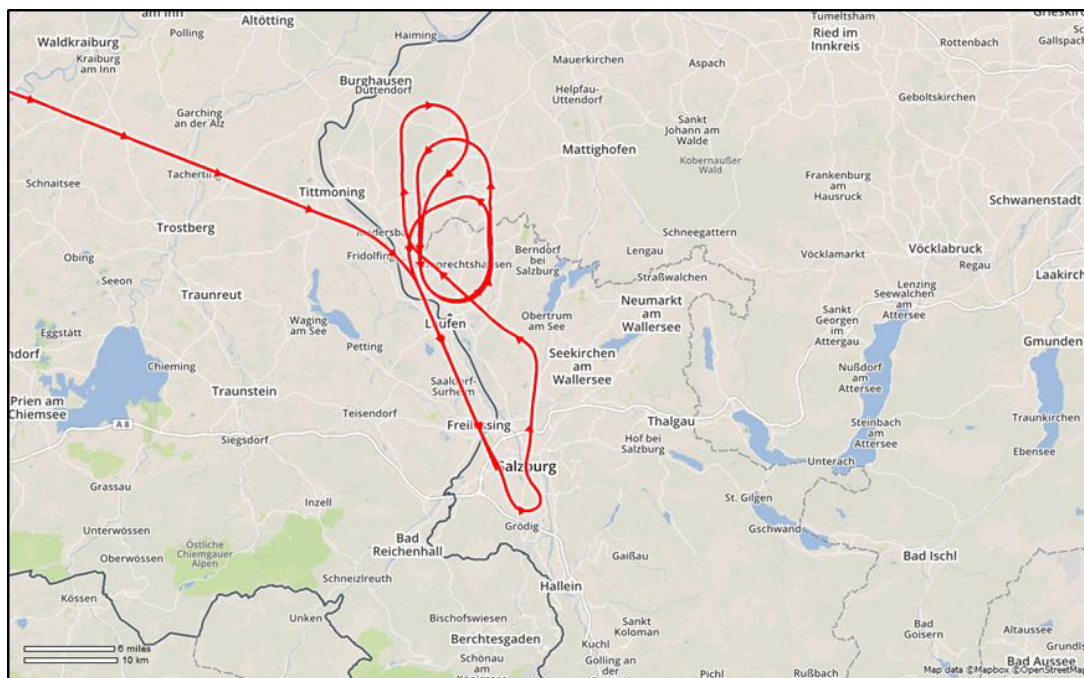
Figure 1: Flight path

The second approach and the landing on runway 15 at Salzburg Airport (LOWS) took place at approximately 16:01 UTC without any further issues/incidents.

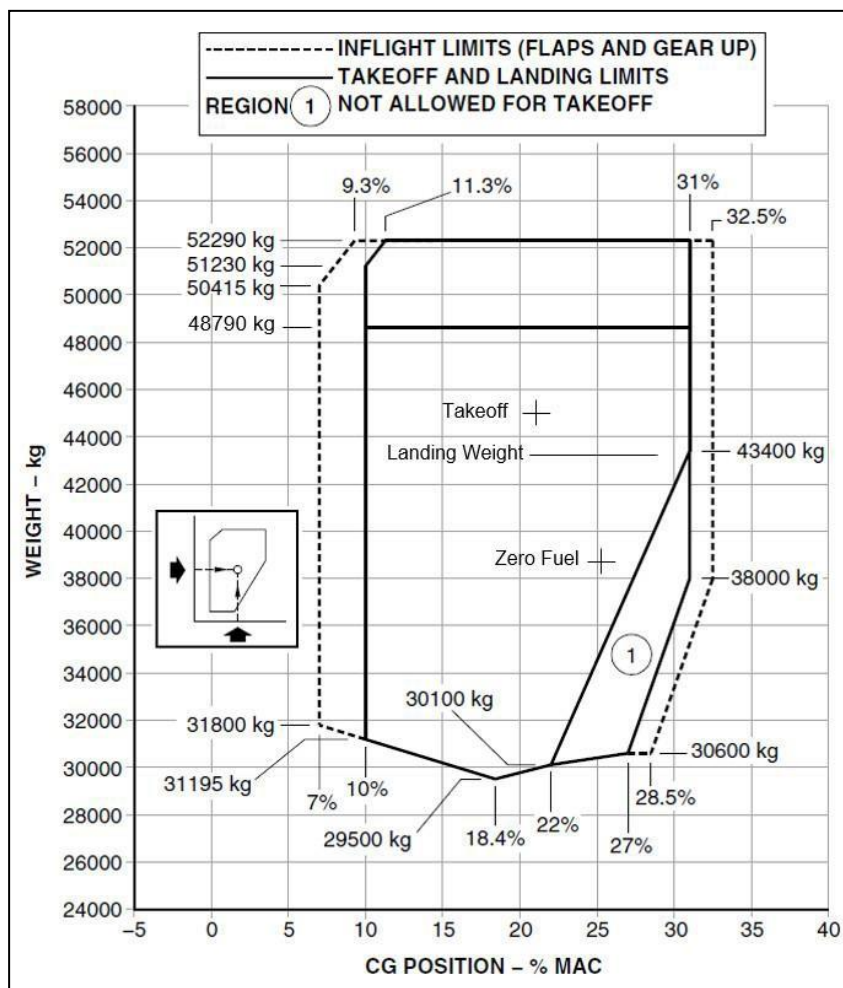
Figure 3: Calculation of the centre of gravity

According to the loading plan and AFM, both the mass and the centre of gravity were within permitted limits at all times throughout the flight.

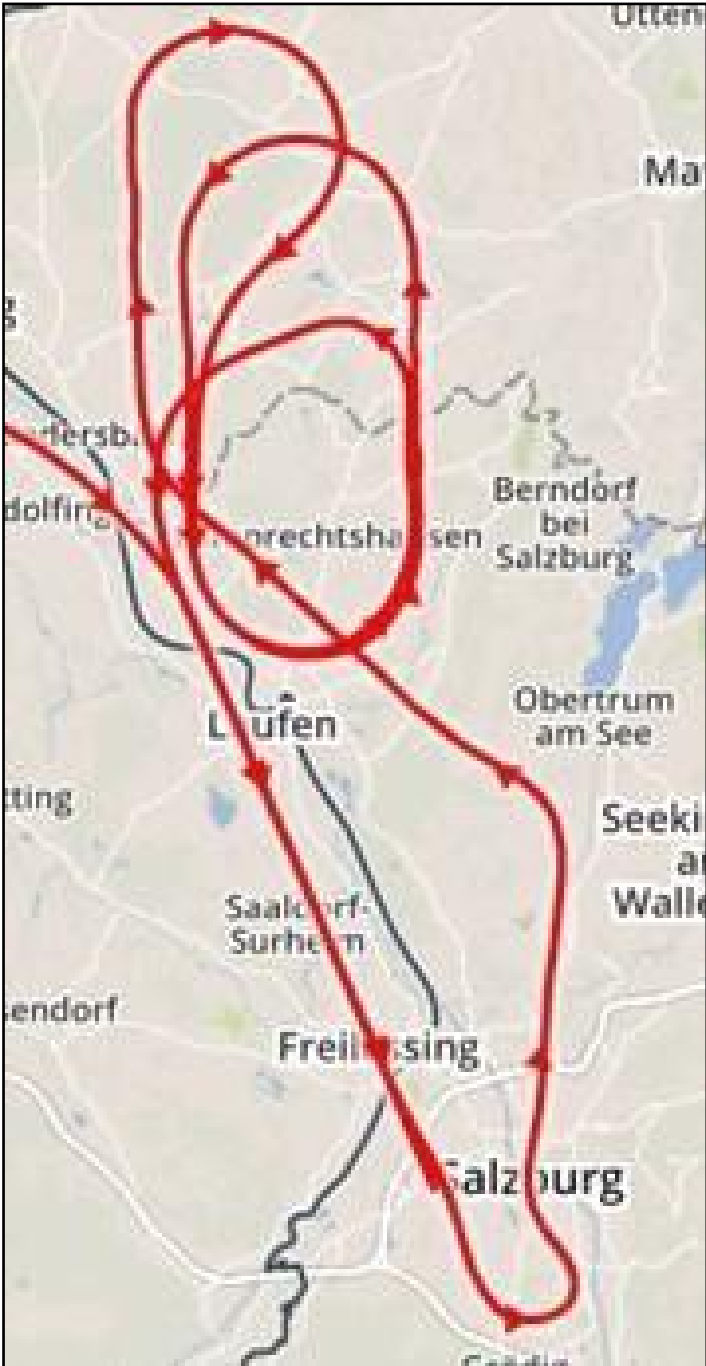
Figure 4: Horizontal view of the flight track

The following radar data was made available to the Safety Investigation Authority (SUB) by Austro Control GmbH. It shows the last approximately 247 km of the flight track up to the landing in Salzburg.

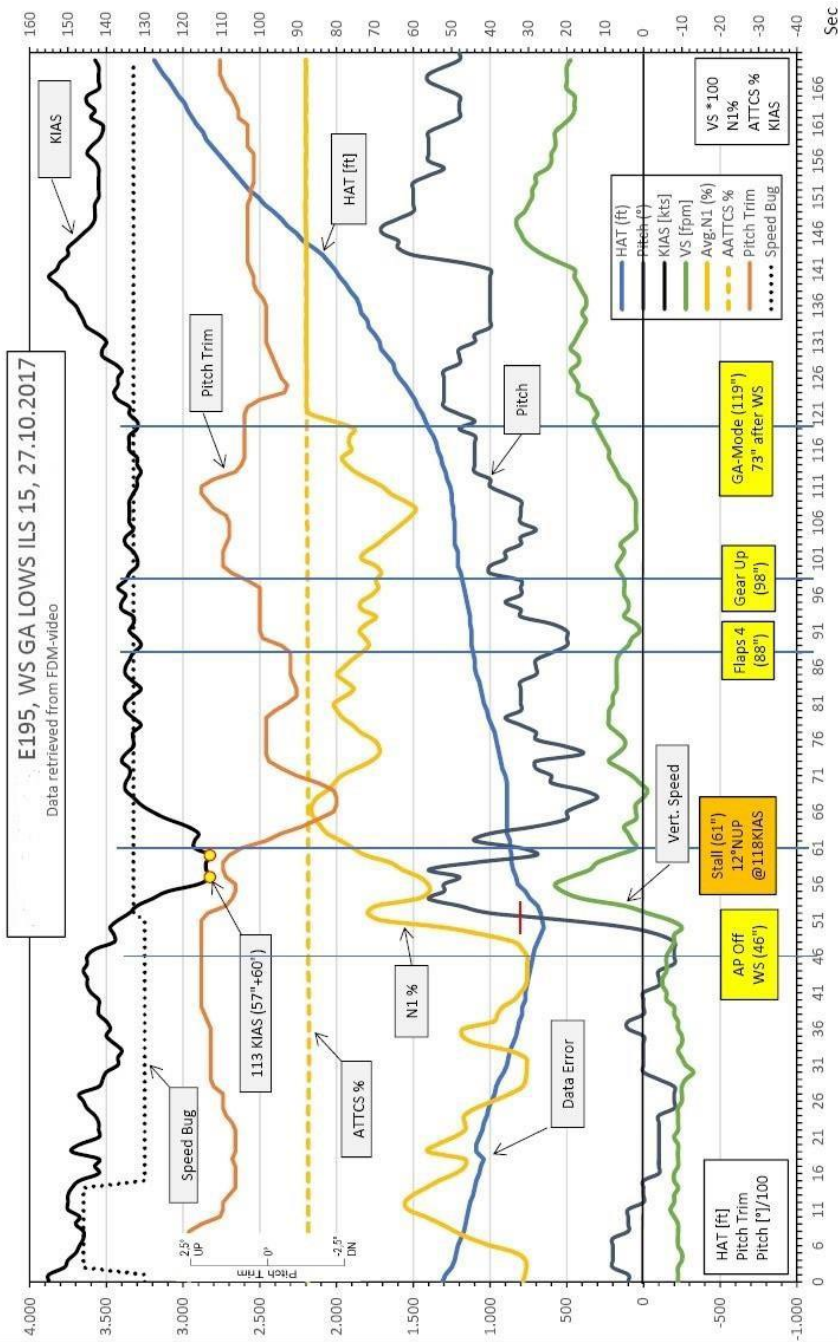
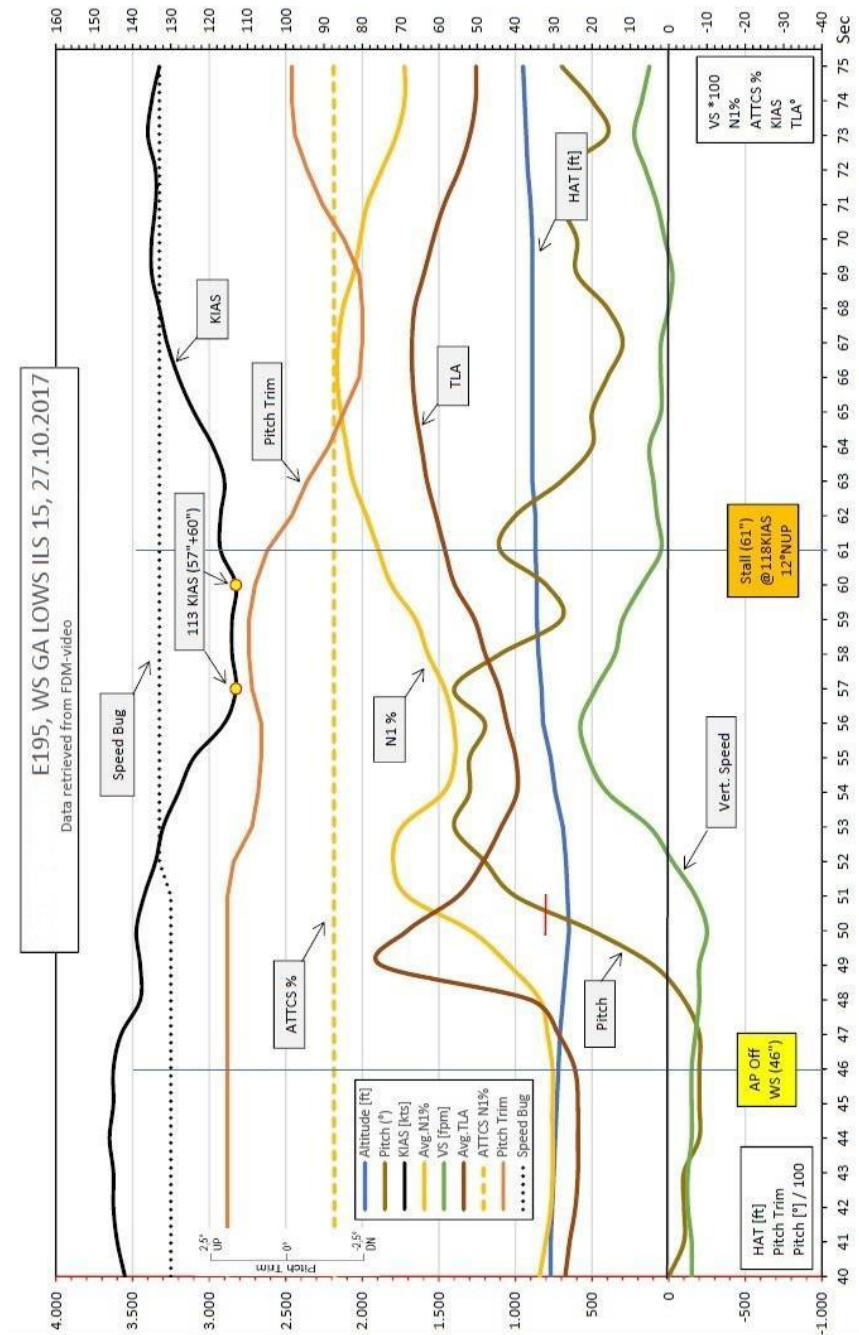
Figure 7: Flight data graphic #1, 170 seconds

The graphics show the windshear caution at second 46 (remained active for 9 seconds). The autopilot was deactivated 1 second before. When the windshear caution was issued, the power levers were moved forward manually and reached a peak value some 3 seconds after the windshear caution was issued (left-hand TLA 74.9°, right-hand TLA 75.3°).

The automatic reduction in engine power, in connection with the increase of the pitch angle, led to a loss of airspeed and the aircraft ultimately reached a minimum speed of 113 KIAS for a period of 3 seconds, 11 seconds after the windshear caution. Since the pitch angle was increased from 7 degrees to 11 degrees 13 seconds after the windshear caution was issued, a warning for an approximately stalled flight condition was then issued 15 seconds after the windshear caution at 113 KIAS. The pitch angle was then reduced to 3 degrees positive. Based on the speedbug setting of 133 KIAS, the engine power was increased again automatically until the target speed set by the speedbug of 133 KIAS was reached.
