Final Report

Accident with the helicopter Sokol W-3A,
on 14.01.2019, at approx. 11:34 UTC at Bürglkopf,
Gemeinde Fieberbrunn, A-6391, Tyrol,
GZ.: 2021-0.905.481

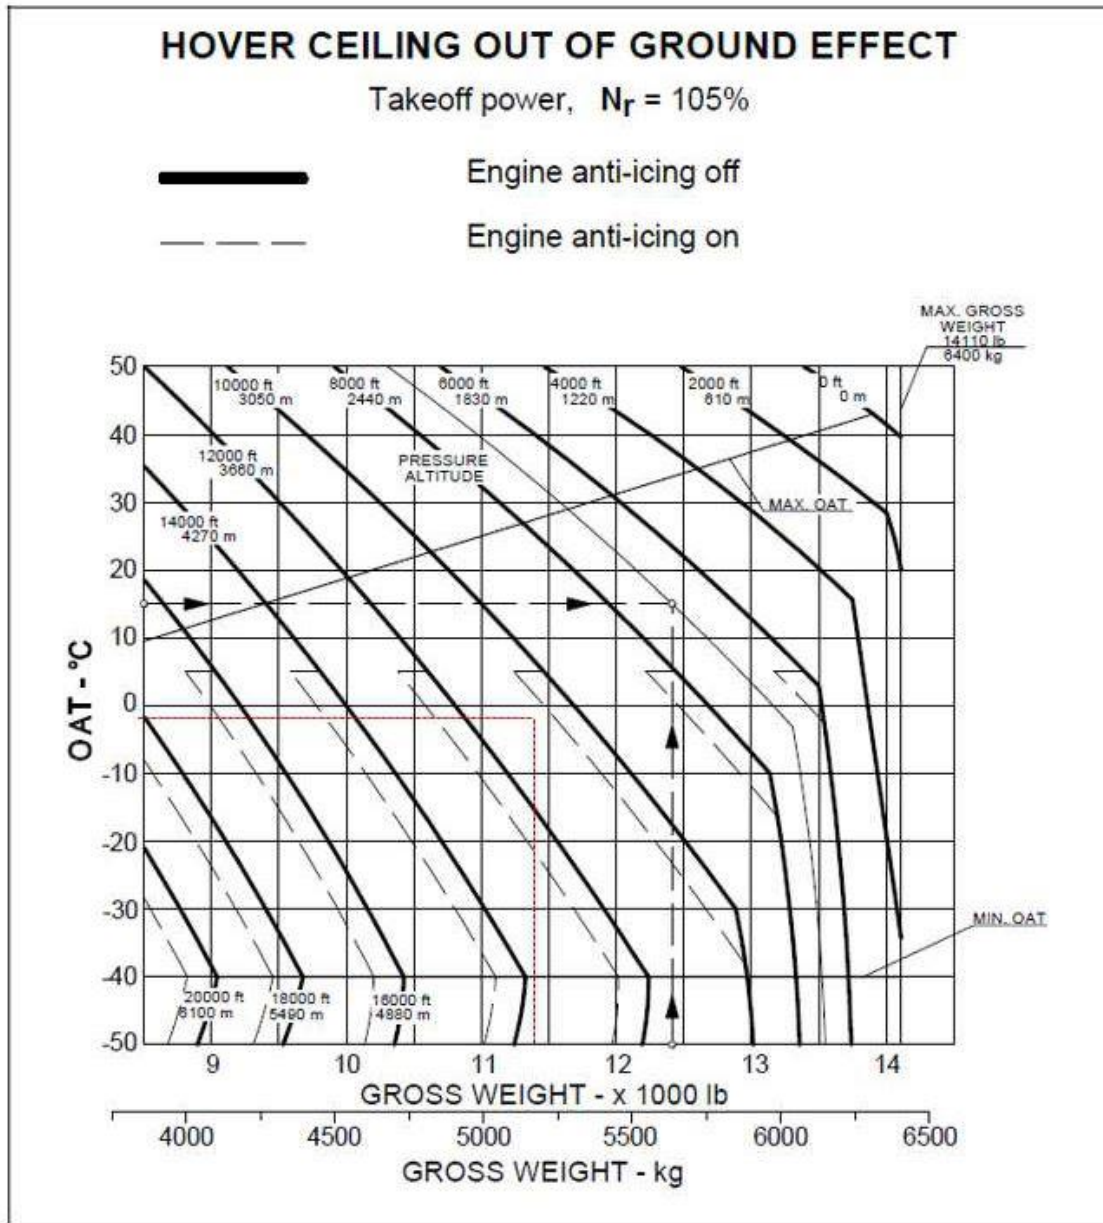
Figure 3: Hover ceiling out of ground effect

The pilot had a power of OEI 30 min at his disposal.

„...If only OEI 30min. power from one engine is available (no disposable power provided by the other engine), it is not possible to perform the hover in windless conditions for the undisturbed rotor characteristics (without icing). For the disposable power value presented in Figure 4 and the WN RPM, the hover IGE in windless conditions would have been possible

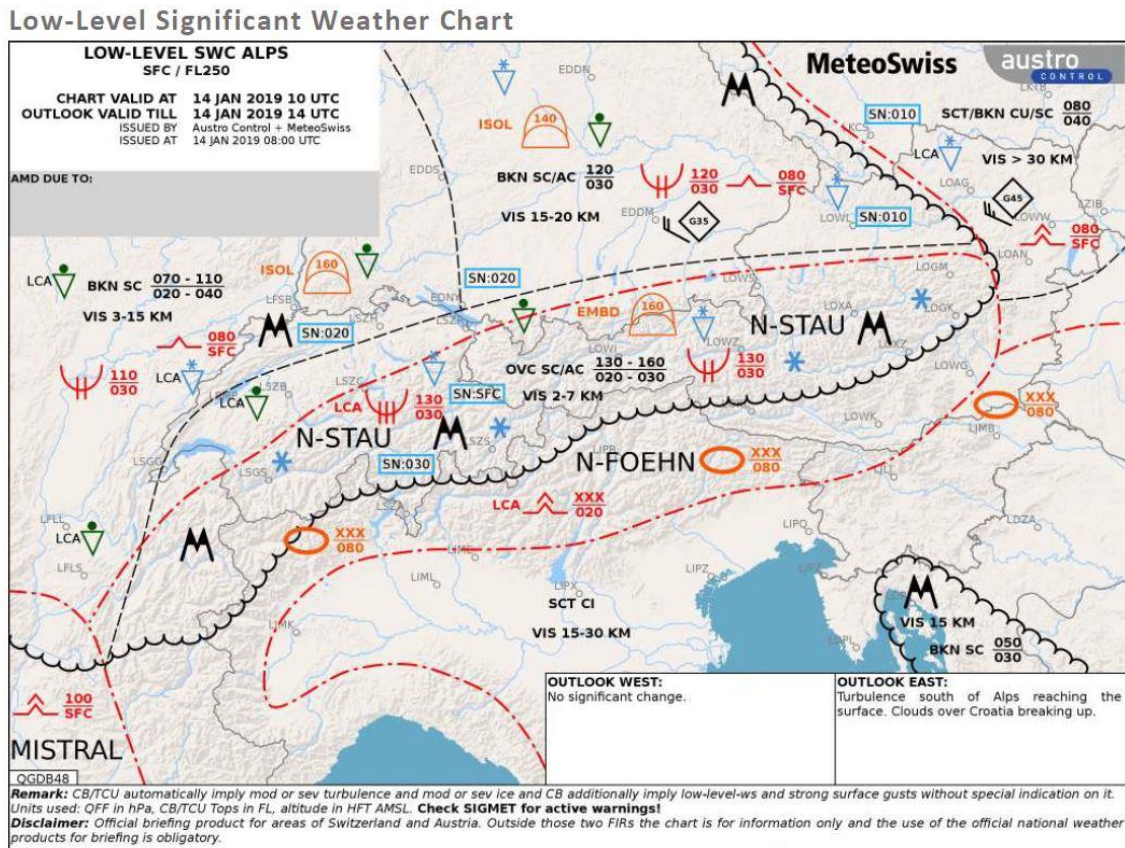
Figure 10: Low-Level Significant weather chart

The contents of the Low-Level Significant and the W/T Chart applicable at the time of the accident predicted snow showers, moderate icing conditions between 3,000 feet (915 metres above MSL) and 13,000 feet, and main cloud bases of approximately 2,000 feet to 3,000 feet for the incident site and its wider surroundings.

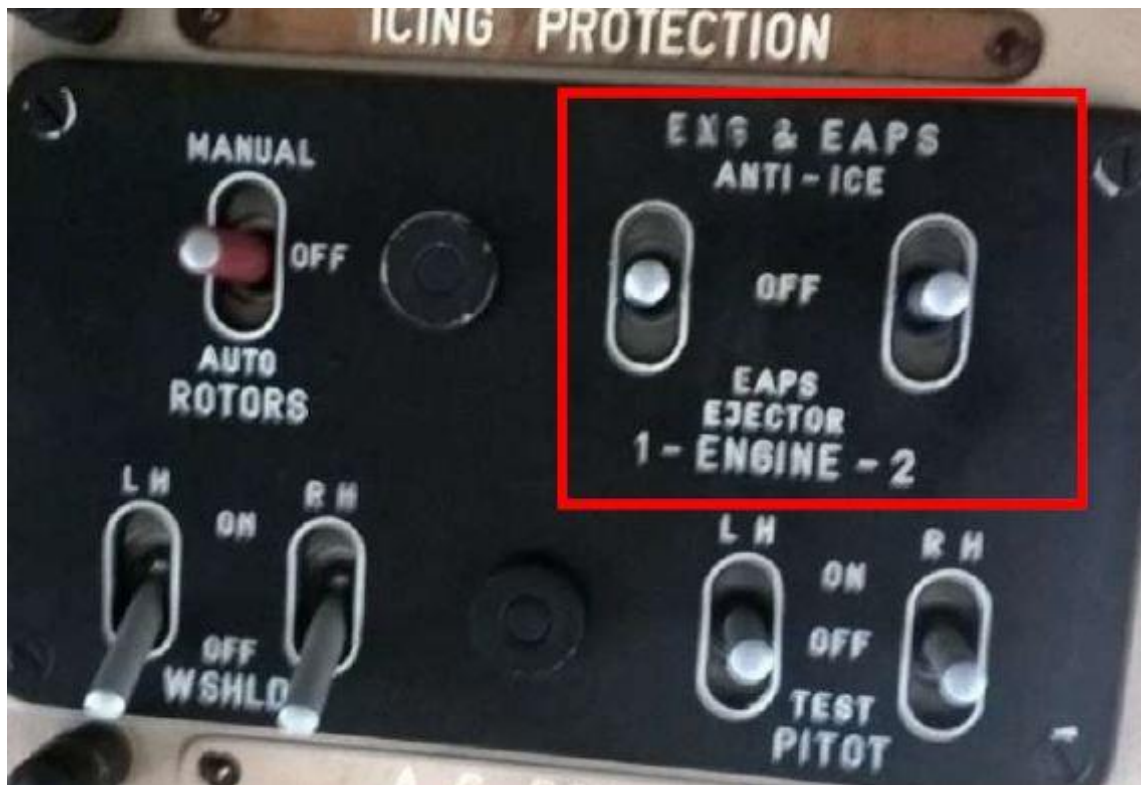
Figure 25: Icing protection

The Engine Inlet Anti-Icing System is actively activated by the pilot by means of toggle switches in the cockpit, whereby both engines have separate switches and technically speaking, fully separate systems. The two toggle switches in the cockpit (one per engine) on the "ICING PROTECTION" panel (positioned on the overhead panel) have three positions each. In the middle position the entire EAPS and Engine Inlet Anti-Icing system is switched off, in the forward position only EAPS Anti-Icing is activated, in the aft position both Engine Inlet Anti-Icing and EAPS Anti-Icing system are active. The Engine Inlet Anti-Icing System must be activated when the outside temperature is less than 5° Celsius.

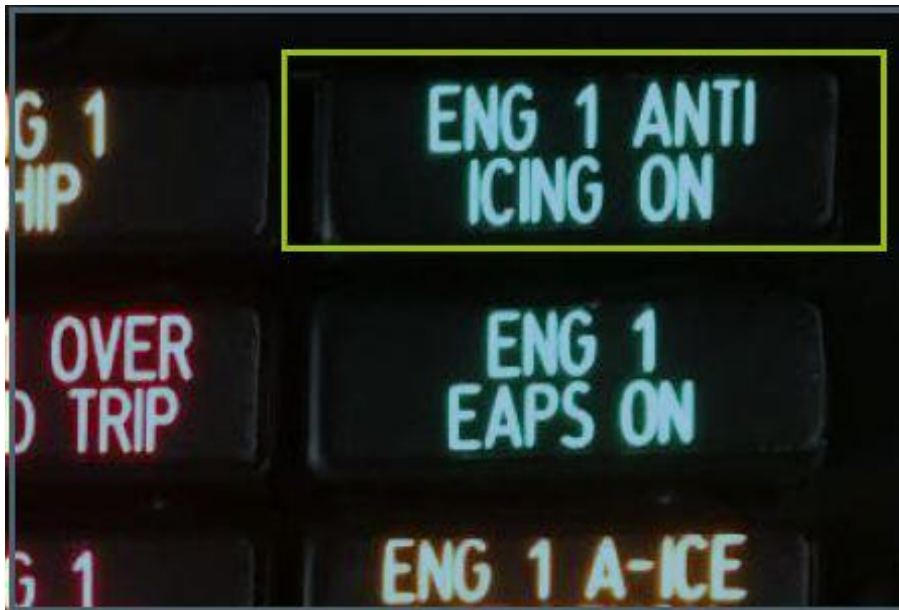
Figure 26: Operation light ENG 1 Anti-Icing ON

The electromagnetically actuated valve, from the Engine Anti-Icing System, controls the hot air, which is branched off from the area immediately after the last compressor stage, via pipes and hoses to the opening holes in the Inlet Case front Struts. When the Engine-Anti-Icing-System is activated and functioning, the position of the electromagnetically controlled valve controls the cockpit display, the Operation Light. It has been found that these lights of both engines were functional.

Partial constraints on the engine-anti-icing system, as in this case caused by corrosion, has no effect on the displays in the cockpit. The electromagnetically actuated valve opened and let the hot air (Combustion Air) pass up to the opening holes in the Inlet Case front Struts. Since these openings were closed by corrosion, no Combustion Air could escape to prevent ice build-up.

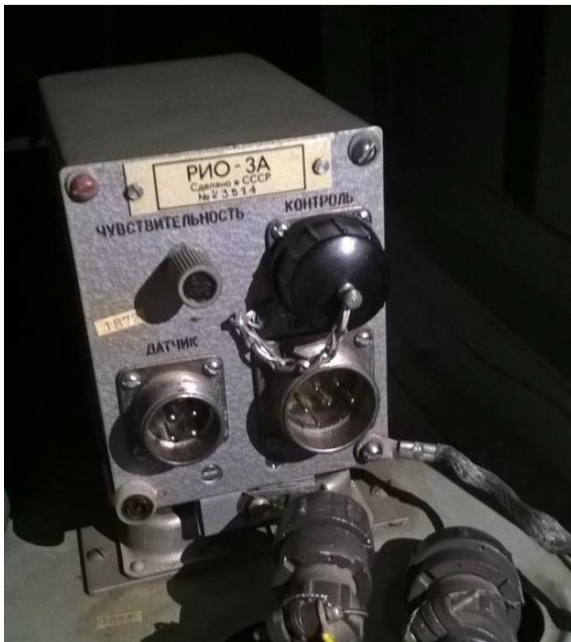
Figure 28: Controll unit RIO 3A

- helicopter de-icing system in Manual Mode verification – proper operation
- helicopter de-icing system in Auto Mode verification
 - no illumination of the "ICE" warning light, no activation of the installed de-icing system.
 - system electric circuit verification in order to failure localization. It was found that two connectors were not connected to the control unit of the RIO 3A sensor, see Figure 28.
 - When the connection with the RIO 3A control unit was established, it could be determined that the "ICE" warning lamp was permanently activated (regardless of which signal the RIO 3A sensor had transmitted). Afterwards the RIO 3A sensor including the cabling up to the RIO 3A control unit was checked, this was done without any abnormalities.
