Final report

Accident with helicopter type MD900(902),
on 1 August 2017, at ca. 18:15 UTC on Grossglockner mountain,
municipal Heiligenblut, A-9844, Carinthia
Ref.: 2022-0.483.594

Investigation report

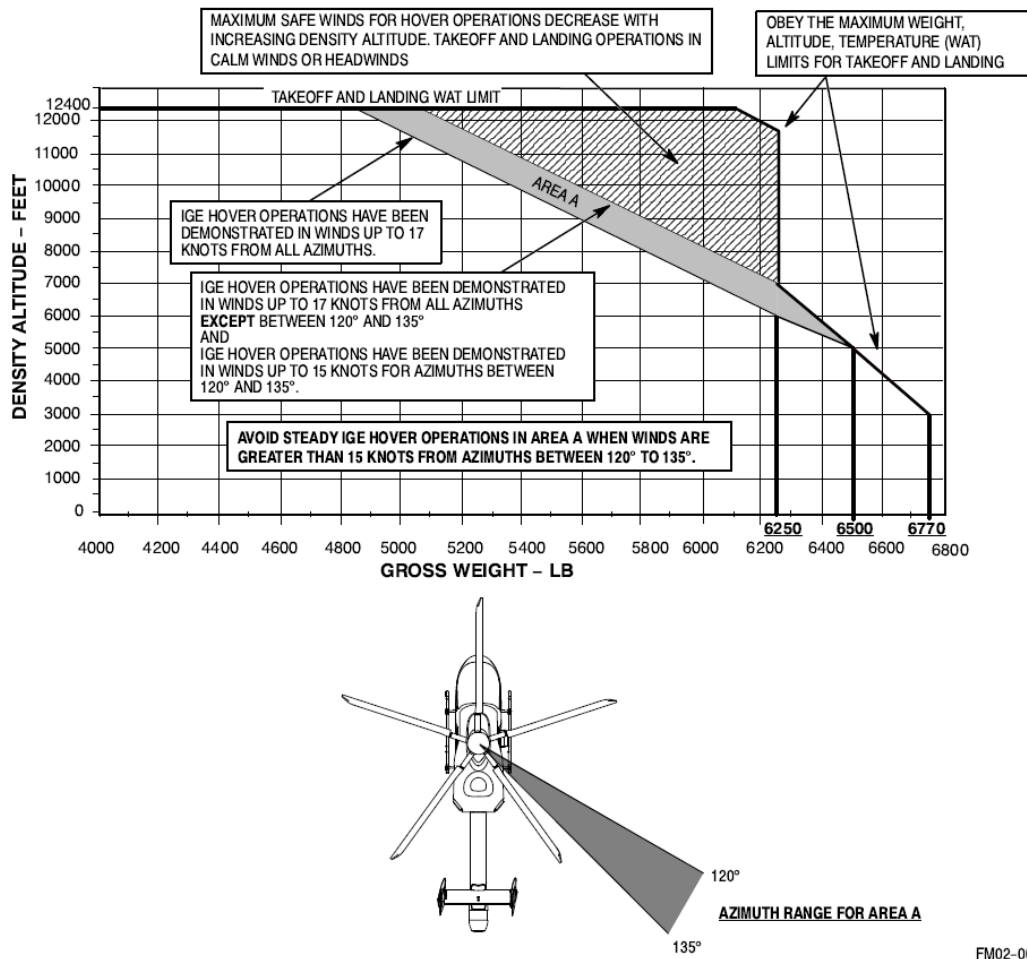
Figure 4 WAT and Crosswind Limits

On 27 December 2006, MDHI issued a mandatory service bulletin (SB) to adapt the rigging of the Directional Control System, to install the Thruster Extension Kit and to check the Fan Felt Seal. In the Airworthiness Directive (AD) 2009-07-13, the FAA stipulated the mandatory implementation of this SB. In the associated FAA Docket No. FAA-2008-0772, a further explanation is given to justify the issue of the AD: during flight tests it was found that the actual controllability limits are not consistent with those in the WAT and crosswind limits diagram (Figure 4).

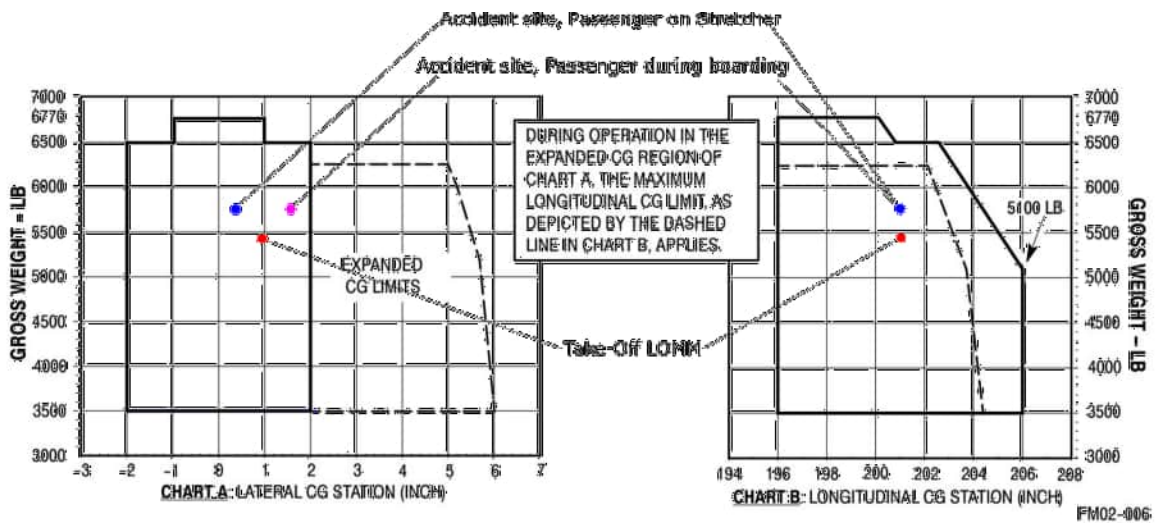
Figure 5 Mass and center of gravity

When taking off at LOMM without the patient, the center of gravity (CG) lever arm was 201.1 in, the take-off mass was 2481 kg (Figure 5). The lateral CG lever arm was +0.98 in when taking-off at LOMM, +1.74 in at the site of the accident when boarding the patient, and +0.18 in when the patient was on the stretcher.

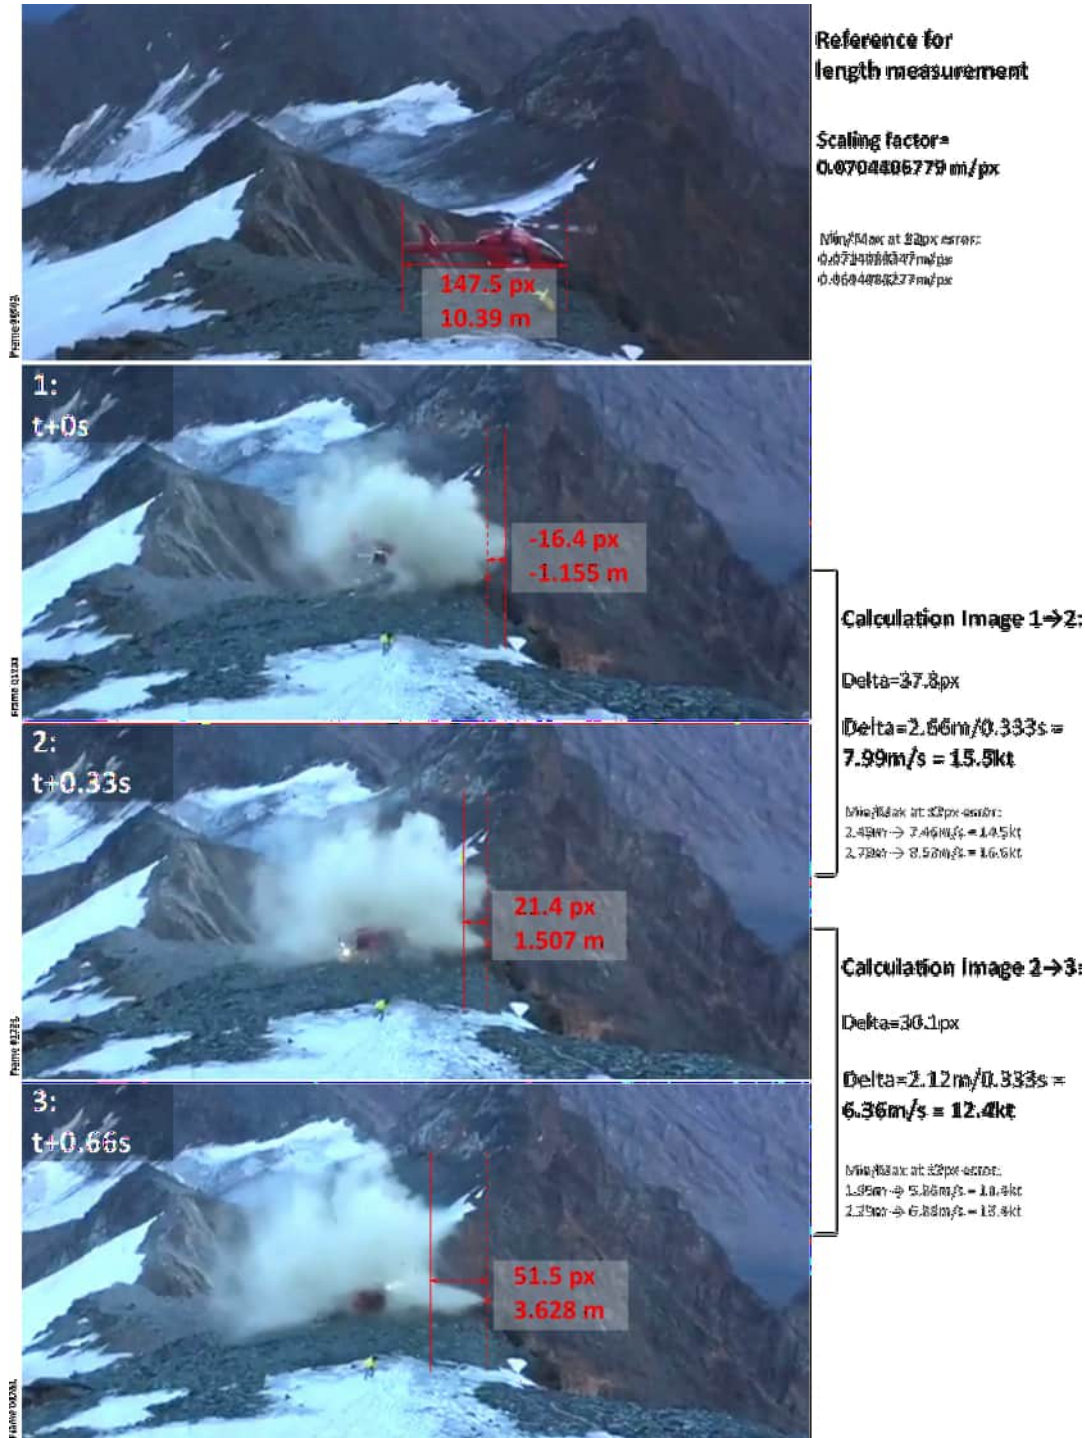
Figure 11 Wind calculation from video

It can also be seen that the dust cloud is moving against the approach direction, over the mountain ridge. This observation is identical to the statements made by the pilot and the lodge keeper.

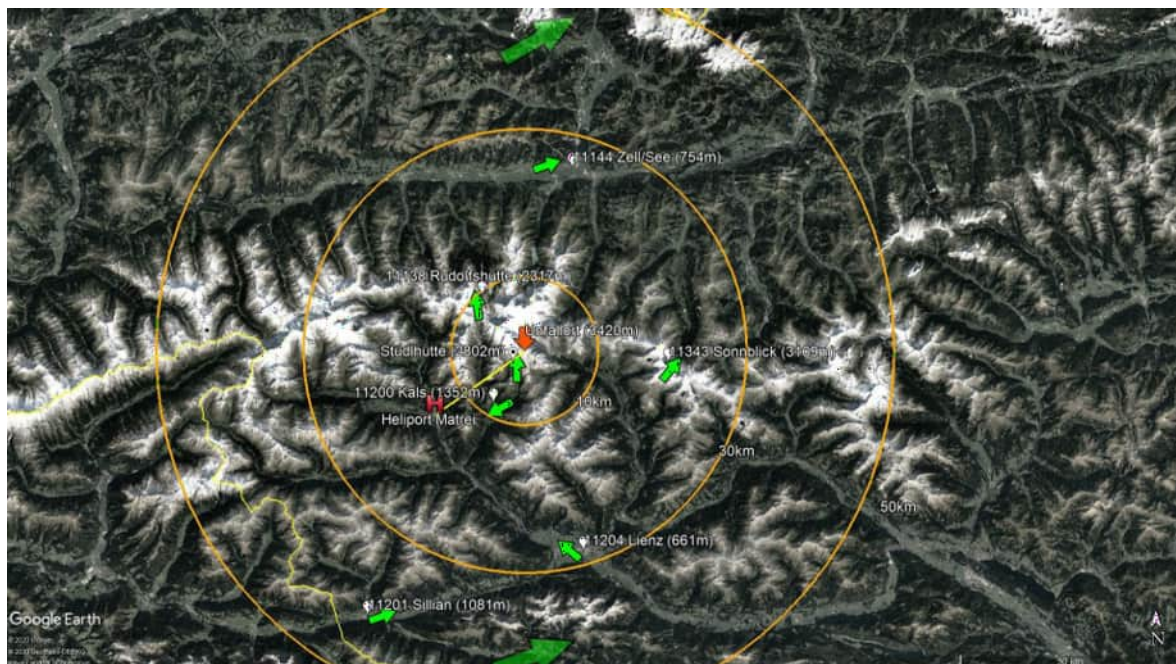
Figure 19 Weather measuring stations around the site of the accident

The accident in question took place in the mountains at an altitude of 3420 m. Localized differences in terms of weather phenomena and data are not uncommon in the mountains at such heights. In addition, there are usually few or no weather stations available at such locations. Nevertheless, data could be saved and evaluated from a sufficient number of surrounding measuring stations at different heights (see section 1.7). The weather stations are located within a radius of 2–40 km from the scene of the accident, the measuring stations at the airports Innsbruck, Salzburg and Klagenfurt are further away. The positions of the measuring stations in the immediate vicinity are shown in Figure 19. The wind directions measured by the respective stations are shown as green arrows.

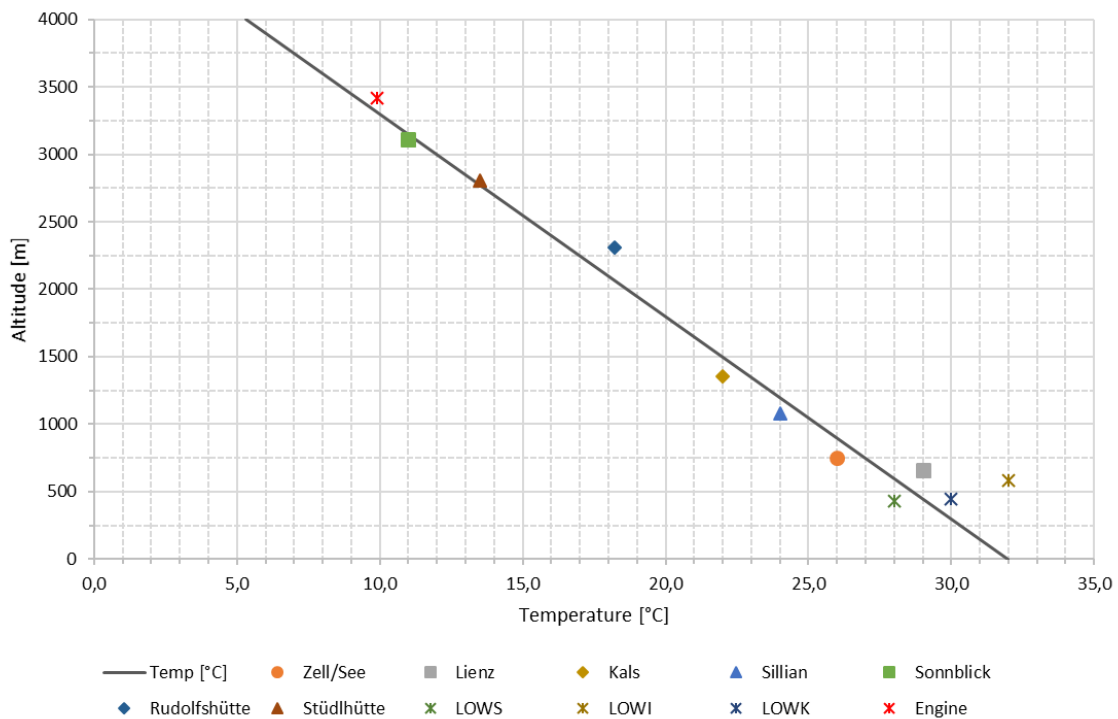
Figure 20 Temperature profile based on measurement data at the accident site at 18:10 hours UTC

The respective temperatures and geographical elevations of the measuring stations and the resulting vertical atmospheric temperature profile for 18:10 hours are shown in Figure 20. In addition, lower-lying stations (especially Lienz, Zell/See, Sillian and Kals), higher-lying stations (Rudolfshütte, Stüdlhütte and Sonnblick) and data from Salzburg (LOWS), Innsbruck (LOWI) and Klagenfurt (LOWK) airports were also included. The air temperature measured at the engine inlet can also be seen, for comparison. From this data, a ground temperature at MSL of 32°C (ISA + 17) and a temperature gradient of -6.67°C/km were calculated. The temperature at the site of the accident at an elevation of 3420 m corresponds to 9.2°C (ISA + 16). This value correlates very well with the measured engine temperature, which is approximately 0.4°C higher. This is realistic because air is slightly warmed up when it is sucked into the engines. The Austro Control wind and temperature chart (Figure 7) shows temperatures of 9 to 11°C at 10000 ft (3048 m) at the surrounding measuring points, whereby these measuring points are located at distances of over 100 km.

of 1017 hPa, the air pressure at the accident site can be determined with the aid of the barometric altitude formula¹ (683 hPa). This corresponds to a display on the altimeter of 10605 ft (3256 m, QNH setting 1020), a pressure altitude² of 10511 ft (3203 m) and a density altitude³ of 12231 ft (3728 m). The density altitude is relevant in that because it is necessary to be able to assess at which point one is in the WAT and crosswind Limits chart (Figure 4) and whether the Takeoff and Landing WAT Limit has been met or exceeded. The correct relation between the values for pressure altitude and density altitude can also be verified using Fig. 5-1 *Density Altitude Chart* from the MDHI RFM.

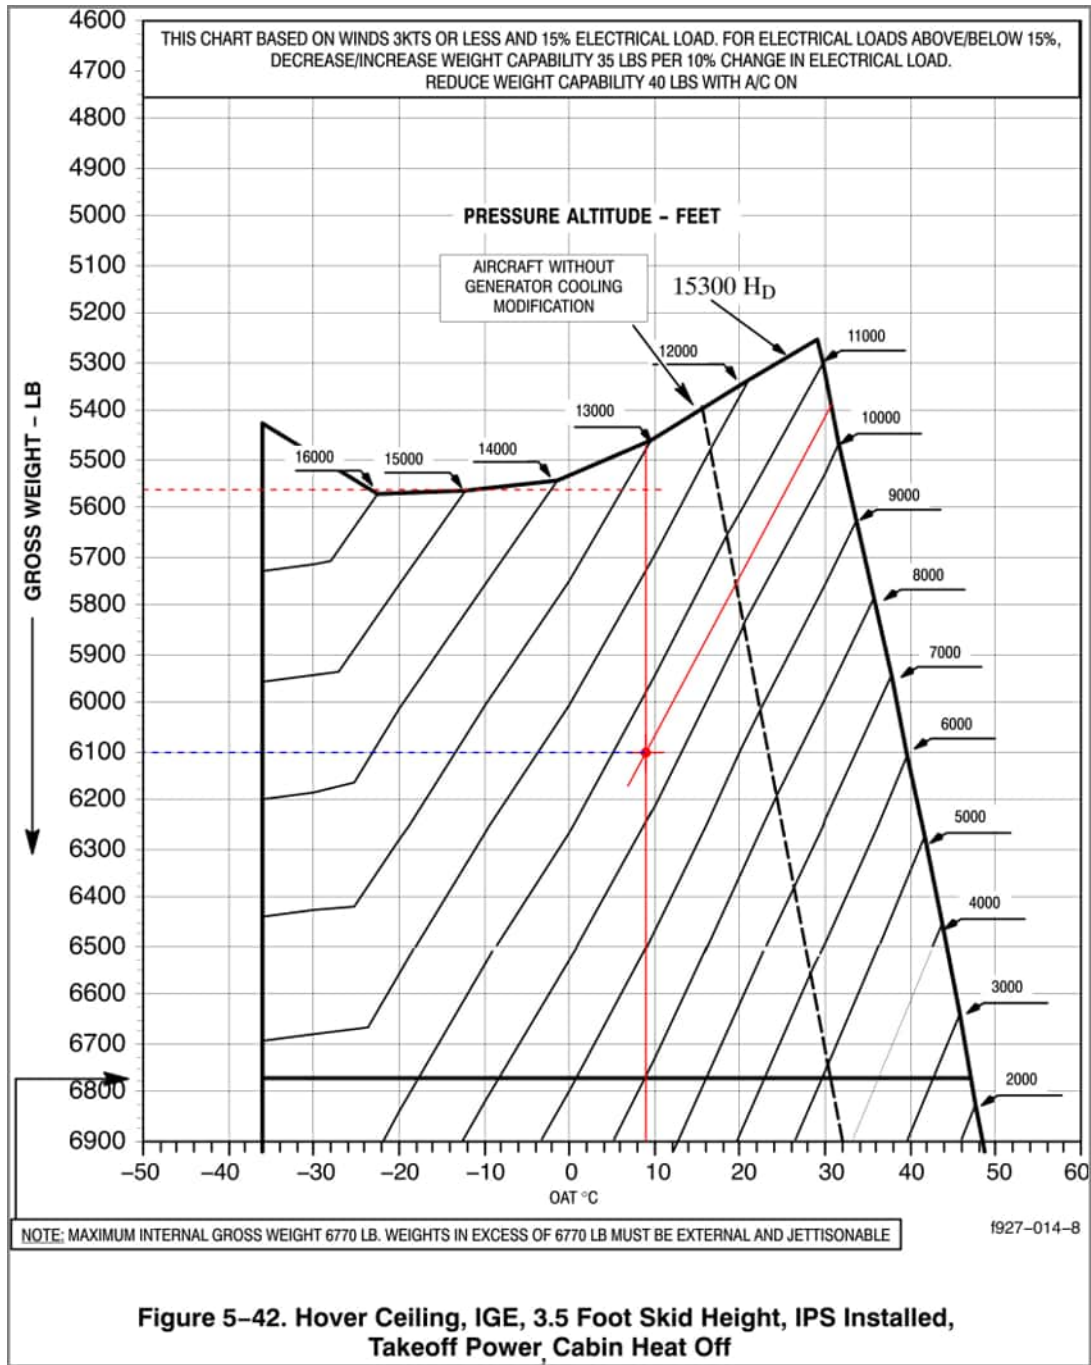
Figure 22 RFM Figure 5-42, Hover Ceiling, IGE, Flight Manual MD900

This report’s Figures 22 and 23 from the “Performance Data” section of the RFM are required to determine the maximum possible hover ceiling for inside and outside the ground effect. The data relating to the incident in question are shown in red. The maximum possible weight as the result of the intersection between the current temperature and the current altitude is shown in blue.

What is noticeable is that in comparison to Figure 2-2 or 5-37, altitudes are expressed as pressure altitudes. It is also noticeable that in all the diagrams from Figure 5-38 to Figure 5-45, the upper limit value is 15300 ft density altitude. This is notable for two reasons. On the one hand, because in Chapter 2 (“Limitations”) the “Maximum operating altitude” is given as 20000 ft density altitude. However, there is no way to carry out a performance calculation for altitudes greater than 15300 ft, as all diagrams end there. Second, because

the diagrams relating to hover in ground effect (HIGE), e.g. Figure 5-42 (this report Figure 22), cover areas greater than 12400 ft, although operation at altitudes greater than 12400 ft in the ground effect is not permitted in accordance with the Limitations chapter. This can lead to pilots mistakenly assuming that such an operation is permissible. It would make sense to mark an operating limit in these HIGE charts at a density altitude of 12400 ft. In addition, these diagrams are based on the assumption that the wind is 3 kt or less. Since no diagrams or other information are available for stronger winds, the diagrams in Figure 5-38 to Figure 5-45 can only be used to a limited extent for the performance calculation in stronger winds.

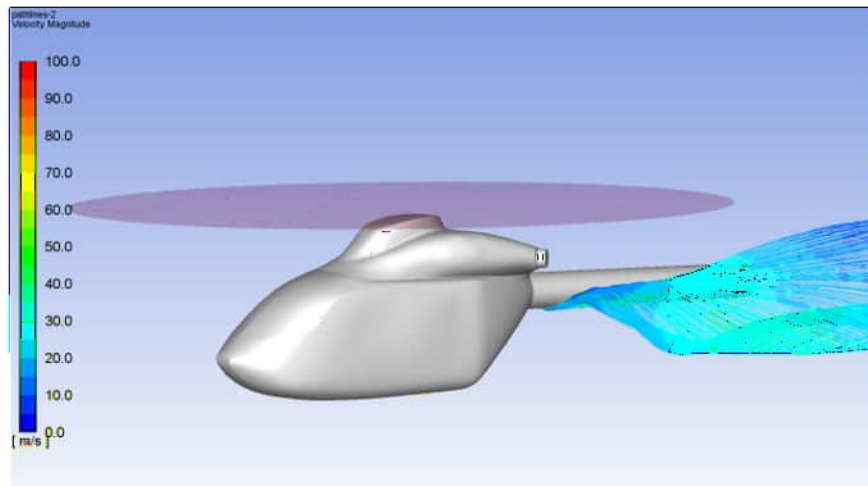
Abbildung 4.5: Detaildarstellung, Stromliniendarstellung bei 0 m Bodenabstand

In Abb.(4.5) ist eine Ablöselinie auf der Backbordseite des Helikopters zu erkennen. Am Beginn der Längsschlitzes löst die Strömung bei etwa 180° bezogen auf die vertikale Symmetrieebene ab. Dieser Winkel vergrößert sich auf etwa 270° am Ende der Ausblasung. Aufgrund des instationären Charakters der Strömung muss jedoch eine, in der realen Strömung vermutliche zeitliche Veränderung dieser Linie, die in der stationären Rechnung nicht dargestellt werden kann, bei der Interpretation berücksichtigt werden.

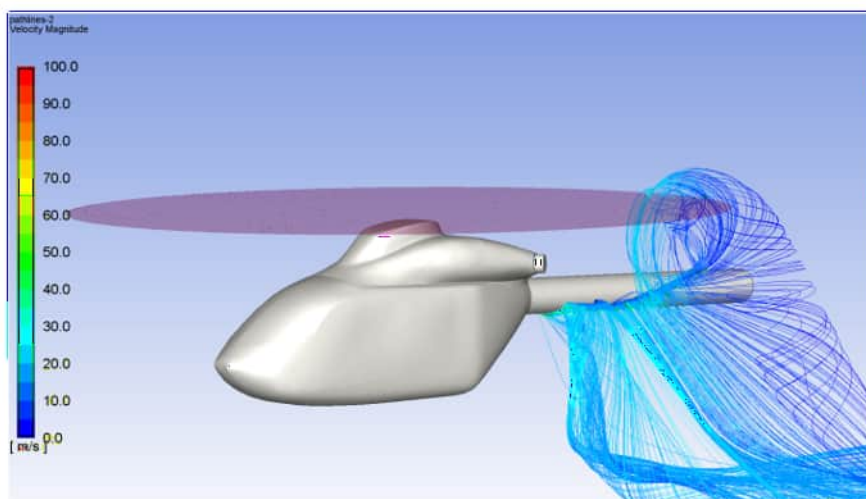
Abbildung 4.9: Detaildarstellung, Stromliniendarstellung bei 3 m Bodenabstand

Am hinteren Teil des Heckauslegers führt die tangentielle Ausblasung an den beiden Längsschlitzen zu einer Umströmung des Heckauslegers bis zirka 270° auf die Backbordseite des Helikopters, siehe Abb. (4.9). Danach löst die Strömung nach oben ab und wird durch den Rotorabwind wieder nach unten gedrückt. Der zweite Wirbel, am Beginn der tangentialen Ausblasung an den beiden Längsschlitzen, löst bereits an der Unterseite des Heckauslegers ab und bildet einen vertikalen Wirbel, dessen Geschwindigkeit höher ist als die des hinteren Wirbels.

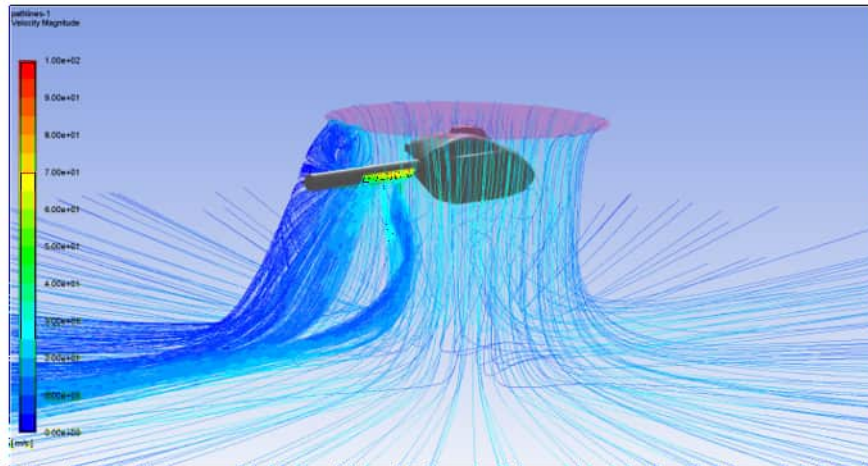
Abbildung 4.10: Stromliniendarstellung bei 6 m Bodenabstand

Der hintere Wirbel interagiert weiterhin mit dem Hauptrotor.

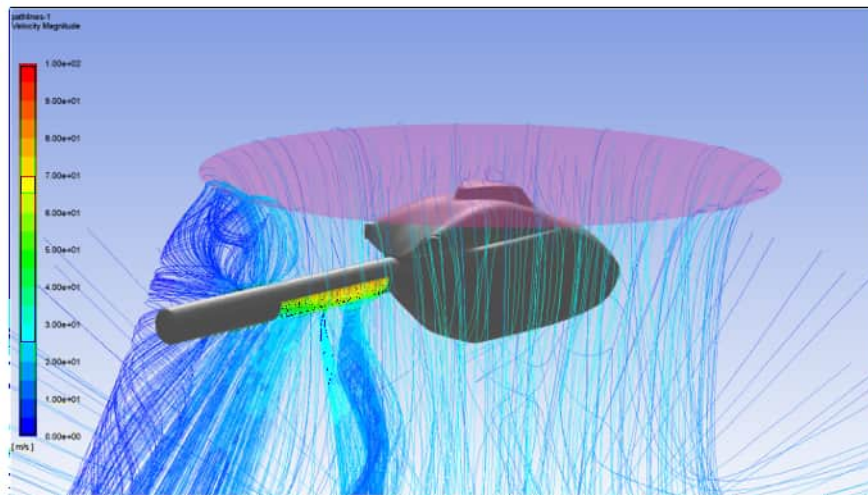
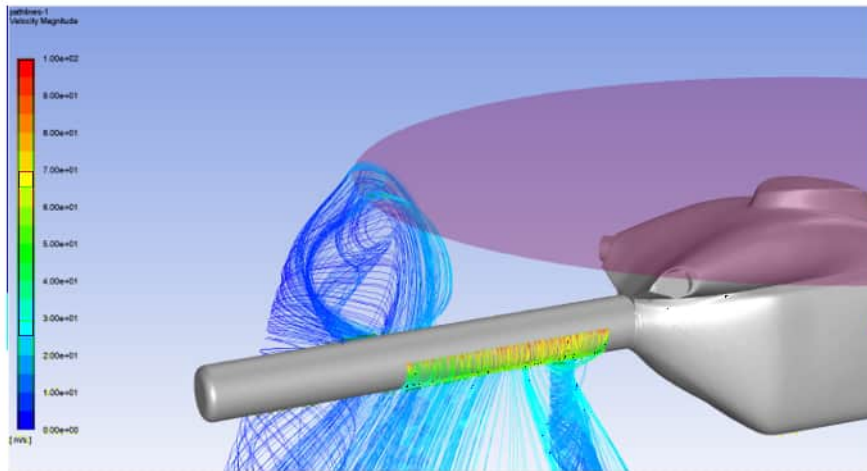
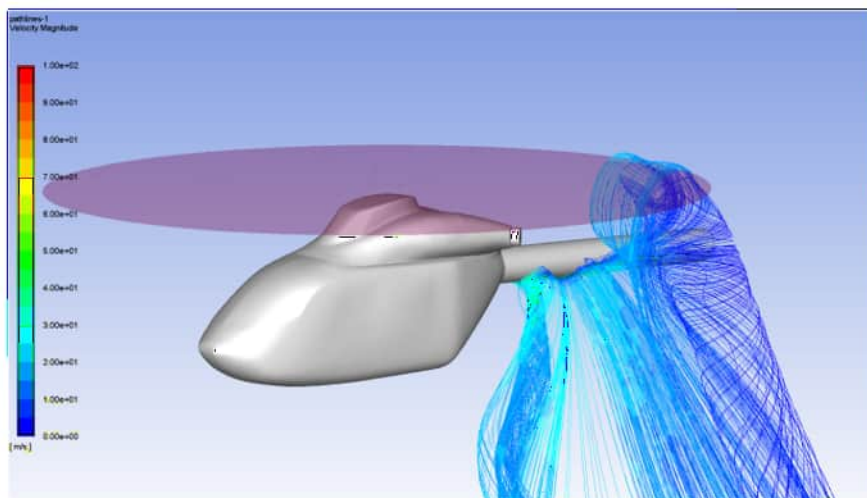
Abbildung 4.11: Detaildarstellung, Stromliniendarstellung bei 6 m Bodenabstand

Abbildung 4.12: Detaildarstellung, Stromliniendarstellung bei 6 m Bodenabstand

Abbildung 4.13: Detaildarstellung, Stromliniendarstellung bei 6 m Bodenabstand

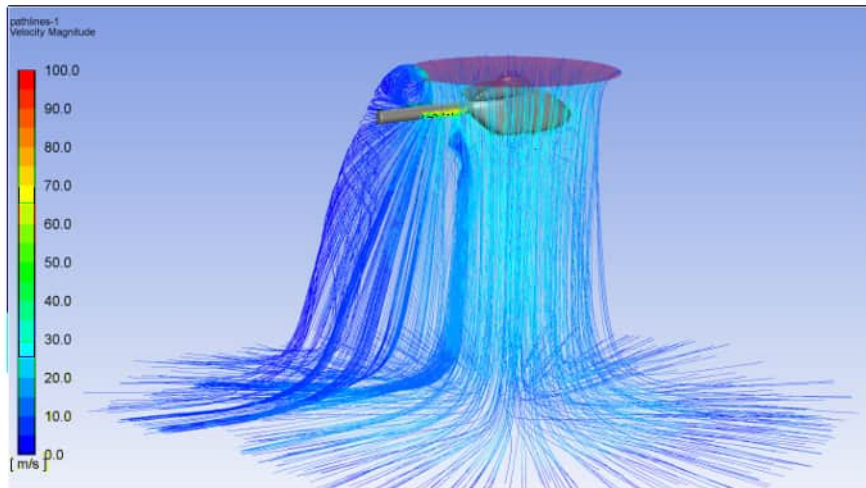
Abbildung (4.14) zeigt das Ergebnis der Simulation für die in dieser Untersuchung maximale Entfernung des Helikopters vom Boden von 15 m. Die beiden großskaligen Wirbel sind weiterhin vorhanden und dominieren das Strömungsbild.

Abbildung 4.14: Stromliniendarstellung bei maximalen Bodenabstand

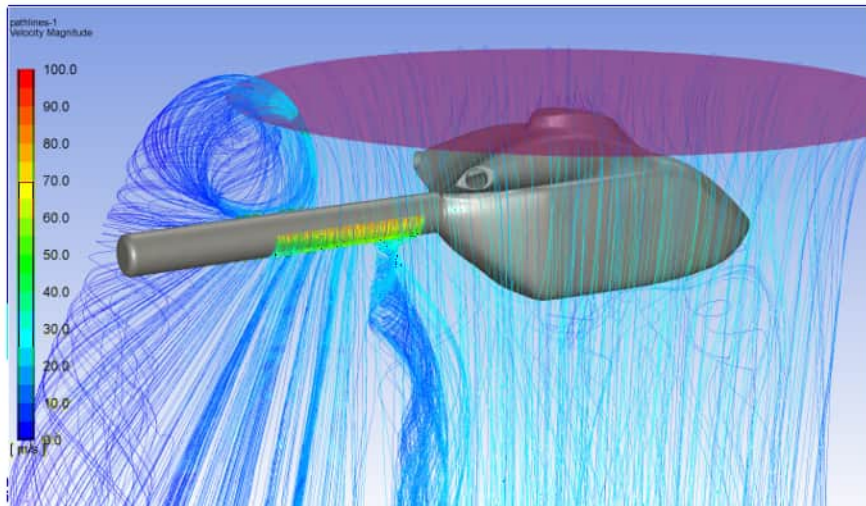
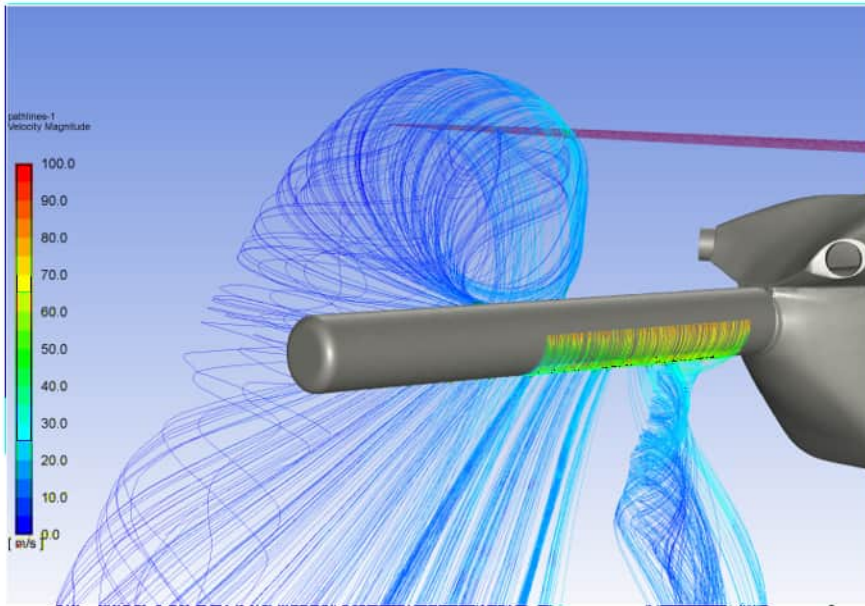
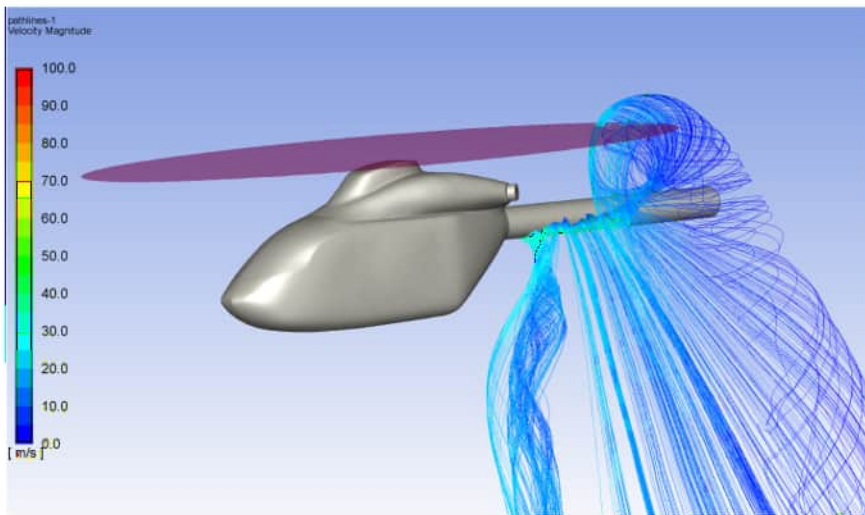
Die Abbildungen (4.15, 4.16) und (4.17) zeigen Detaildarstellungen dieser Wirbel.

Abbildung 4.15: Detaildarstellung, Stromliniendarstellung bei maximalen Bodenabstand

Abbildung 4.16: Detaildarstellung, Stromliniendarstellung bei maximalen Bodenabstand

Abbildung 4.17: Detaildarstellung, Stromliniendarstellung bei maximalen Bodenabstand

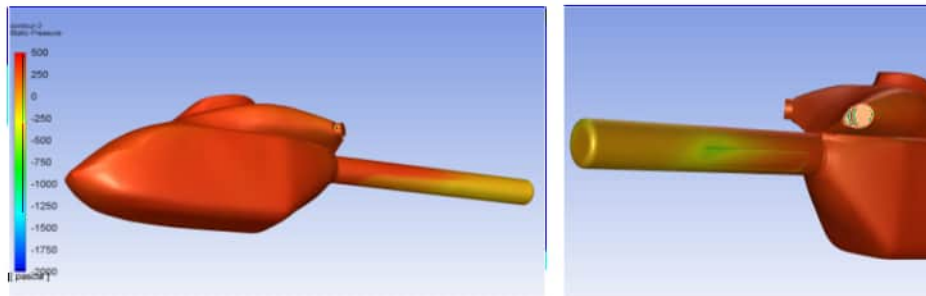
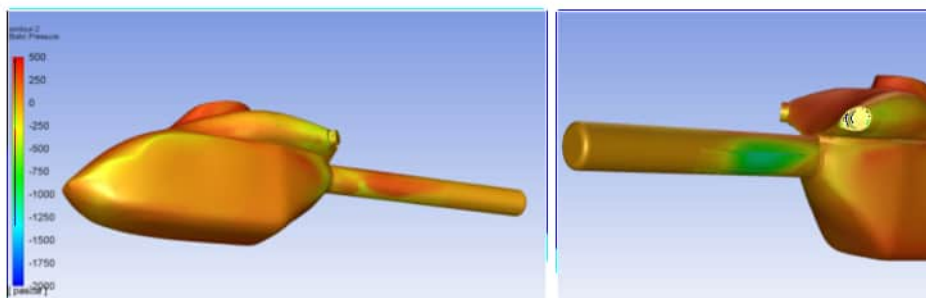
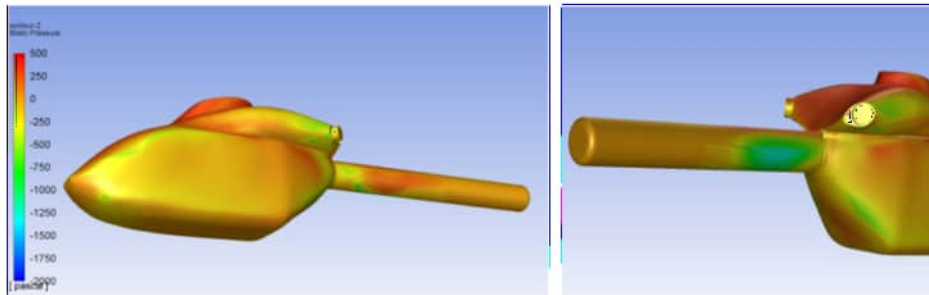
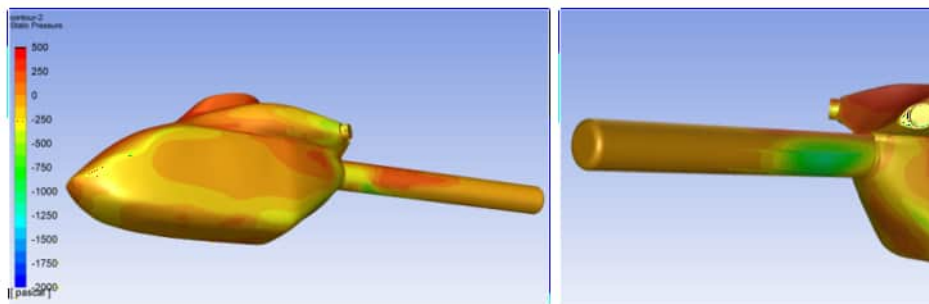
ein Gebiet mit lokalem Unterdruck ersichtlich, welches ab 3 m Bodenabstand seine Lage nicht wesentlich ändert und im Einflussbereich des Rotor liegt. Dieses Unterdruckgebiet entsteht während des Abhebenvorganges bei einem Bodenabstand zwischen 0 m und 3 m.

Abbildung 4.18: Druckverteilung am Helikopter bei 0 m Bodenabstand, Minimum und Maximum der Farbskala geclippt.

Abbildung 4.19: Druckverteilung am Helikopter bei 3 m Bodenabstand, Minimum und Maximum der Farbskala geclippt.

Abbildung 4.20: Druckverteilung am Helikopter bei 6 m Bodenabstand, Minimum und Maximum der Farbskala geclippt.

Abbildung 4.21: Druckverteilung am Helikopter bei 15 m Bodenabstand, Minimum und Maximum der Farbskala geclippt.

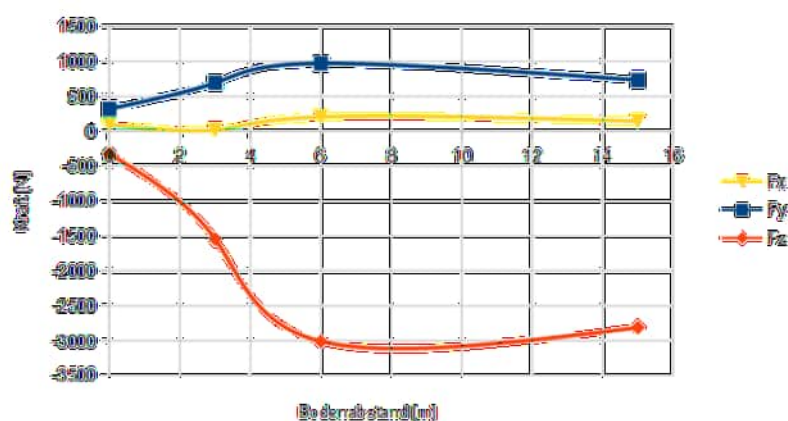
Abbildung 5.1: Kräfte F_x , F_y und F_z , orientiert als Kräfte, die von der Strömung auf den Helikopter wirken, dargestellt über dem Abstand des Helikopters vom Boden

Während die Kraft F_x , in Richtung der Längsachse des Helikopters, relativ wenig variiert und die kleinste absolute Größe über dem Bodenabstand aufweist, nimmt die Kraft F_y , die seitlich auf den Helikopter wirkt, ähnlich der Kraft F_z mit größer werdenden Bodenabstand zu.

Abbildungen (5.1) und (5.2) zeigen, dass mit der Entfernung des Helikopters vom Boden, im Zuge des Abhebevorgangs sowohl die Kräfte als auch die Momente zunehmen. Geht man also davon aus, dass der Hauptrotor unverändert dieselbe Auftriebskraft erzeugt, würde der Gesamtauftrieb des Helikopters sinken.

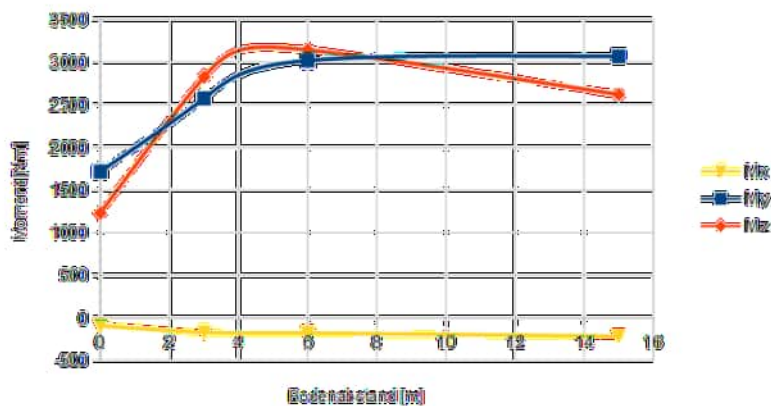
Ebenso wie die Kraft, ist das Moment M_x jenes Moment um die Hochachse, welches von der Strömung auf den Helikopter ausgeübt wird. Da die z-Achse von der Erde weggerichtet positiv gezählt wird, ist das Moment M_x im Uhrzeigersinn drehend. Für die Auswertung des Moments wurde ein Schwerpunkt in der Rotorachse, 1.15 m über der Bodenplatte des Helikopters angenommen. Die erhaltenen Werte sind in Abb. (5.2) über dem Bodenabstand dargestellt. Das Moment M_x wächst von 1000 Nm bei 0 m Bodenabstand auf ca. 3000 Nm in 4 m Höhe. Ein Zuwachs bedeutet eine Drehbewegung um die Hochachse nach links, welche der Pilot mit rechtem Pedal ausgleichen müsste. Ab einer Schwebhöhe von zirka vier Metern hat der Abstand vom Boden keinen Einfluss mehr ($M_x \approx$ konstant). Das Moment M_y , in Richtung der Querachse, nimmt ähnlich dem Giermoment mit größer werdenden Bodenabstand zu.

Abbildung 5.2: Momente M_x , M_y und M_z , orientiert als Momente, die von der Strömung auf den Helikopter wirken, dargestellt über dem Abstand des Helikopters vom Boden
