Final Report

Accident with aircraft Bombardier DHC-8-402,
on 04 April 2019, at ca. 08:56 UTC on Innsbruck Airport (LOWI),
A-6020, Innsbruck, Tyrol
Ref.: 2021-0.432.817

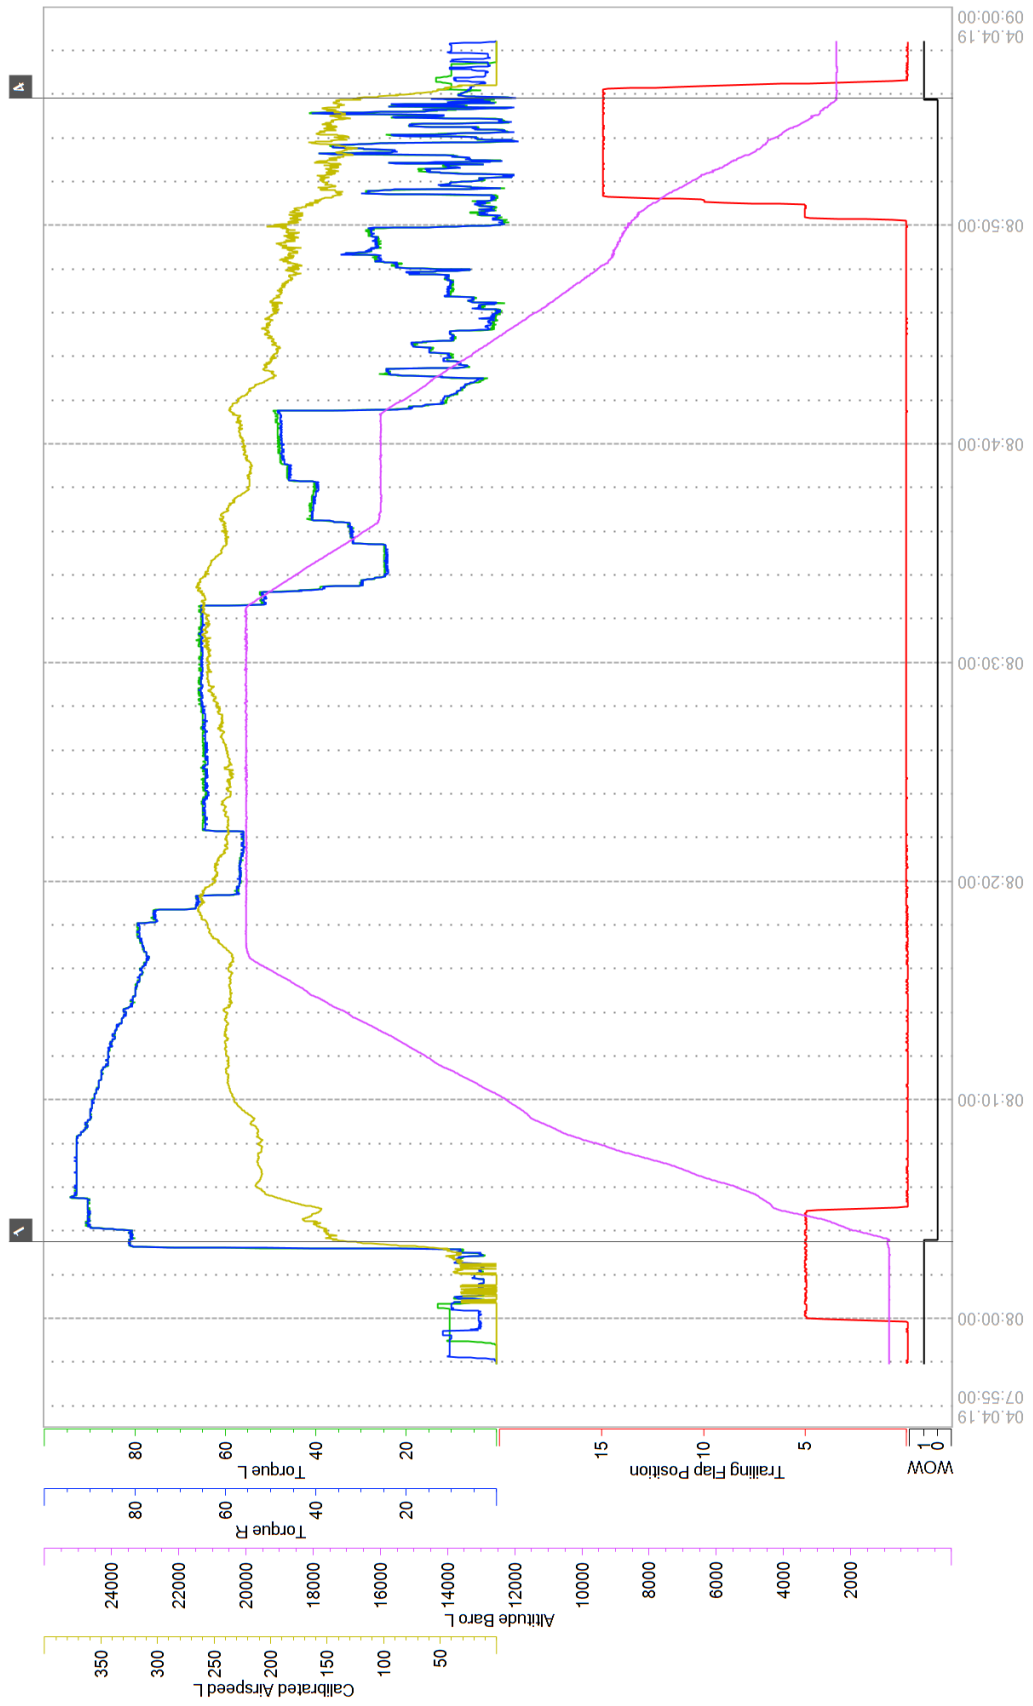
Figure 15: FDR data of the entire flight

The FDR/QAR data relevant for this occurrence can be found in Figure 15 to Figure 17. At the top of the diagrams marked with [1] to [6] are:

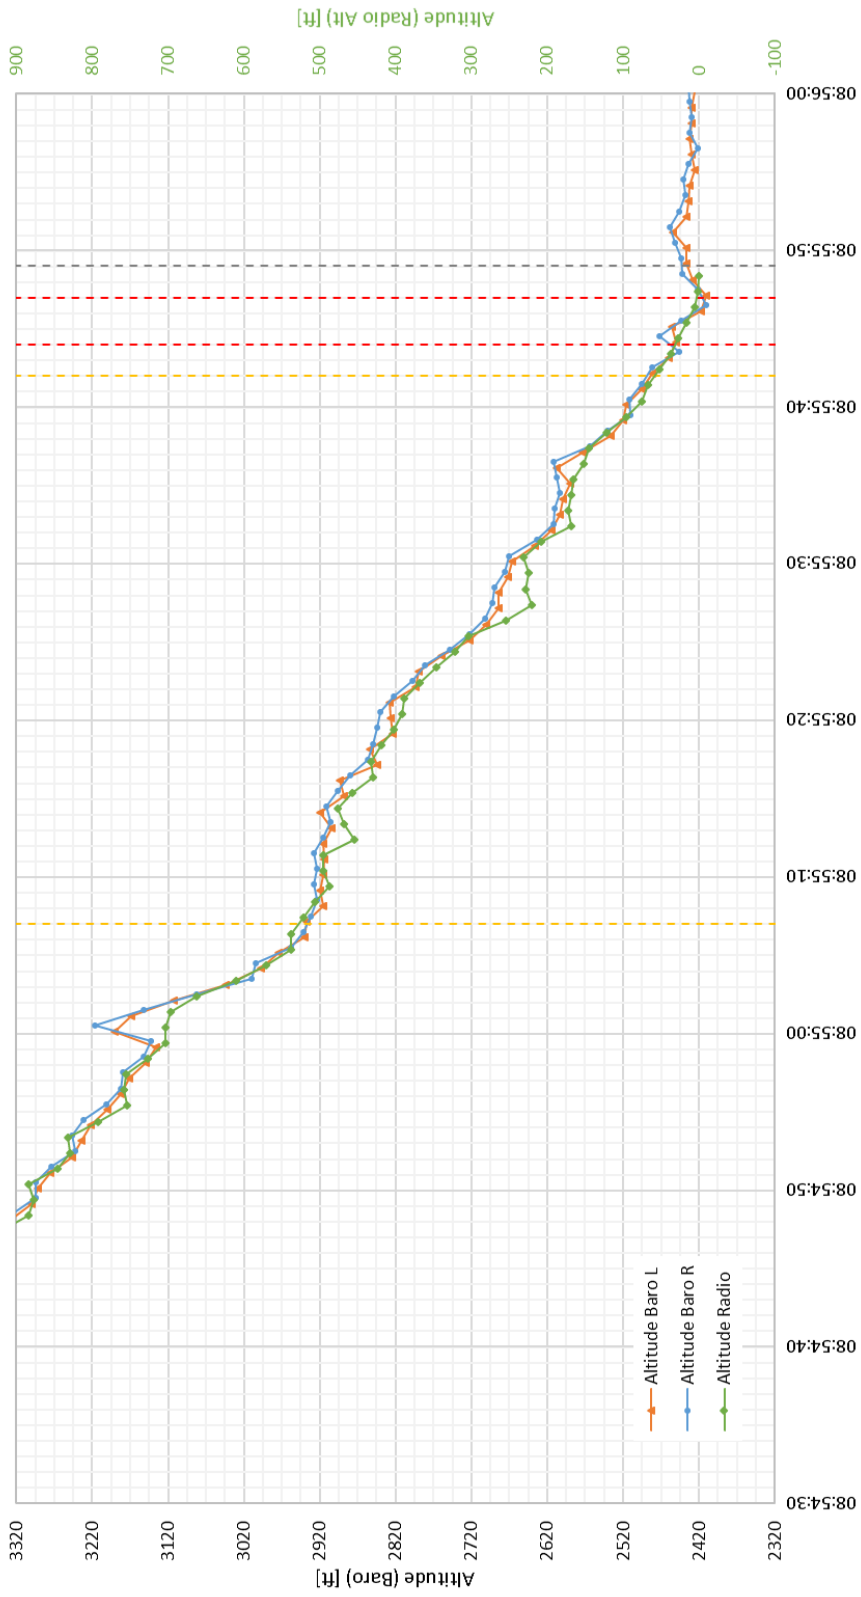
Figure 18: Altitude information

Figure 18 also shows the data of the barometric altimeter (L(ef) and R(ight)) as well as the data of the radar altimeter (Radio). Figure 19 shows the vertical rate of climb and descent calculated from this data. The rates of climb and descent were averaged for smoothing purposes over nine data points of the respective altimeter data. The data from the radar altimeter should be viewed with caution, and therefore only as an additional reference, as it is also affected by the terrain below the aircraft.
