Final Report

Accident with helicopter of type Bell 429,
on 21 November 2021, at approx. 15:53 UTC, at airfield Wr. Neustadt/Ost,
A-2700, Wr. Neustadt, Lower Austria
Ref: 2023-0.384.199

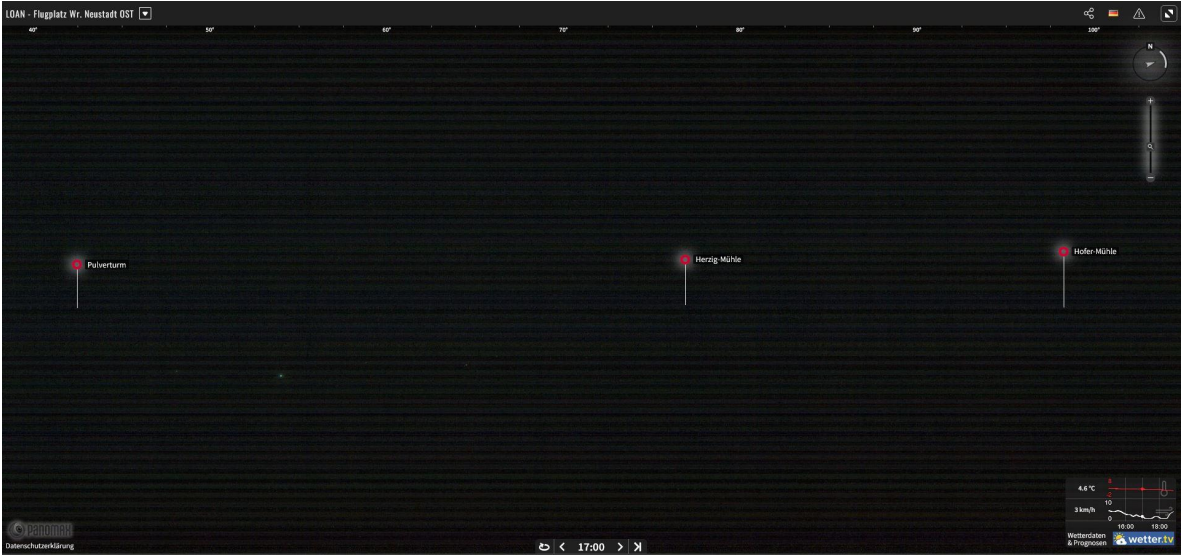
Photos could be retrieved via a webcam located at the airfield Wr. Neustadt/Ost, which provided an indication of the weather at the time of the accident. The images 6 to 10 show the weather at the airfield looking towards the accident site, in particular the prevailing fog and the onset of twilight between 14:40 and 16:00 UTC (shown as local time on the images).

The accident occurred at the airfield Wr. Neustadt/Ost (airfield altitude 273 m / 896 ft) at about 15:53 (16:53 local time). The time of the accident was therefore about 7 minutes after the end of civil evening twilight¹. According to aviation definition, the time of the accident was therefore in the night, thus darkness prevailed, which can also be seen on the recordings of a webcam located at the airfield (Figs. 6 to 10).

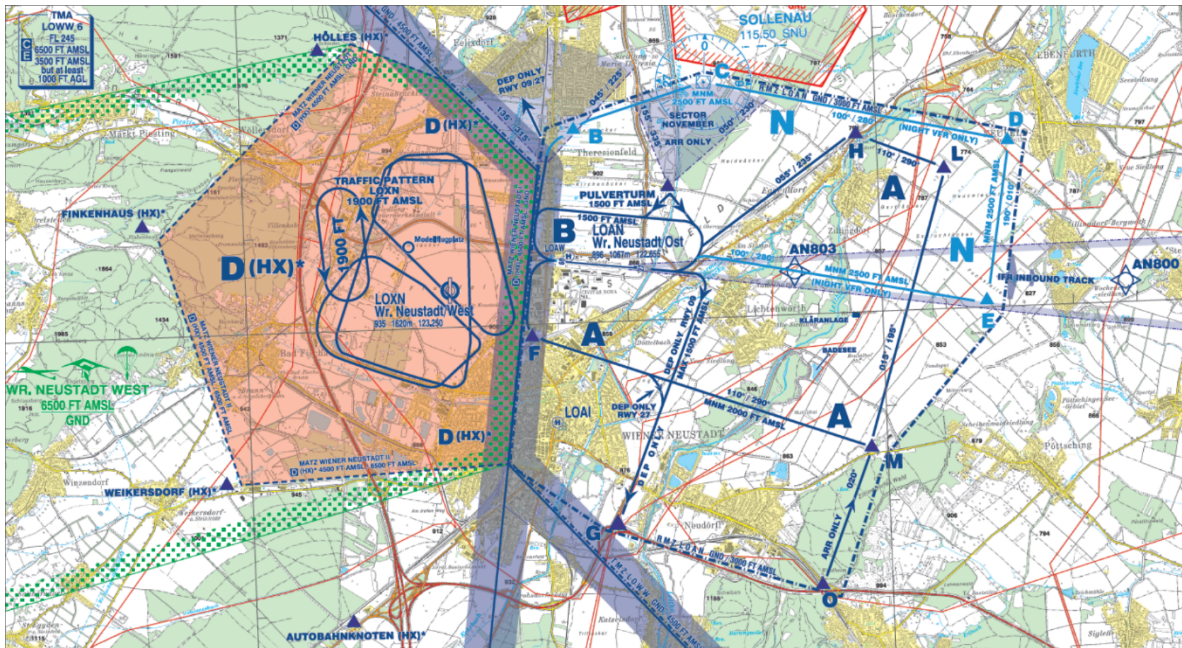
Figure 16 LOAN AIP – Visual flight chart

The approach procedures valid at the time of the accident were described in the AIP. Several visual approach procedures were available at the time of the accident. The approach procedure relevant to this accident for the approach to runway 27 from the south is shown in Figures 15 and 16. At night, i.e. after ECET, traffic pattern N must be used exclusively (Figure 14 and Figure 16, light blue).
